NYC Department of Education
Building Condition Assessment Survey 2023 - 2024

Architectural Inspection

Q414

Asset: PRE-K CENTER @ 106-02 NORTHERN BOULEVARD - QUEENS, 106-02 NORTHERN BOULEVARD, New York, 11368

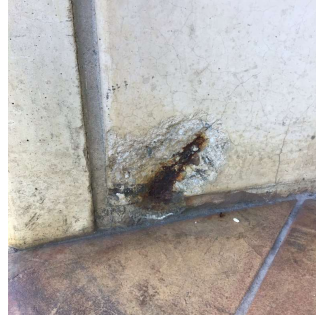
Facade A

Question	Response
EXTERIOR	Inspected
AREAWAY	Does not Exist
AWNINGS AND CANOPIES	Does not Exist
CHIMNEY	Does not Exist
COPING	Not Required
CORNICE	Not Required
DOORS	Inspected
DOORS AND FRAMES	Inspected
Condition	2 - Between Good and Fair
Deficiency	No deficiencies recorded
DOOR HARDWARE	Inspected
Condition	2 - Between Good and Fair
Deficiency	No deficiencies recorded
LINTELS	Inspected
Condition	2 - Between Good and Fair
Deficiency	No deficiencies recorded
TRANSOM/SIDE LIGHT	Inspected
Condition	2 - Between Good and Fair
Deficiency	No deficiencies recorded
EXTERIOR WALLS	Inspected
Material Type(s)	Concrete
Replacement Quantity	800
Replacement Uom	S.F.
Instance on All Facades	Inspected
Instance Condition	4 - Between Fair and Poor
Instance Quantity	800
Instance Quantity Uom	S.F.
Deficiency	CAST IN PLACE / PRE-CAST CONCRETE: MAJOR CRACKS/SPALLING
Roof Plan reference

Deficiency Quantity	10
Quantity Uom	S.F.

REPLACE
PRIORITY 4
LEVEL 2

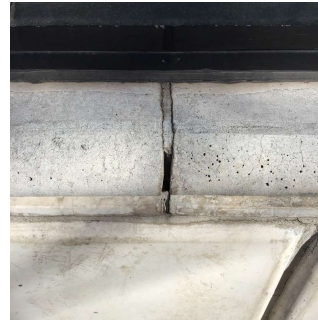
Facade B

CAST IN PLACE / PRE-CAST CONCRETE: DETERIORATED JOINTS

Deficiency Quantity
Quantity Uom
Potential Action
Urgency of Action
Purpose of Action

20
L.F.
REPOINT
PRIORITY 3
LEVEL 2

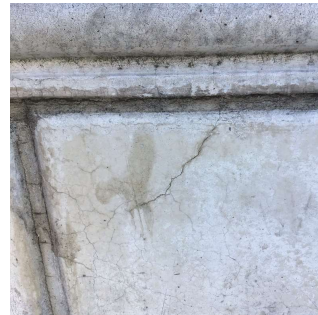
Facade A

CAST IN PLACE / PRE-CAST CONCRETE: MINOR CRACKS/SPALLING

10

S.F.

REPAIR

PRIORITY 3
