NYC Department of Education
Building Condition Assessment Survey 2023 - 2024

Architectural Inspection

Asset: BENJAMIN N. CARDOZO HS - Q, 57-00 223 STREET, New York, 11364

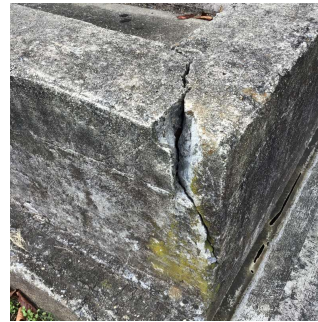
AW2

Question	Response
Architectural	
EXTERIOR	Inspected
AREAWAY	Inspected
Instance on AW1-AW4	Inspected
Instance Condition	3 - Fair
Instance Quantity	4
Instance Quantity Uom	EACH
Deficiency	AREAWAY WALLS: CRACKS AND SPALLING

REPLACE

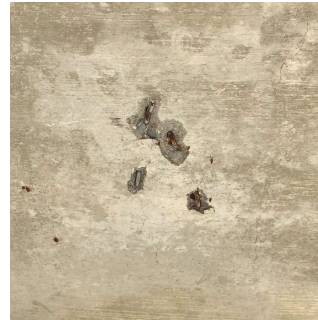
Facade C

CONCRETE: EXPOSED REBAR

REPAIR

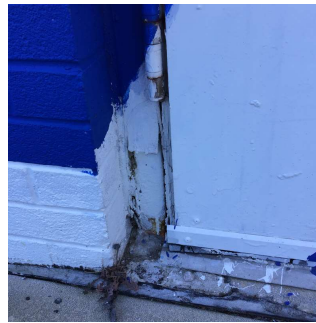
Facade F

METAL CLAD: DETERIORATED DOOR AND FRAME - MAJOR DETERIORATION

4
EACH
REPLACE
PRIORITY 4
LEVEL 2

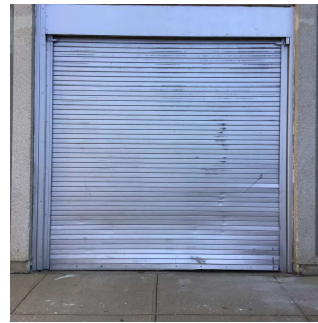
Facade E

ROLL-UP DOOR: DETERIORATED DOOR AND FRAME - MAJOR DETERIORATION

600
S.F.
REPLACE
PRIORITY 4
LEVEL 2

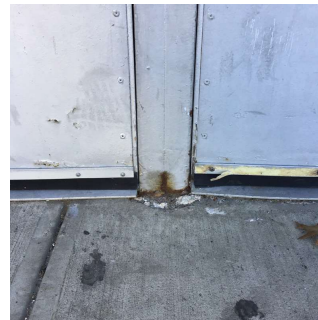
Facade F - Exit 10

METAL CLAD: DETERIORATED DOOR AND FRAME - MINOR DETERIORATION

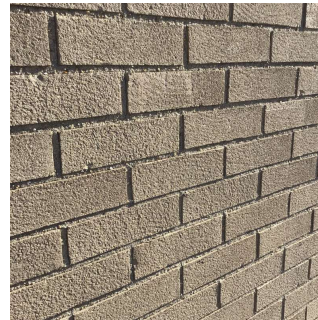
Facade K

BRICK: DETERIORATED JOINTS

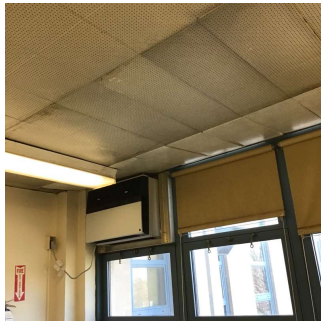
Violations	Room 167 No violations recorded.
Deficiency	ACOUSTIC TILES: DAMAGED/MISSING
Deficiency Location/Instance	Corridor near Rooms 328, 326, 323, 314, 307 and others
Deficiency Quantity	600
Quantity Uom	S.F.
Potential Action	REPLACE
Urgency of Action	PRIORITY 3
Purpose of Action	LEVEL 2

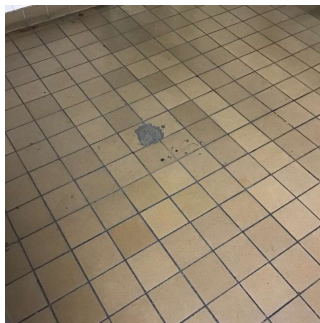
Violations	Serving area No violations recorded.
Walls	
Instance on 1st Floor	Inspected
Condition	2 - Between Good and Fair
Deficiency	CERAMIC TILE: BROKEN/ MISSING
Deficiency Location/Instance	Womens locker Room, near Prep area, Near Locker Room, Serving area
Deficiency Quantity	40
Quantity Uom	S.F.
Potential Action	REPLACE
Urgency of Action	PRIORITY 3
Purpose of Action	LEVEL 2
Deficiency Photo1

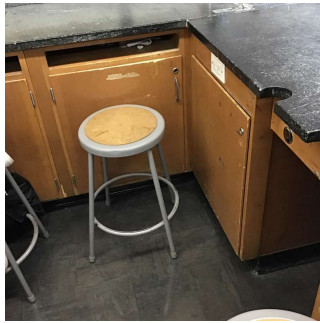
Room 251
Violations	No violations recorded.
SCIENCE PREP ROOM	
	Inspected
Instance on Rooms 252, 258	Inspected
Alternative use	No
Fixed Equipment	
Instance on Rooms 252, 258	Inspected
Condition	3 - Fair
Deficiency	CABINETS: MISSING/DAMAGED
Deficiency Location/Instance	Rooms 252, 258
Deficiency Quantity	10
Quantity Uom	L.F.
Potential Action	REPLACE
Urgency of Action	PRIORITY 3
Purpose of Action	LEVEL 2
Deficiency Photo1

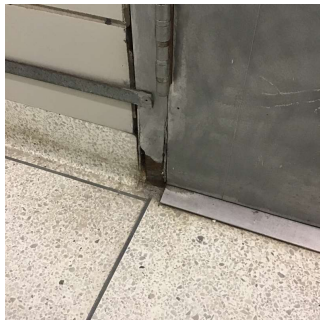
Violations	Stair D/Basement Vestibule No violations recorded.
Deficiency	METAL: DETERIORATED DOOR
Deficiency Location/Instance	Stairs C/1, 3, D/1, 2, F/Basement Vestibule and others
Deficiency Quantity	15
Quantity Uom	EACH
Potential Action	MAINTENANCE
Urgency of Action	PRIORITY 3
Purpose of Action	LEVEL 2
