NYC Department of Education
Building Condition Assessment Survey 2023 - 2024

Architectural Inspection

Asset: SPRINGFIELD GDNS AF - QUEENS, 143-10 SPRINGFIELD BLVD, New York, 11413

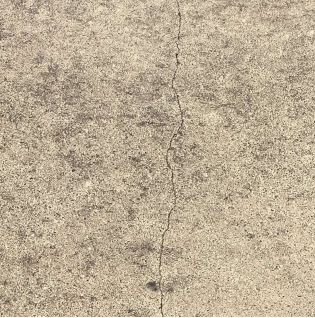
Question	Response
ATHLETIC FIELDS	
PLAYING SURFACE	
Deficiency	No deficiencies recorded
Instance on Football/Soccer Field	Inspected
Instance Condition	2 - Between Good and Fair
Instance Quantity	140,000
Instance Quantity Uom	S.F.
Deficiency	No deficiencies recorded
Instance on Handball Courts	Inspected
Instance Condition	2 - Between Good and Fair
Instance Quantity	4,000
Instance Quantity Uom	S.F.
Deficiency	POURED-IN-PLACE CONCRETE: DAMAGED/WORN OUT
Deficiency Location/Instance	Handball Courts
Roof Plan reference

Deficiency Quantity	30
Quantity Uom	S.F.
Potential Action	REPAIR
Urgency of Action	PRIORITY 3
Purpose of Action	LEVEL 2
Deficiency Photo1

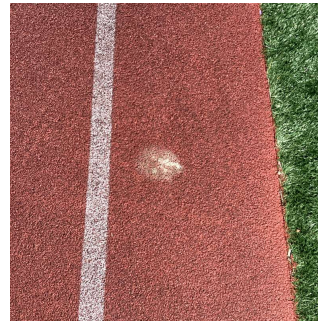
Handball Courts
Violations	No violations recorded.
Instance on Running Track	Inspected
Instance Condition	3 - Fair
Instance Quantity	42,000
Instance Quantity Uom	S.F.
Deficiency	ATHLETIC WEARING SURFACE: DAMAGED/DETERIORATED
Deficiency Location/Instance	Running Track

Deficiency Quantity

170

REPLACE

PRIORITY 4

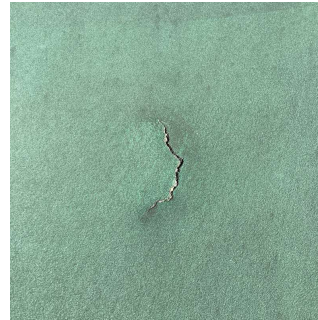
ASPHALT: DAMAGED/DETERIORATED

Tennis Courts

10

REPAIR

PRIORITY 3

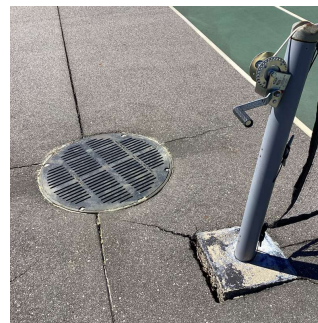
ASPHALT: DAMAGED/DETERIORATED

Tennis Courts

30

REPLACE

PRIORITY 4

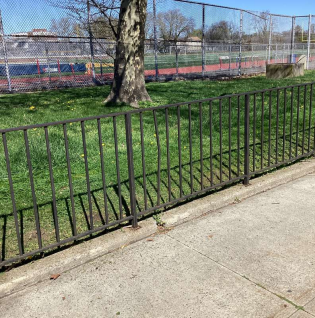
Drainage System for Soil	Inspected
Catch Basins/Manhole - Surrounded by Soil	Inspected
Condition	2 - Between Good and Fair
Deficiency	No deficiencies recorded
Culverts - Soil Covering	Does not Exist
DRINKING FOUNTAINS	
Condition	2 - Between Good and Fair
Deficiency	No deficiencies recorded
FENCES	
Condition	4 - Between Fair and Poor
Deficiency	WROUGHT IRON: DAMAGED/DETERIORATED
Deficiency Location/Instance	Springfield Boulevard
Deficiency Quantity	160
Quantity Uom	S.F.
Potential Action	REPLACE
Urgency of Action	PRIORITY 3
Purpose of Action	LEVEL 2

Question	Response
SITE	
FENCES	
Deficiency Photo1

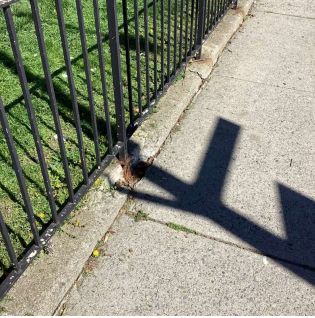
Violations	Springfield Boulevard No violations recorded.
Deficiency	CONCRETE CURB: DAMAGED/DETERIORATED
Deficiency Location/Instance	Springfield Boulevard
Deficiency Quantity	140
Quantity Uom	S.F.
Potential Action	REPLACE
Urgency of Action	PRIORITY 3
Purpose of Action	LEVEL 2
Deficiency Photo1

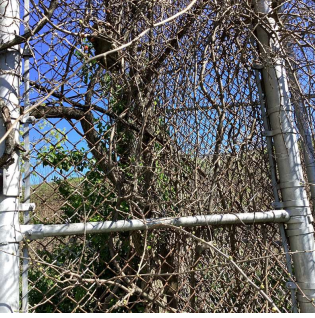
Violations	Springfield Boulevard No violations recorded.
Deficiency	CHAIN LINK: RUST - MAJOR
Deficiency Location/Instance	Near Baseball Field, Near Exit 20
Deficiency Quantity	1,000
Quantity Uom	S.F.
Potential Action	REPLACE
Urgency of Action	PRIORITY 3
Purpose of Action	LEVEL 2
Deficiency Photo1

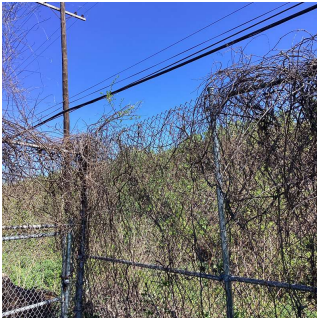
Violations	Near Baseball Field No violations recorded.
Deficiency	CHAIN LINK: DAMAGED POST/RAIL

Question	Response
SITE	
FENCES	
Deficiency Location/Instance	Near Baseball Field, 185th street, Near Exit 18
Deficiency Quantity	80
Quantity Uom	L.F.
Potential Action	REPLACE
Urgency of Action	PRIORITY 3
Purpose of Action	LEVEL 2
Deficiency Photo1

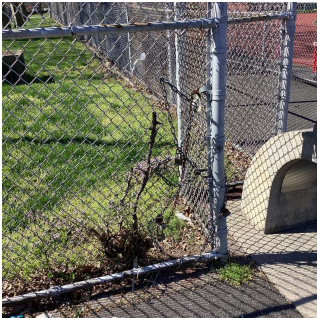
Violations	Near Baseball Field No violations recorded.
Deficiency	CHAIN LINK: DAMAGED/DETERIORATED
Deficiency Location/Instance	Springfield boulevard, Near Baseball Field, 185th Street
Deficiency Quantity	1,700
Quantity Uom	S.F.
Potential Action	REPLACE
Urgency of Action	PRIORITY 3
Purpose of Action	LEVEL 2
Deficiency Photo1

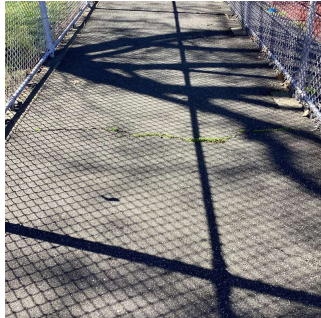
Question	Response
SITE	
PAVING	
Student Use	
Asphalt	Inspected
Deficiency	No deficiencies recorded
Concrete	Inspected
Condition	2 - Between Good and Fair
Deficiency	No deficiencies recorded
Pavers	Does not Exist
Site Sidewalks & Walkways	Inspected
Asphalt	Inspected
Condition	3 - Fair
Deficiency	CRACKS - MAJOR
Deficiency Location/Instance	Near Springfield boulevard, Near Bleachers, Near Tennis Courts
Deficiency Quantity	400
Quantity Uom	S.F.
Potential Action	REPLACE
Urgency of Action	PRIORITY 3
Purpose of Action	LEVEL 2
Deficiency Photo1

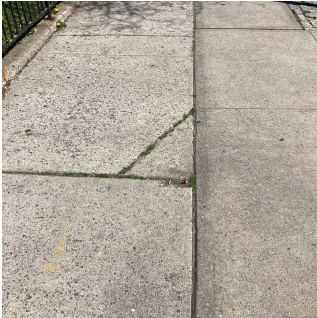
Priority Condition Exist Last Year?	Priority Category	Condition Description	Component Affected	Location Description	Person(s) Notified	Person(s) Title	PhotoImage
Yes	Tripping Hazard	Severely heaving concrete DOT sidewalk is a potential tripping hazard.	SITE PAVING DOT Sidewalk Concrete	Springfield Boulevard	Jose Chacone	Fireman

Question	Response
SITE	
PAVING	
DOT Sidewalk	
Concrete	
Violations	No violations recorded.
Deficiency	DAMAGED/DETERIORATED/MISSING SECTIONS
Deficiency Location/Instance	Springfield Boulevard, 185th Street
Deficiency Quantity	1,050
Quantity Uom	S.F.
Potential Action	REPLACE
Urgency of Action	PRIORITY 3
Purpose of Action	LEVEL 2
Deficiency Photo1

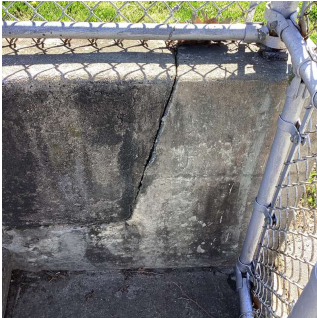
Violations	Springfield Boulevard No violations recorded.
Pavers	Does not Exist
PLAYGROUNDS	Does not Exist
RETAINING WALLS	Inspected
Are there any Retaining Walls 6' OR higher facing public street/sidewalk?	No
Condition	3 - Fair
Deficiency	CAST IN PLACE CONCRETE: CRACKS/SPALLING - MAJOR
Deficiency Location/Instance	Near Springfield boulevard, Near Tennis Courts,
Deficiency Quantity	80
Quantity Uom	S.F.
Potential Action	REPLACE
Urgency of Action	PRIORITY 3
Purpose of Action	LEVEL 2
Deficiency Photo1

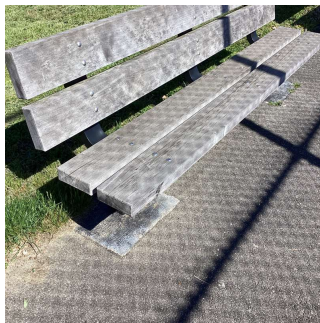
Question	Response
SITE	
SEATING	
Benches	
Concrete	Does not Exist
Metal/Wood/Plastic	Inspected
Condition	3 - Fair
Deficiency	DAMAGED/DETERIORATED
Deficiency Location/Instance	Near Tennis Courts
Deficiency Quantity	1
Quantity Uom	EACH
Potential Action	REPLACE
Urgency of Action	PRIORITY 3
Purpose of Action	LEVEL 2
Deficiency Photo1

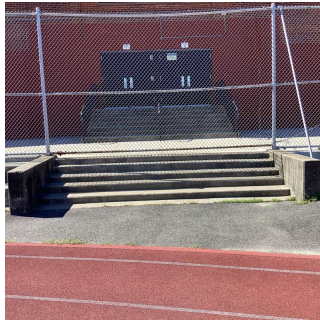
Violations	Near Tennis Courts No violations recorded.
SITE WALLS (NOT RETAINING WALLS)	Inspected
Condition	2 - Between Good and Fair
Deficiency	No deficiencies recorded
STAIRS/RAMPS: EXTERIOR	Inspected
Railings	Inspected
Condition	4 - Between Fair and Poor
Deficiency	MISSING
Deficiency Location/Instance	Near Exit 18
Deficiency Quantity	10
Quantity Uom	L.F.
Potential Action	REPLACE
Urgency of Action	PRIORITY 5
Purpose of Action	LEVEL 6
Deficiency Photo1

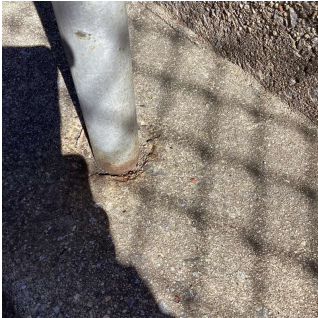
Violations	Near Exit 18 No violations recorded.
Deficiency	DAMAGED
Deficiency Location/Instance	Near Springfield boulevard

Question	Response
SITE	
STAIRS/RAMPS: EXTERIOR	
Railings	
Deficiency Quantity	10
Quantity Uom	L.F.
Potential Action	REPLACE
Urgency of Action	PRIORITY 3
Purpose of Action	LEVEL 2
Deficiency Photo1

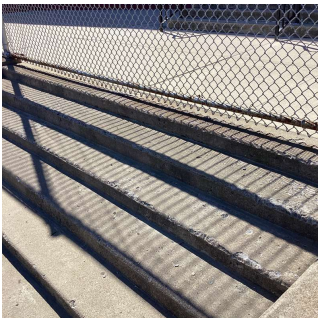
Near Springfield boulevard
Violations	No violations recorded.
Site Cheek/flank Walls	Inspected
Condition	2 - Between Good and Fair
Deficiency	No deficiencies recorded
Stairs/ramps	Inspected
Condition	2 - Between Good and Fair
Deficiency	CAST IN PLACE CONCRETE: CRACKS/SPALLING - MAJOR
Deficiency Location/Instance	Near Exit 18
Deficiency Quantity	30
Quantity Uom	S.F.
Potential Action	REPLACE
Urgency of Action	PRIORITY 3
Purpose of Action	LEVEL 2
Deficiency Photo1
