NYC Department of Education
Building Condition Assessment Survey 2023 - 2024

Architectural Inspection

Asset: **PRE-K CENTER @ 98-22 55 AVENUE - QUEENS, 98-22 55 AVENUE, New York, 11368**

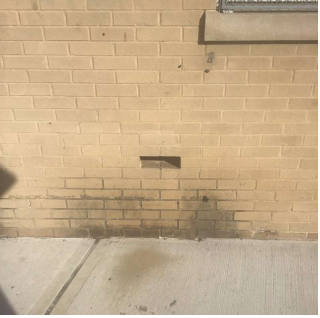
Question	Response
EXTERIOR	
DOORS	
TRANSOM/SIDE LIGHT	Inspected
Condition	2 - Between Good and Fair
Deficiency	No deficiencies recorded
EXTERIOR WALLS	Inspected
Material Type(s)	Masonry, Steel
Replacement Quantity	2,400
Replacement Uom	S.F.
Instance on Facades A, B	Inspected
Instance Condition	4 - Between Fair and Poor
Instance Quantity	2,400
Instance Quantity Uom	S.F.
Deficiency	BRICK: MAJOR / THRU CRACKS
Roof Plan reference

Deficiency Quantity	10
Quantity Uom	S.F.
Potential Action	REMOVE AND REBUILD
Urgency of Action	PRIORITY 4
Purpose of Action	LEVEL 2
Deficiency Photo1

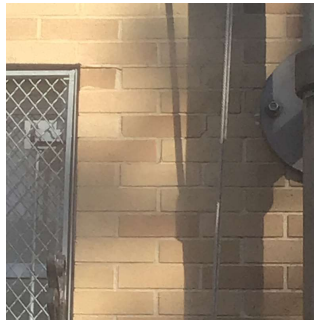
Violations	Facade A No violations recorded.
Deficiency	BRICK: MINOR CRACKS AND SPALLING

RESTITCH

PRIORITY 3

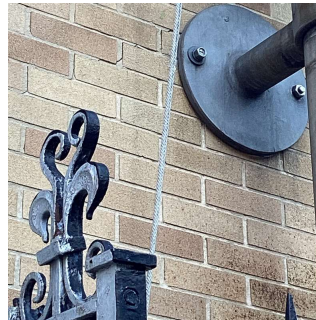
Facade A

BRICK: DETERIORATED JOINTS

REPOINT

PRIORITY 3

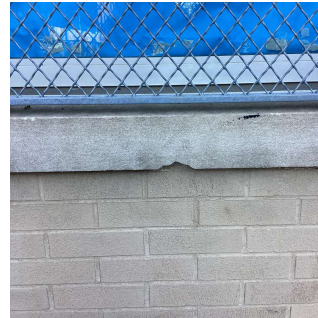
Facade A

BRICK: DETERIORATED MASONRY SILLS - MINOR

REPAIR

PRIORITY 3
LEVEL 2

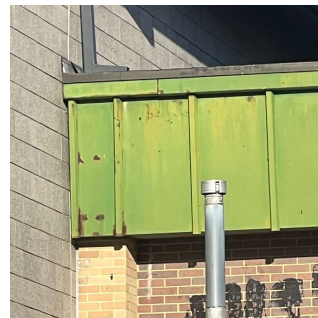
Facade A

METAL PANEL: MAJOR RUSTING

REPLACE

PRIORITY 4

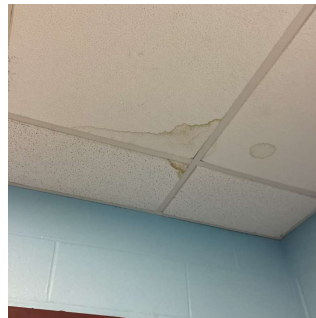
Roof 1 - Room 103 (Roof 1 - Room 104 similar)

Deficiency	MODIFIED BITUMEN: ROOFING: MAJOR ACTIVE ROOF LEAKS IN INSTRUCTIONAL SPACE
------------	---

REPLACE ROOFING WITH MAJOR EQUIPMENT REMOVAL
 PRIORITY 5

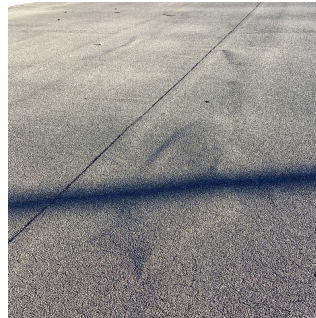
Roof 2

Deficiency	MODIFIED BITUMEN: ROOFING: DELAMINATION
------------	---

REPLACE ROOFING WITH MAJOR EQUIPMENT REMOVAL
 PRIORITY 4

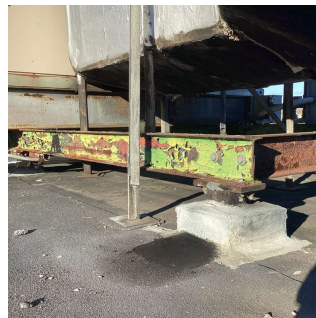
Roof 2

HEIGHT LESS THAN 18"

REPLACE

PRIORITY 3

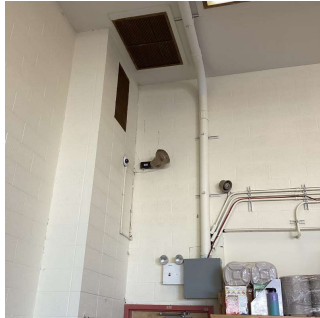
Question	Response
INTERIOR	
GYMNASIUM	
Floor Finish	
Deficiency	No deficiencies recorded
Seating	
Instance on 1st Floor	Does not Exist
Sliding-folding Partition	
Instance on 1st Floor	Does not Exist
Stage	
Instance on 1st Floor	Does not Exist
Walls	
Instance on 1st Floor	Inspected
Condition	2 - Between Good and Fair
Deficiency	MASONRY: CRACKS/SPALLING
Deficiency Location/Instance	Left Side
Deficiency Quantity	20
Quantity Uom	S.F.
Potential Action	REPLACE
Urgency of Action	PRIORITY 3
Purpose of Action	LEVEL 2
Deficiency Photo1

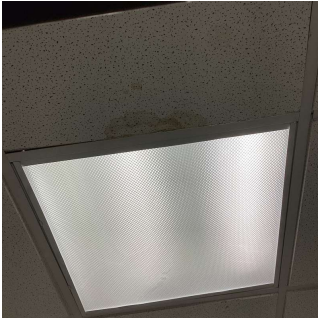
Question	Response
INTERIOR	
TOILET ROOMS - STAFF	
Ceiling	
Deficiency	ACOUSTIC TILES: DAMAGED/MISSING
Deficiency Location/Instance	Inside Room 103
Deficiency Quantity	10
Quantity Uom	S.F.
Potential Action	REPLACE
Urgency of Action	PRIORITY 3
Purpose of Action	LEVEL 2
Deficiency Photo1

Violations	Inside Room 103 No violations recorded.
Door(s)	Inspected
Condition	2 - Between Good and Fair
Deficiency	No deficiencies recorded
Floor Finish	Inspected
Condition	2 - Between Good and Fair
Deficiency	No deficiencies recorded
Stalls	Does not Exist
Walls	Inspected
Condition	2 - Between Good and Fair
Deficiency	No deficiencies recorded
TOILET ROOMS - STUDENTS	
Ceiling	Inspected
Condition	2 - Between Good and Fair
Deficiency	No deficiencies recorded
Door(s)	Inspected
Condition	2 - Between Good and Fair
Deficiency	No deficiencies recorded
Floor Finish	Inspected
Condition	2 - Between Good and Fair
Deficiency	No deficiencies recorded
