**NYC Department of Education**  
**Building Condition Assessment Survey 2023 - 2024**

Architectural Inspection

Q443

**Asset:**           **3K CENTER @ 18-31 131ST STREET - QUEENS, 18-31 131ST STREET, 11356**

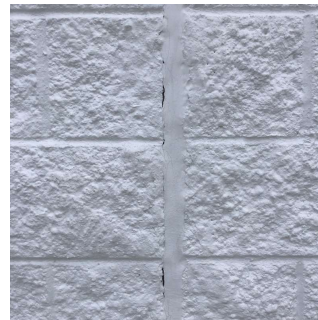
Facade D

STONE: DETERIORATED CONTROL/EXPANSION JOINTS

Deficiency Quantity

30

Quantity Uom

L.F.

Potential Action

MAINTENANCE

Urgency of Action

PRIORITY 3

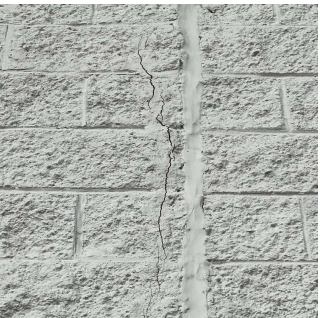
STONE: CHIPPED/SPALLED/BROKEN PIECES - MINOR

Deficiency Quantity	40
Quantity Uom	S.F.
Potential Action	REPAIR
Urgency of Action	PRIORITY 3
Purpose of Action	LEVEL 2
Deficiency Photo1

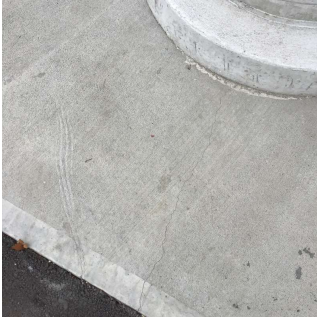
Question	Response
<b>SITE</b>	
<b>PAVING</b>	
<b>Student Use</b>	Inspected
<b>Pavers</b>	Does not Exist
<b>Site Sidewalks &amp; Walkways</b>	Inspected
<b>Asphalt</b>	Inspected
Condition	1 - Good
Deficiency	No deficiencies recorded
<b>Concrete</b>	Inspected
Condition	2 - Between Good and Fair
Deficiency	CRACKS - MAJOR
Deficiency Location/Instance	Near Main Entrance
Deficiency Quantity	25
Quantity Uom	S.F.
Potential Action	REPLACE
Urgency of Action	PRIORITY 3
Purpose of Action	LEVEL 2
Deficiency Photo1

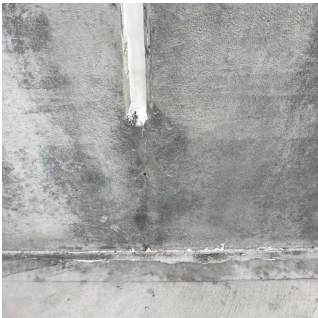
Near Playground
Violations	No violations recorded.
<b>SEATING</b>	Inspected
<b>Benches</b>	
<b>Concrete</b>	Does not Exist
<b>Metal/Wood/Plastic</b>	Inspected

Question	Response
<b>SITE</b>	
<b>PLAYGROUNDS</b>	
<b>Play Equipment</b>	
Instance on Main Entrance - South	Inspected
Condition	1 - Good
Deficiency	No deficiencies recorded
<b>Safety Surfacing</b>	
Instance on Main Entrance - South	Inspected
Condition	1 - Good
Deficiency	No deficiencies recorded
<b>Unpaved Area</b>	
Instance on Main Entrance - South	Does not Exist
<b>PLAYING SURFACE</b>	Does not Exist
<b>RETAINING WALLS</b>	Inspected
Are there any Retaining Walls 6' OR higher facing public street/sidewalk?	No
Condition	2 - Between Good and Fair
Deficiency	CAST IN PLACE CONCRETE: CRACKS/SPALLING - MAJOR
Deficiency Location/Instance	Near Playground
Deficiency Quantity	10
Quantity Uom	S.F.
Potential Action	REPLACE
Urgency of Action	PRIORITY 3
Purpose of Action	LEVEL 2
Deficiency Photo1
