NYC Department of Education
Building Condition Assessment Survey 2023 - 2024

Architectural Inspection

Q446

Asset: BRYANT AF - QUEENS, 48-10 31 AVENUE, New York, 11103

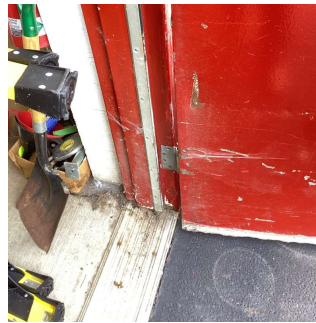
Facade A

Deficiency METAL: DETERIORATED DOOR AND FRAME - MINOR DETERIORATION

Deficiency Quantity 4
 Quantity Uom EACH
 Potential Action MAINTENANCE
 Urgency of Action PRIORITY 3
 Purpose of Action LEVEL 2

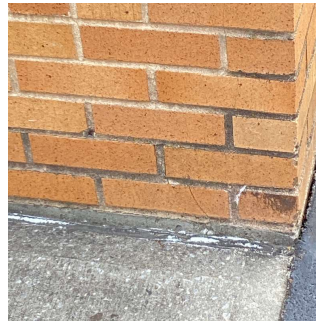
Facade B

BRICK: MINOR CRACKS AND SPALLING

S.F.
RESTITCH
PRIORITY 3
LEVEL 2

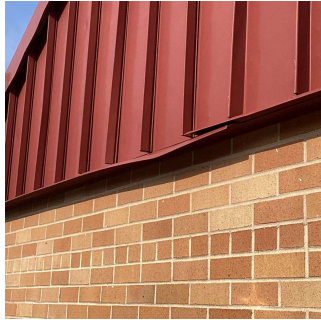
METAL PANEL: DAMAGED TRIM

10
L.F.
REPLACE
PRIORITY 4
LEVEL 2

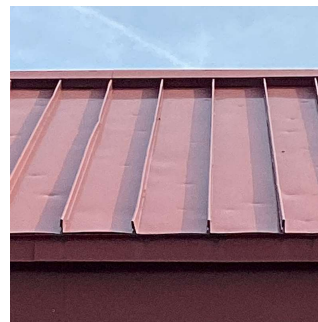
Roof 1

Deficiency	METAL: ROOFING: DETERIORATED

Deficiency Quantity

REPAIR

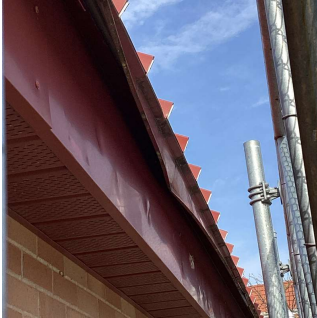
METAL: FLASHING: DETERIORATED METAL FLASHING

REMOVE AND REPLACE

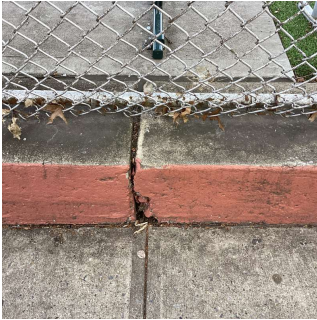
Condition	1 - Good
Deficiency	No deficiencies recorded
Culverts - Concrete Covering	Does not Exist
Drainage System for Soil	Does not Exist
DRINKING FOUNTAINS	Inspected
Condition	1 - Good
Deficiency	No deficiencies recorded
FENCES	Inspected
Condition	3 - Fair
Deficiency	CONCRETE CURB: DAMAGED/DETERIORATED
Deficiency Location/Instance	49th Street
Deficiency Quantity	40
Quantity Uom	S.F.
Potential Action	REPLACE
Urgency of Action	PRIORITY 3
Purpose of Action	LEVEL 2

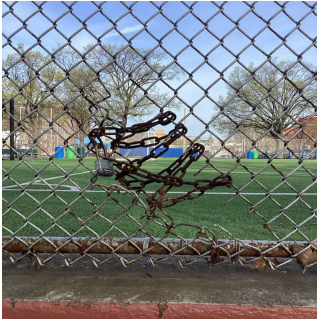
Violations	49th Street No violations recorded.
Deficiency	CHAIN LINK: DAMAGED/DETERIORATED
Deficiency Location/Instance	49th Street
Deficiency Quantity	200
Quantity Uom	S.F.
Potential Action	REPLACE
Urgency of Action	PRIORITY 3
Purpose of Action	LEVEL 2
Deficiency Photo1

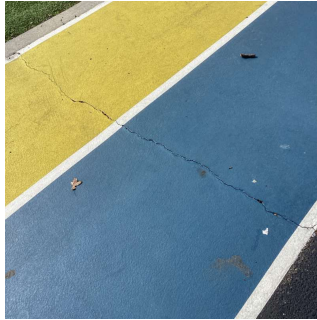
Violations	49th Street No violations recorded.
IRRIGATION SYSTEM	Does not Exist
PAVING	Inspected
Student Non-Use	Inspected
Gravel Exists?	No
Asphalt	Does not Exist
Concrete	Inspected
Condition	1 - Good
Deficiency	No deficiencies recorded
Pavers	Does not Exist
Student Use	Inspected
Gravel Exists?	No
Asphalt	Inspected
Condition	2 - Between Good and Fair
Deficiency	CRACKS - MAJOR
Deficiency Location/Instance	48th Street
Deficiency Quantity	10
Quantity Uom	S.F.
Potential Action	REPLACE

Question	Response
SITE	
PAVING	
Student Use	
Asphalt	
Urgency of Action	PRIORITY 3
Purpose of Action	LEVEL 2
Deficiency Photo1

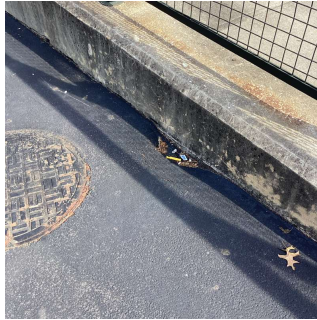
Violations	48th Street No violations recorded.
Concrete	Inspected
Condition	1 - Good
Deficiency	No deficiencies recorded
Pavers	Does not Exist
Site Sidewalks & Walkways	Inspected
Asphalt	Inspected
Condition	2 - Between Good and Fair
Deficiency	POTHOLES
Deficiency Location/Instance	Near Drinking Fountain
Deficiency Quantity	10
Quantity Uom	S.F.
Potential Action	REPAIR
Urgency of Action	PRIORITY 3
Purpose of Action	LEVEL 2
Deficiency Photo1

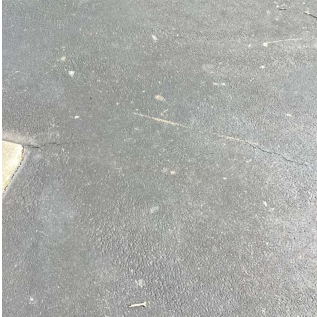
Violations	Near Drinking Fountain No violations recorded.
Deficiency	CRACKS - MAJOR
Deficiency Location/Instance	48th Street
Deficiency Quantity	10
Quantity Uom	S.F.
Potential Action	REPLACE
Urgency of Action	PRIORITY 3
Purpose of Action	LEVEL 2

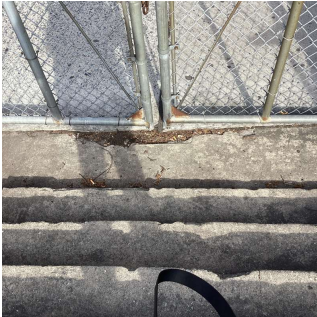
Violations	48th Street No violations recorded.
Concrete	Inspected
Condition	2 - Between Good and Fair
Deficiency	CRACKS - MAJOR
Deficiency Location/Instance	48th Street
Deficiency Quantity	25
Quantity Uom	S.F.
Potential Action	REPLACE
Urgency of Action	PRIORITY 3
Purpose of Action	LEVEL 2
Deficiency Photo1

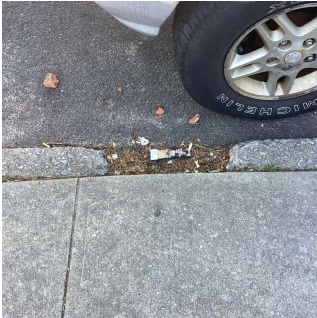
Question	Response
SITE	
PAVING	
DOT Sidewalk	
Concrete	
Violations	No violations recorded.
Deficiency	DAMAGED CURBS
Deficiency Location/Instance	Newtown Road, 48th Street, Broadway
Deficiency Quantity	170
Quantity Uom	L.F.
Potential Action	REPLACE
Urgency of Action	PRIORITY 3
Purpose of Action	LEVEL 2
Deficiency Photo1

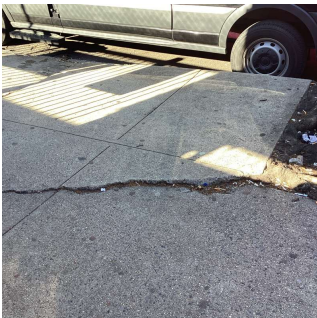
Violations	Newtown Road No violations recorded.
Deficiency	HEAVING
Deficiency Location/Instance	Newtown Road, 48th Street, 49th Street
Deficiency Quantity	325
Quantity Uom	S.F.
Potential Action	REPLACE
Urgency of Action	PRIORITY 5
Purpose of Action	LEVEL 6
Deficiency Photo1

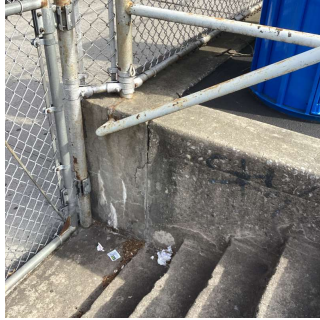
Question	Response
SITE	
RETAINING WALLS	
Deficiency Quantity	10
Quantity Uom	L.F.
Potential Action	REPLACE
Urgency of Action	PRIORITY 3
Purpose of Action	LEVEL 2
Deficiency Photo1	 
Violations	Newtown Road No violations recorded.
Deficiency	CAST IN PLACE CONCRETE: CRACKS/SPALLING - MAJOR
Deficiency Location/Instance	48th Street, Newtown Road, Broadway, 49th Street, near Schoolyard
Deficiency Quantity	360
Quantity Uom	S.F.
Potential Action	REPLACE
Urgency of Action	PRIORITY 3
Purpose of Action	LEVEL 2
Deficiency Photo1	 
Violations	Broadway No violations recorded.
SEATING	Does not Exist
SITE WALLS (NOT RETAINING WALLS)	Inspected
Condition	2 - Between Good and Fair
Deficiency	No deficiencies recorded
STAIRS/RAMPS: EXTERIOR	Inspected
Railings	Inspected
Condition	2 - Between Good and Fair
Deficiency	No deficiencies recorded
Site Cheek/flank Walls	Inspected
Condition	2 - Between Good and Fair
Deficiency	CAST IN PLACE CONCRETE: CRACKS/SPALLING - MAJOR

Deficiency Location/Instance	48th Street
Deficiency Quantity	10
Quantity Uom	S.F.

Question	Response
SITE	
STAIRS/RAMPS: EXTERIOR	
Site Cheek/flank Walls	
Potential Action	REPLACE
Urgency of Action	PRIORITY 3
Purpose of Action	LEVEL 2
Deficiency Photo1

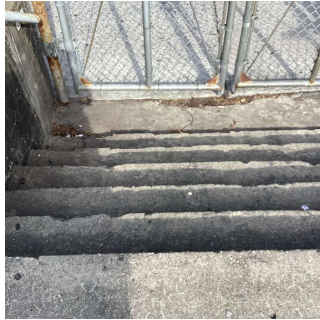
Violations	48th Street No violations recorded.
Stairs/ramps	Inspected
Condition	3 - Fair
Deficiency	CAST IN PLACE CONCRETE: CRACKS/SPALLING - MAJOR
Deficiency Location/Instance	48th Street
Deficiency Quantity	50
Quantity Uom	S.F.
Potential Action	REPLACE
Urgency of Action	PRIORITY 3
Purpose of Action	LEVEL 2
Deficiency Photo1
