NYC Department of Education
Building Condition Assessment Survey 2023 - 2024

Architectural Inspection

Asset: NEWCOMERS HIGH SCHOOL (OLD LIC)-Q, 28-01 41ST AVENUE, New York, 11101

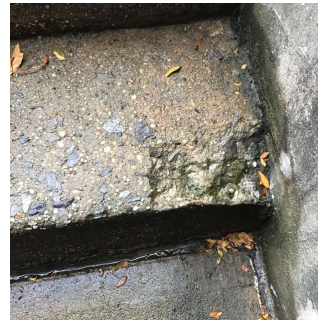
AW7

Deficiency	AREAWAY STAIRS: DETERIORATED TREADS/RISERS/NOSINGS
------------	--

Deficiency Quantity	10
Quantity Uom	S.F.
Potential Action	REPLACE
Urgency of Action	PRIORITY 4
Purpose of Action	LEVEL 2
Deficiency Photo1

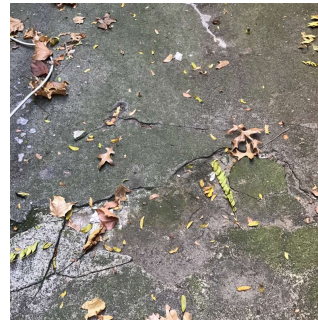
AW

AREAWAY SLAB: CRACKS AND SPALLING

REPLACE

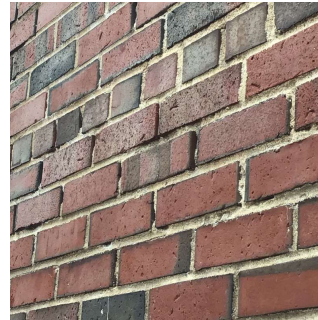
CH

BRICK: DETERIORATED JOINTS

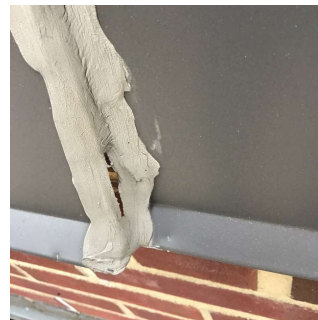
Roof 3

METAL: DETERIORATED TRANSVERSE JOINTS

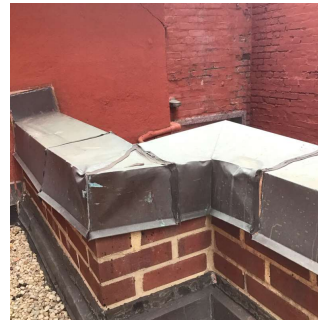
Roof 7

METAL: DETERIORATED

REPLACE-IN-KIND

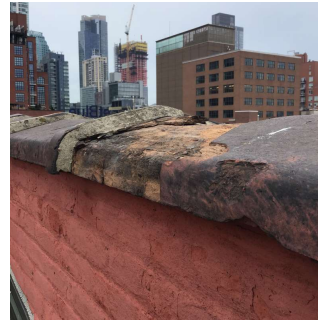
Roof 2

TERRA COTTA: CRACKED/BROKEN PIECES

REPLACE-IN-KIND

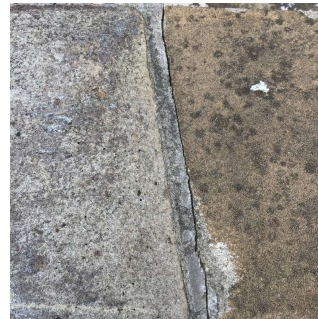
Roof 2

CAST STONE: DETERIORATED TRANSVERSE JOINTS

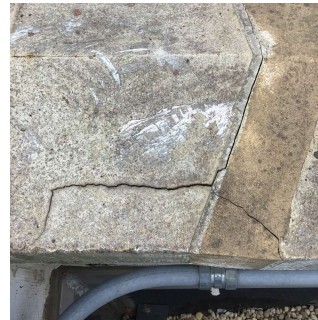
Roof 2

CAST STONE: CRACKED/BROKEN PIECES

REPLACE-IN-KIND

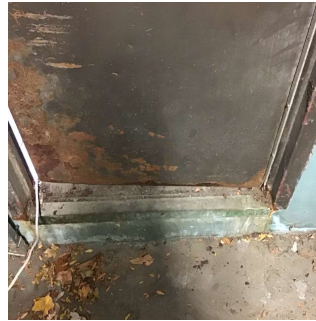
Facade H

METAL: DETERIORATED DOOR AND FRAME - MAJOR DETERIORATION

REPLACE

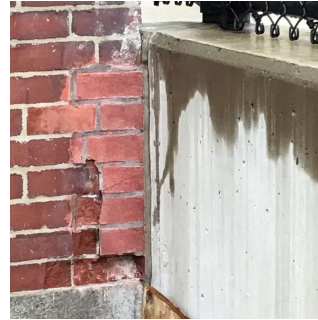
Facade H

BRICK: CRACKS/DISPLACED/SPALLED BRICK AT BUILDING CORNERS

10
S.F.
REMOVE AND REBUILD
PRIORITY 4
LEVEL 2

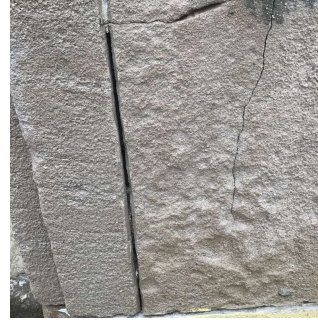
Facade H

STONE: DETERIORATED JOINTS

30
L.F.
REPOINT
PRIORITY 4
LEVEL 2

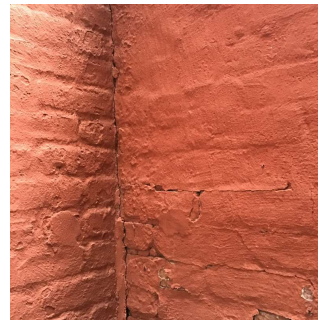
Roof 7

Deficiency	BRICK: MAJOR DETERIORATION/CRACKS
Roof Plan reference

Deficiency Quantity	10
Quantity Uom	S.F.
Potential Action	REMOVE AND REBUILD
Urgency of Action	PRIORITY 4
Purpose of Action	LEVEL 2
Deficiency Photo1

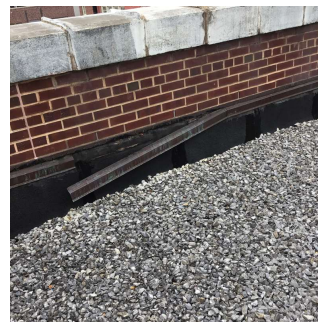
Roof 1

Does this roof instance have a Sustainable Roof System?	No
Do solar panels exist on these roofs?	No
Is/Are the roof(s) suitable for Solar Panel installation?	Yes
Installation Year	1995
Source of Installation	Custodial Staff
Deficiency	IRMA: FLASHING: CAP FLASHING DAMAGED

10
L.F.
REPLACE
PRIORITY 4
LEVEL 2

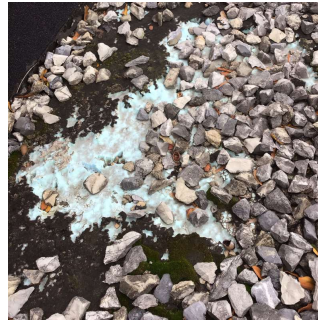
Roof 1

IRMA: ROOFING: DAMAGED INSULATION

120
S.F.
REPLACE
PRIORITY 4
LEVEL 2

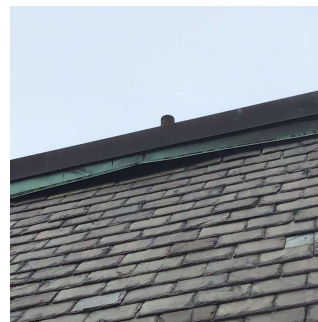
Question	Response
EXTERIOR	
ROOF	
Roofing	
ROOFING	
	Roof 3
Instance Quantity	4,000
Instance Quantity Uom	S.F.
Does the roof have major mechanical equipment sitting on Dunnage Steel less than 18" above the Roofing?	No
Does this roof instance have a Sustainable Roof System?	No
Do solar panels exist on these roofs?	No
Is/Are the roof(s) suitable for Solar Panel installation?	No
Installation Year	1954
Source of Installation	Custodial Staff
Deficiency	SLATE ROOF: ROOFING: MAJOR ACTIVE ROOF LEAKS IN INSTRUCTIONAL SPACE
Roof Plan reference	 
Deficiency Quantity	100
Quantity Uom	S.F.
Potential Action	REPLACE ROOFING
Urgency of Action	PRIORITY 5
Purpose of Action	LEVEL 2
Deficiency Photo1	 
	Roof 9 - Auditorium vestibule exit 8
Violations	No violations recorded.
Deficiency	SLATE ROOF: FLASHING: DETERIORATED METAL FLASHING

Roof 3
No violations recorded.

20
L.F.
REMOVE AND REPLACE
PRIORITY 4
LEVEL 2

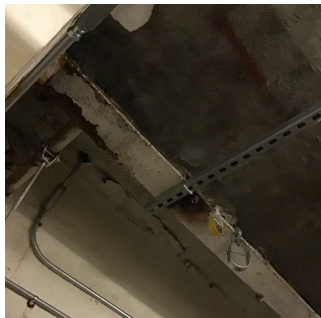
Basement - SB4
Violations	No violations recorded.
Deficiency	STEEL COLUMNS/BEAMS: DETERIORATED MASONRY FIREPROOFING
Deficiency Location/Instance	Basement - SB4
Deficiency Quantity	20
Quantity Uom	S.F.
Potential Action	REPLACE

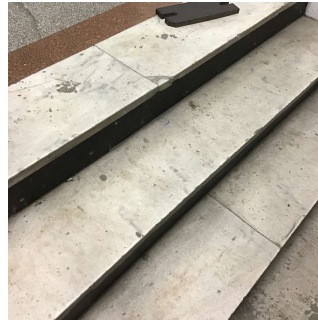
Yes	Tripping Hazard	Deteriorated stone stair tread is a potential Tripping Hazard.	INTERIOR STAIRS/RAMP S: INTERIOR Stairs and Landings	Vestibule Exit 9	Rolend Pompey	Handyman
