NYC Department of Education
Building Condition Assessment Survey 2023 - 2024

Architectural Inspection

Asset: LONG ISLAND CITY HS (NEW) - Q, 14-30 BROADWAY, New York, 11101

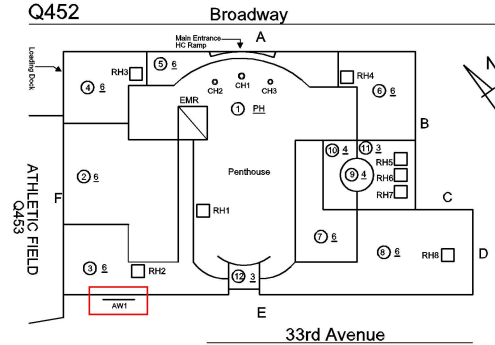
Roof Plan reference

AREAWAY WALLS: CRACKS AND SPALLING

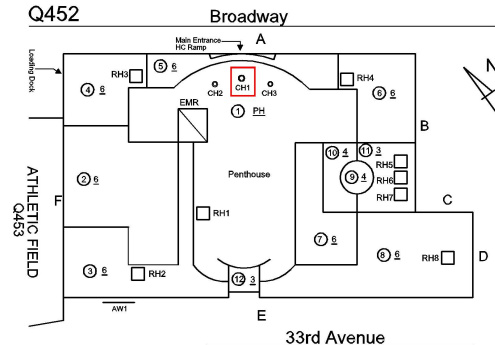
Roof Plan reference

METAL: DENTS, MAJOR RUSTING

Deficiency Quantity	10
Quantity Uom	S.F.
Potential Action	REPLACE-UPGRADE
Urgency of Action	PRIORITY 4
Purpose of Action	LEVEL 2
Deficiency Photo1

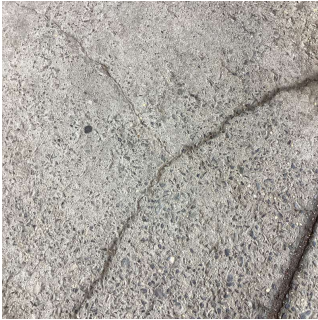
DETERIORATED CONCRETE PLATFORM WITH CRACKED, SPALLED CONCRETE OR EXPOSED REINFORCING

10
S.F.
REPAIR
PRIORITY 3
LEVEL 2

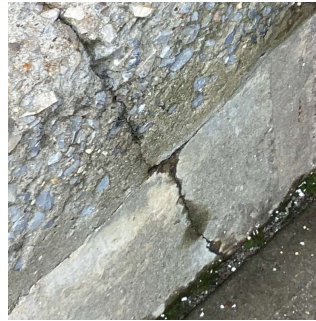
Facade F

CAST IN PLACE CONCRETE: CRACKS/SPALLING - MINOR

10
S.F.
REPAIR
PRIORITY 3
LEVEL 2

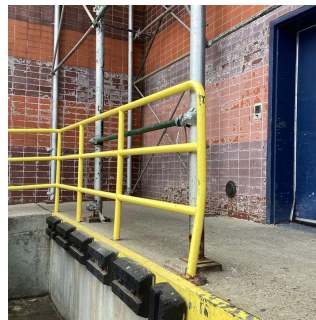
Facade F

DAMAGED

REPLACE

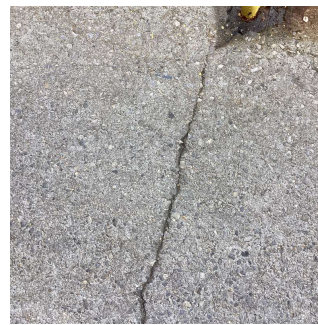
Facade F

CONCRETE: CRACKS/SPALLING - MINOR

30
S.F.
REPAIR
PRIORITY 3
LEVEL 2

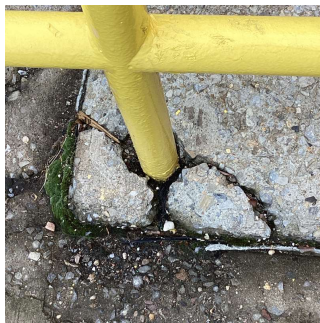
CONCRETE: CRACKS/SPALLING - MAJOR

10
S.F.
REPLACE
PRIORITY 4
LEVEL 2

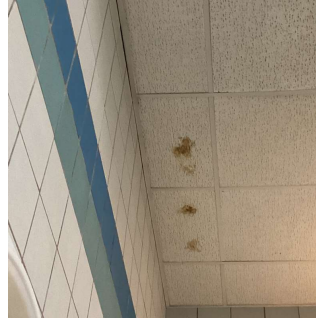
CEILING	
Instance on 1st Floor	Inspected
Condition	3 - Fair
Deficiency	ACOUSTIC TILE: MISSING/WATER DAMAGED/BROKEN TILES
Deficiency Location/Instance	1st Floor
Deficiency Quantity	10
Quantity Uom	S.F.

Potential Action	REPLACE
Urgency of Action	PRIORITY 4
Purpose of Action	LEVEL 2
Deficiency Photo1

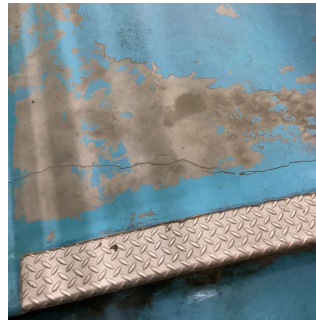
Deficiency	CONCRETE: CRACKS/SPALLING
Deficiency Location/Instance	1st Floor
Deficiency Quantity	30
Quantity Uom	S.F.
Potential Action	REPAIR
Urgency of Action	PRIORITY 3
Purpose of Action	LEVEL 2
Deficiency Photo1

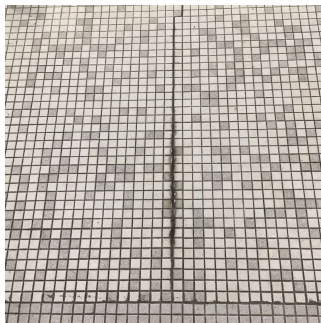
Deficiency	CERAMIC TILES: BROKEN/MISSING/WORN TILES
Deficiency Location/Instance	1st Floor
Deficiency Quantity	100
Quantity Uom	S.F.
Potential Action	REPLACE
Urgency of Action	PRIORITY 4
Purpose of Action	LEVEL 2

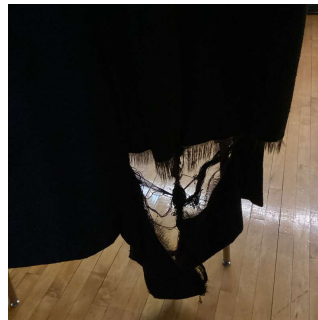
Lateral Left Side

Instance on 1st Floor (605 Seats)	Inspected
Condition	4 - Between Fair and Poor
Deficiency	WORN/DETERIORATED
Deficiency Location/Instance	Lateral Right and Left Side
Deficiency Quantity	400
Quantity Uom	S.F.
Potential Action	REPLACE
Urgency of Action	PRIORITY 3
Purpose of Action	LEVEL 2
Deficiency Photo1

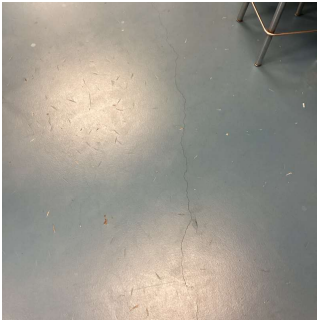
Violations	Room 313 No violations recorded.
Deficiency	EPOXY FLOORING: CRACKS/SPALLING
Deficiency Location/Instance	Rooms 602, 662, 684, 668, 674, and others
Deficiency Quantity	600
Quantity Uom	S.F.
Potential Action	REPLACE
Urgency of Action	PRIORITY 3
Purpose of Action	LEVEL 2
Deficiency Photo1

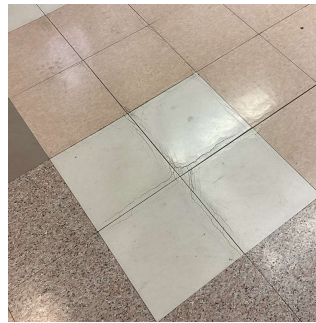
Violations	Room 668 No violations recorded.
Deficiency	VINYL TILES: DETERIORATED SUBSTRATE
Deficiency Location/Instance	Corridor near Room 480
Deficiency Quantity	50
Quantity Uom	S.F.
Potential Action	REPLACE
Urgency of Action	PRIORITY 3
Purpose of Action	LEVEL 2

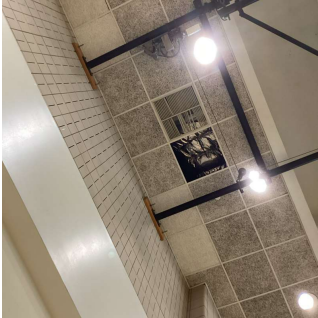
Question	Response
INTERIOR	
GYMNASIUM	
Ceiling	
Instance on 2nd Floor	Inspected
Condition	2 - Between Good and Fair
Deficiency	TECTUM: DAMAGED/MISSING
Deficiency Location/Instance	Near Entrance
Deficiency Quantity	10
Quantity Uom	S.F.
Potential Action	REPLACE
Urgency of Action	PRIORITY 3
Purpose of Action	LEVEL 2
Deficiency Photo1

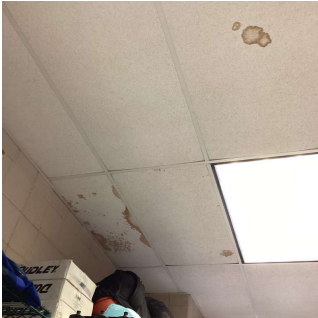
Violations	Near Entrance No violations recorded.
Deficiency	ACOUSTIC TILES: DAMAGED/MISSING
Deficiency Location/Instance	Room 286 Gymnasium Office, Near Entrance
Deficiency Quantity	40
Quantity Uom	S.F.
Potential Action	REPLACE
Urgency of Action	PRIORITY 3
Purpose of Action	LEVEL 2
Deficiency Photo1

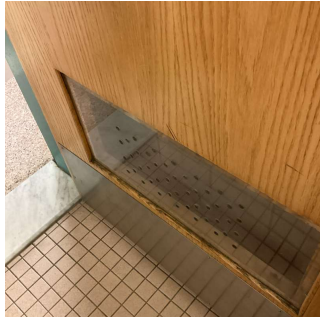
Violations	Room 677M No violations recorded.
Door(s)	Inspected
Condition	5 - Poor
Deficiency	WOOD: DAMAGED LOUVER
Deficiency Location/Instance	Room 277G
Deficiency Quantity	1
Quantity Uom	EACH
Potential Action	MAINTENANCE
Urgency of Action	PRIORITY 3
Purpose of Action	LEVEL 2
Deficiency Photo1

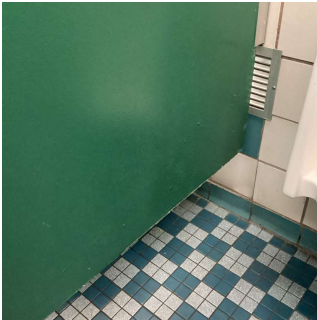
Room 277B
Violations	No violations recorded.
Floor Finish	Inspected
Condition	2 - Between Good and Fair
Deficiency	No deficiencies recorded
Stalls	Inspected
Condition	4 - Between Fair and Poor
Deficiency	RUST - MAJOR
Deficiency Location/Instance	Room 143
Deficiency Quantity	1
Quantity Uom	EACH
Potential Action	REPLACE
Urgency of Action	PRIORITY 3
Purpose of Action	LEVEL 2
Deficiency Photo1

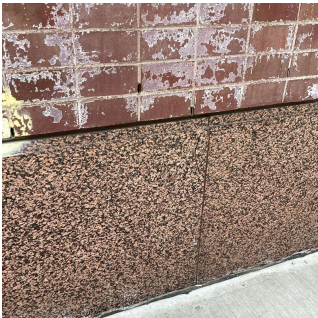
Violations	Broadway Avenue No violations recorded.
Pavers	Does not Exist
PLAYGROUNDS	Inspected
Instance on East Side of the building	Inaccessible
PLAYING SURFACE	Does not Exist
RETAINING WALLS	Inspected
Are there any Retaining Walls 6' OR higher facing public street/sidewalk?	No
Condition	2 - Between Good and Fair
Deficiency	No deficiencies recorded
SEATING	Does not Exist
SITE WALLS (NOT RETAINING WALLS)	Inspected
Condition	3 - Fair
Deficiency	STONE: CRACKS/SPALLING - MAJOR
Deficiency Location/Instance	Containerization Area
Deficiency Quantity	40
Quantity Uom	S.F.
Potential Action	REPLACE
Urgency of Action	PRIORITY 3
Purpose of Action	LEVEL 2
Deficiency Photo1
