NYC Department of Education
Building Condition Assessment Survey 2023 - 2024

Architectural Inspection

Q453

Asset: LONG ISLAND CITY AF - QUEENS, 14-30 BROADWAY, New York, 11106

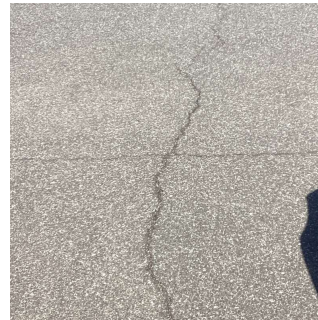
Question	Response
Architectural	
EXTERIOR	Does not Exist
INTERIOR	Does not Exist
ATHLETIC FIELDS	Inspected
PLAYING SURFACE	Inspected
Synthetic Turf Field exists?	Yes
Year of Installation	2013
Replacement Quantity	129,000
Replacement Uom	S.F.
Instance on Football/Baseball/Soccer Field	Inspected
Instance Condition	2 - Between Good and Fair
Instance Quantity	105,000
Instance Quantity Uom	S.F.
Deficiency	No deficiencies recorded
Instance on Tennis Courts	Inspected
Instance Condition	3 - Fair
Instance Quantity	24,000
Instance Quantity Uom	S.F.
Deficiency	ASPHALT: DAMAGED/DETERIORATED
Deficiency Location/Instance	Tennis Courts

300
S.F.
REPAIR
PRIORITY 3
LEVEL 2

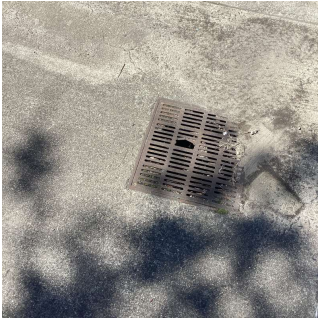
Question	Response
SITE	
CONTAINERIZATION	Does not Exist
Drainage System for Asphalt	Inspected
Catch Basins/Manhole - Surrounded by asphalt	Inspected
Condition	2 - Between Good and Fair
Deficiency	No deficiencies recorded
Culverts - Asphalt Covering	Does not Exist
Drainage System for Concrete	Inspected
Catch Basins/Manhole - Surrounded by concrete	Inspected
Condition	3 - Fair
Deficiency	DAMAGED COVER
Deficiency Location/Instance	Broadway Entrance
Deficiency Quantity	1
Quantity Uom	EACH
Potential Action	REPLACE
Urgency of Action	PRIORITY 3
Purpose of Action	LEVEL 2
Deficiency Photo1

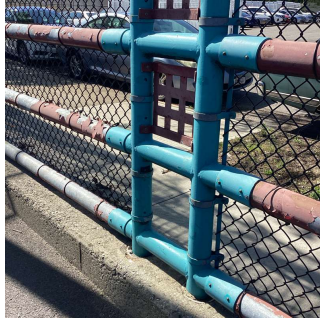
Violations	Broadway Entrance No violations recorded.
Culverts - Concrete Covering	Does not Exist
Drainage System for Soil	Does not Exist
DRINKING FOUNTAINS	Inspected
Condition	2 - Between Good and Fair
Deficiency	No deficiencies recorded
FENCES	Inspected
Condition	4 - Between Fair and Poor
Deficiency	WROUGHT IRON: DAMAGED/DETERIORATED

Deficiency Location/Instance	33rd Avenue
Deficiency Quantity	10
Quantity Uom	S.F.
Potential Action	REPLACE
Urgency of Action	PRIORITY 3
Purpose of Action	LEVEL 2

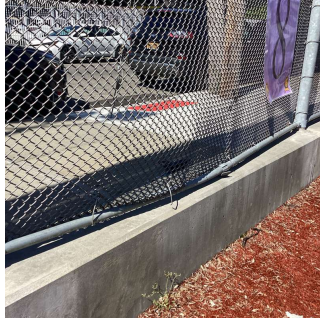
Violations	33rd Avenue No violations recorded.
Deficiency	CHAIN LINK: DAMAGED POST/RAIL
Deficiency Location/Instance	33rd Avenue
Deficiency Quantity	10
Quantity Uom	L.F.
Potential Action	REPLACE
Urgency of Action	PRIORITY 3
Purpose of Action	LEVEL 2
Deficiency Photo1

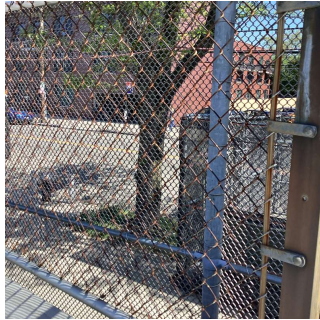
Violations	33rd Avenue No violations recorded.
Deficiency	CHAIN LINK: RUST - MAJOR
Deficiency Location/Instance	Bleachers Area
Deficiency Quantity	1,100
Quantity Uom	S.F.
Potential Action	REPLACE
Urgency of Action	PRIORITY 3
Purpose of Action	LEVEL 2
Deficiency Photo1

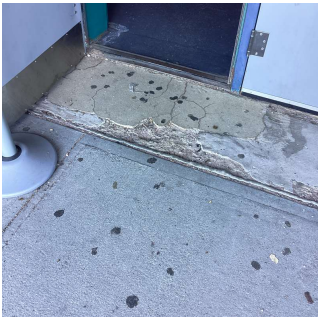
Question	Response
SITE	
PAVING	
Student Use	Inspected
Concrete	Inspected
Condition	2 - Between Good and Fair
Deficiency	No deficiencies recorded
Pavers	Does not Exist
Site Sidewalks & Walkways	Inspected
Asphalt	Does not Exist
Concrete	Inspected
Condition	3 - Fair
Deficiency	DAMAGED/DETERIORATED/MISSING SECTIONS
Deficiency Location/Instance	Exits 8, 9, Broadway Entrance
Deficiency Quantity	150
Quantity Uom	S.F.
Potential Action	REPLACE
Urgency of Action	PRIORITY 3
Purpose of Action	LEVEL 2
Deficiency Photo1

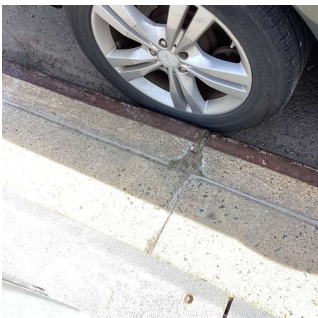
Violations	Exit 9 No violations recorded.
Pavers	Does not Exist
DOT Sidewalk	Inspected
Asphalt	Does not Exist
Concrete	Inspected
Condition	3 - Fair
Deficiency	DAMAGED CURBS
Deficiency Location/Instance	Broadway Avenue, 33rd Avenue
Deficiency Quantity	30
Quantity Uom	L.F.
Potential Action	REPLACE
Urgency of Action	PRIORITY 3
Purpose of Action	LEVEL 2
Deficiency Photo1

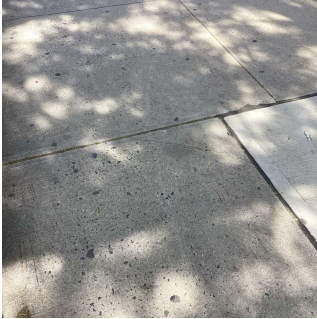
Question	Response
SITE	
PAVING	
DOT Sidewalk	
Concrete	
Violations	Broadway Avenue No violations recorded.
Deficiency	DAMAGED/DETERIORATED/MISSING SECTIONS
Deficiency Location/Instance	12nd Street, Broadway Avenue
Deficiency Quantity	150
Quantity Uom	S.F.
Potential Action	REPLACE
Urgency of Action	PRIORITY 3
Purpose of Action	LEVEL 2
Deficiency Photo1

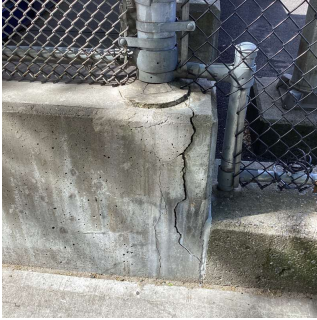
Violations	Broadway Avenue No violations recorded.
Pavers	Does not Exist
PLAYGROUNDS	Does not Exist
RETAINING WALLS	Inspected
Are there any Retaining Walls 6' OR higher facing public street/sidewalk?	No
Condition	3 - Fair
Deficiency	CAST IN PLACE CONCRETE: CRACKS/SPALLING - MAJOR
Deficiency Location/Instance	Broadway Avenue, Entrance tennis Court
Deficiency Quantity	60
Quantity Uom	S.F.
Potential Action	REPLACE
Urgency of Action	PRIORITY 3
Purpose of Action	LEVEL 2
Deficiency Photo1

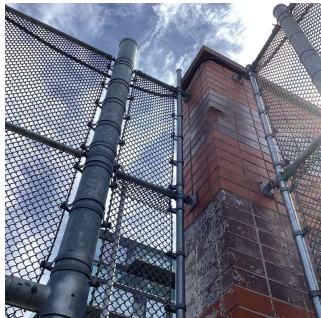
Question	Response
SITE	
SITE WALLS (NOT RETAINING WALLS)	
Condition	2 - Between Good and Fair
Deficiency	BRICK: CRACKS/SPALLING - MAJOR
Deficiency Location/Instance	Near Containerization Area
Deficiency Quantity	20
Quantity Uom	S.F.
Potential Action	REPLACE
Urgency of Action	PRIORITY 3
Purpose of Action	LEVEL 2
Deficiency Photo1
