**NYC Department of Education**  
**Building Condition Assessment Survey 2023 - 2024**

Architectural Inspection

Q454

**Asset:**        **PRE-K CENTER @ 123-07 22ND AVENUE - QUEENS, 123-07 22ND AVENUE, New York, 11356**

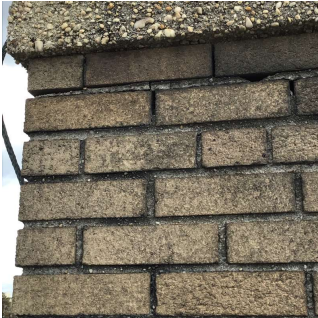
Violations	CH1 and CH2 No violations recorded.
<b>COPING</b>	
Condition	Inspected 2 - Between Good and Fair
Deficiency	No deficiencies recorded
<b>CORNICE</b>	
	Does not Exist

Violations	AW4 No violations recorded.
<b>AWNINGS AND CANOPIES</b>	
Condition	Inspected 2 - Between Good and Fair
Deficiency	No deficiencies recorded
<b>CHIMNEY</b>	
Material Type(s)	Inspected Masonry
Condition	3 - Fair
Deficiency	BRICK: DETERIORATED JOINTS
Roof Plan reference

Deficiency Quantity	50
Quantity Uom	S.F.
Potential Action	REPOINT
Urgency of Action	PRIORITY 3
Purpose of Action	LEVEL 2
Deficiency Photo1

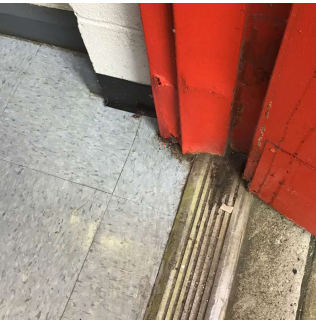
Question	Response
<b>EXTERIOR</b>	
<b>DOORS</b>	Inspected
<b>DOORS AND FRAMES</b>	Inspected
Condition	4 - Between Fair and Poor
Deficiency	METAL: DETERIORATED DOOR AND FRAME - MAJOR DETERIORATION
Roof Plan reference

<p>The photograph shows a close-up of a metal door frame where it meets the ground. The frame is heavily rusted and bent. It is set against a red brick wall. The surrounding concrete and brick show signs of wear and deterioration.</p>
Violations	Facade F No violations recorded.
<b>DOOR HARDWARE</b>	Inspected
Condition	3 - Fair
Deficiency	No deficiencies recorded
<b>LINTELS</b>	Inspected
Condition	2 - Between Good and Fair
Deficiency	No deficiencies recorded
<b>TRANSOM/SIDE LIGHT</b>	Inspected
Condition	2 - Between Good and Fair
Deficiency	No deficiencies recorded
<b>EXTERIOR WALLS</b>	Inspected
Material Type(s)	Masonry
Replacement Quantity	15,000
Replacement Uom	S.F.
Instance on All Facades	Inspected
Instance Condition	3 - Fair
Instance Quantity	15,000
Instance Quantity Uom	S.F.
Deficiency	BRICK: CRACKS/DISPLACED/SPALLED BRICK AT BUILDING CORNERS

<p>The diagram is a roof plan of building Q454. It shows a rectangular building with facades labeled A through H. Facade A is on the left, facing 123RD STREET. Facade B is the top edge, C is the right edge, and H is the bottom edge facing 22ND AVENUE. There are two entrances: 'Main Entrance' on facade A and 'BH' on facade G. The plan includes two building additions: '1949 Building' (labeled 2) and '1962 Addition' (labeled 1). Other features include 'CH1' and 'CH2' on facade E, and 'AW4', 'AW5', and 'AW6' on facade D. A north arrow is located on the right side of the plan.</p>
Deficiency Quantity	1
Quantity Uom	EACH
Potential Action	REPLACE
Urgency of Action	PRIORITY 4
Purpose of Action	LEVEL 2

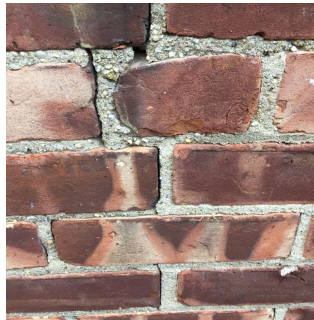
Facade B

BRICK: MAJOR / THRU CRACKS

Deficiency Quantity

10

Potential Action

REMOVE AND REBUILD

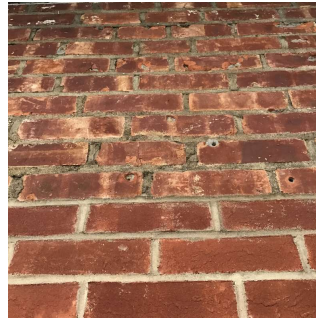
Facade D  
No violations recorded.

BRICK: DETERIORATED JOINTS

Urgency of Action  
Purpose of Action  
Deficiency Photo1

PRIORITY 4  
LEVEL 2

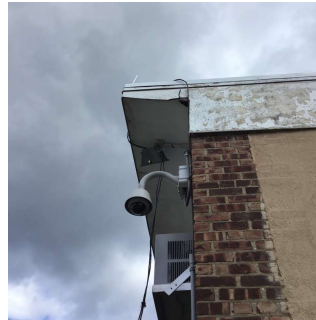
Facade B

Inspected  
3 - Fair  
METAL: DETERIORATION/DAMAGED/MISSING PIECES

Deficiency Quantity  
Quantity Uom  
Potential Action  
Urgency of Action  
Purpose of Action

10  
S.F.  
REPLACE  
PRIORITY 4  
LEVEL 2

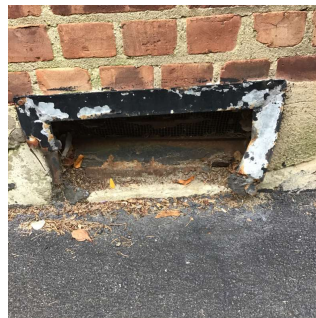
**BROKEN/ DENTED BLADES**

REPLACE

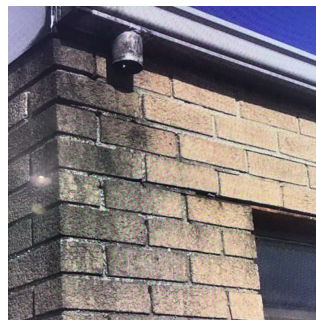
BH

Question	Response
<b>EXTERIOR</b>	
<b>LOUVER</b>	Inspected
	Facade B
Violations	No violations recorded.
<b>PARAPETS</b>	Inspected
Material Type(s)	Masonry
Replacement Quantity	3,000
Replacement Uom	C.F.
Instance on Roof 2	Inspected
Instance Condition	2 - Between Good and Fair
Instance Quantity	3,000
Instance Quantity Uom	C.F.
Deficiency	No deficiencies recorded
<b>PLAZA DECK</b>	Does not Exist
<b>ROOF</b>	Inspected
<b>Roofing</b>	Inspected
Replacement Quantity	8,000
Replacement Uom	S.F.
<b>ROOF HATCH/SMOKE HATCH</b>	Inspected
Condition	2 - Between Good and Fair
Deficiency	No deficiencies recorded
<b>LEADERS, GUTTERS, DOWNSPOUTS, SCUPPERS</b>	Inspected
Condition	3 - Fair
Deficiency	DAMAGED/MISSING
Roof Plan reference

Deficiency Quantity  
Quantity Uom  
Potential Action  
Urgency of Action  
Purpose of Action  
Deficiency Photo1

10  
L.F.  
REPLACE  
PRIORITY 4  
LEVEL 2

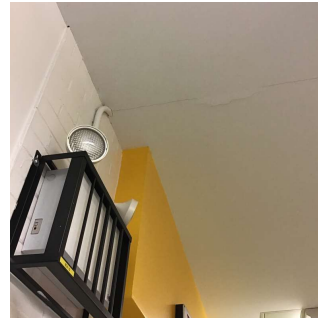
Roof 2 - Corridor near Room 105

Roof 1
Instance Quantity	8,000
Instance Quantity Uom	S.F.
Does the roof have major mechanical equipment sitting on Dunnage Steel less than 18" above the Roofing?	No
Does this roof instance have a Sustainable Roof System?	No
Do solar panels exist on these roofs?	No
Is/Are the roof(s) suitable for Solar Panel installation?	No
Installation Year	1990
Source of Installation	Custodial Staff
Deficiency	<b>MODIFIED BITUMEN: ROOFING: MAJOR ACTIVE ROOF LEAKS IN INSTRUCTIONAL SPACE</b>
Roof Plan reference

Deficiency Quantity	100
Quantity Uom	S.F.
Potential Action	<b>REPLACE ROOFING WITHOUT MAJOR EQUIPMENT REMOVAL</b>

Urgency of Action	<b>PRIORITY 5</b>
Purpose of Action	<b>LEVEL 2</b>

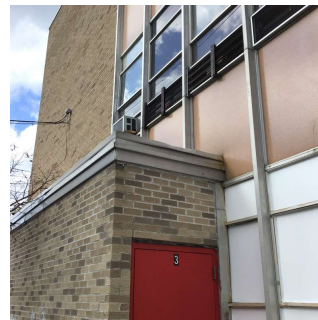
R3

**MODIFIED BITUMEN: FLASHING: CAP FLASHING DAMAGED**

REPLACE

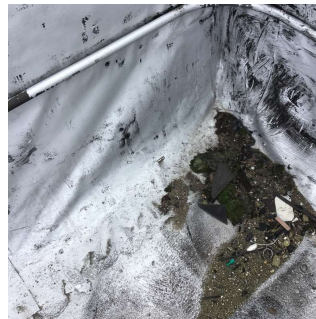
Roof 2  
No violations recorded.

**ROOFING**

Deficiency Quantity  
Quantity Uom  
Potential Action

Urgency of Action  
Purpose of Action  
Deficiency Photo1

30  
S.F.  
REPLACE ROOFING WITHOUT MAJOR EQUIPMENT  
REMOVAL  
PRIORITY 4  
LEVEL 2

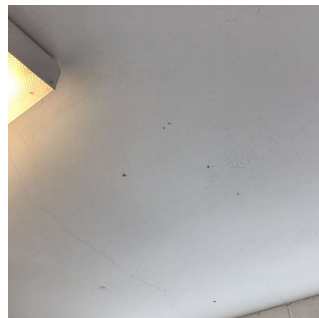
BULKHEAD/PENTHOUSE CEILING: PLASTER  
DAMAGED/DETERIORATED

Question	Response
<b>EXTERIOR</b>	
<b>ROOF</b>	
<b>Specialties</b>	
<b>BULKHEAD/PENTHOUSE</b>	
Potential Action	REPLACE
Urgency of Action	PRIORITY 3
Purpose of Action	LEVEL 2
Deficiency Photo1

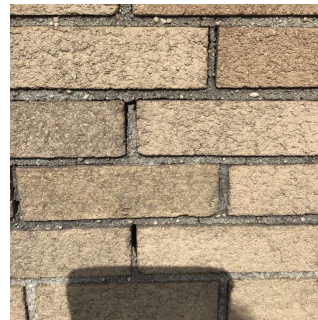
BH  
No violations recorded.

Deficiency	No violations recorded.
Deficiency	BULKHEAD/PENTHOUSE WALLS/EXTERIOR: DETERIORATED JOINTS

Deficiency Quantity  
Quantity Uom  
Potential Action  
Urgency of Action  
Purpose of Action  
Deficiency Photo1

200  
S.F.  
REPOINT  
PRIORITY 3  
LEVEL 2

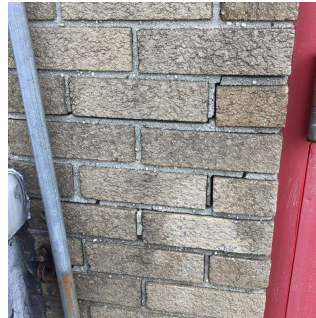
BH

Deficiency **BULKHEAD/PENTHOUSE WALLS/EXTERIOR: MAJOR THRU CRACKS**

Deficiency Quantity  
Quantity Uom  
Potential Action  
Urgency of Action  
Purpose of Action

30  
S.F.  
REMOVE AND REBUILD  
PRIORITY 4  
LEVEL 2

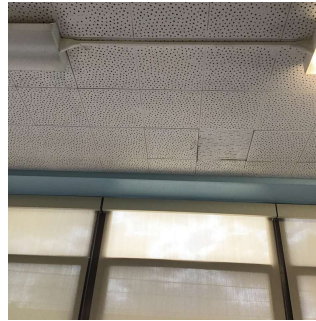
Room 305

Question	Response
<b>INTERIOR</b>	
<b>STRUCTURAL</b>	
<b>FOUNDATION WALLS</b>	
Deficiency Photo1	 
Violations	Basement - Boiler Room No violations recorded.
<b>ROOF STRUCTURE</b>	
Condition	Inspected
Deficiency	2 - Between Good and Fair
Deficiency	No deficiencies recorded
<b>VAULTS-BUNKERS</b>	Does not Exist
<b>AUDITORIUM</b>	Does not Exist
<b>CAFETERIA</b>	Does not Exist
<b>CLASSROOMS/CORRIDORS/ADMIN SPACES</b>	Inspected
<b>Ceiling</b>	Inspected
Condition	2 - Between Good and Fair
Deficiency	PLASTER: CRACKS/SPALLING - ACTIVE LEAK
Deficiency Location/Instance	Corridor near Room 105
Deficiency Quantity	20
Quantity Uom	S.F.
Potential Action	REPLACE
Urgency of Action	PRIORITY 5
Purpose of Action	LEVEL 2
Deficiency Photo1	 
Violations	Corridor near Room 105 No violations recorded.
Deficiency	ACOUSTIC TILES ON PLASTER: DAMAGED/MISSING
Deficiency Location/Instance	Rooms 207, 305, Corridor near Rooms 207, 304
Deficiency Quantity	30

Quantity Uom	S.F.
Potential Action	REPLACE
Urgency of Action	PRIORITY 3
Purpose of Action	LEVEL 2

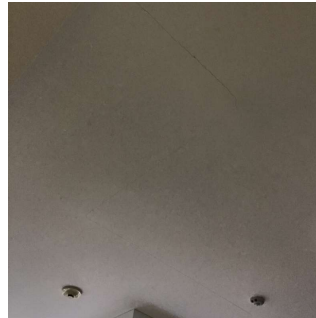
Room 108

PLASTER: CRACKS/SPALLING

REPLACE

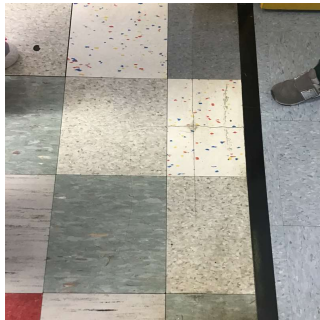
Question	Response
<b>INTERIOR</b>	
<b>CLASSROOMS/CORRIDORS/ADMIN SPACES</b>	
<b>Door(s)</b>	Inspected
	Room 304
Violations	No violations recorded.
<b>Floor Finish</b>	Inspected
Condition	2 - Between Good and Fair
Deficiency	VINYL TILES: DETERIORATED SUBSTRATE
Deficiency Location/Instance	Corridor near Rooms 207, 208
Deficiency Quantity	20
Quantity Uom	S.F.
Potential Action	REPLACE
Urgency of Action	PRIORITY 3
Purpose of Action	LEVEL 2
Deficiency Photo1

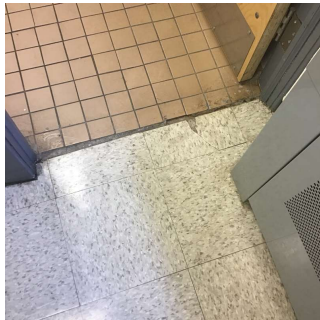
Violations	Corridor near Room 208 No violations recorded.
Deficiency	VINYL TILES: BROKEN/DETERIORATED/MISSING TILES
Deficiency Location/Instance	Corridor Near Room B05, 105, 205, 207, 305, and others.
Deficiency Quantity	50
Quantity Uom	S.F.
Potential Action	REPLACE
Urgency of Action	PRIORITY 3
Purpose of Action	LEVEL 2
Deficiency Photo1

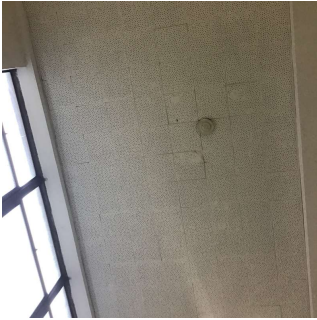
Violations	Near Windows No violations recorded.

Deficiency	ACOUSTIC TILES ON PLASTER: DAMAGED/MISSING
Deficiency Location/Instance	Near Windows
Deficiency Quantity	10
Quantity Uom	S.F.
Potential Action	REPLACE
Urgency of Action	PRIORITY 3
Purpose of Action	LEVEL 2
Deficiency Photo1

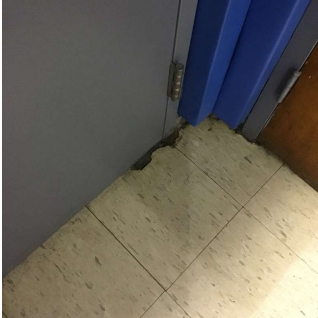
Question	Response
<b>INTERIOR</b>	
<b>GYMNASIUM</b>	
<b>Floor Finish</b>	
Condition	2 - Between Good and Fair
Deficiency	VINYL TILES: BROKEN/DETERIORATED/MISSING TILES
Deficiency Location/Instance	Near Room B10, Stair D
Deficiency Quantity	10
Quantity Uom	S.F.
Potential Action	REPLACE
Urgency of Action	PRIORITY 3
Purpose of Action	LEVEL 2
Deficiency Photo1

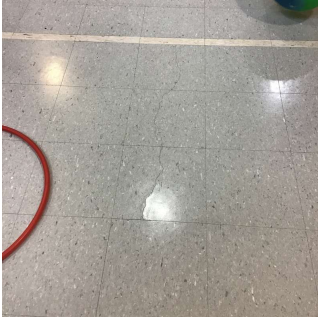
Near Room B10
Violations	No violations recorded.
Deficiency	VINYL TILES: DETERIORATED SUBSTRATE
Deficiency Location/Instance	Near Entrance, Center.
Deficiency Quantity	20
Quantity Uom	S.F.
Potential Action	REPLACE
Urgency of Action	PRIORITY 3
Purpose of Action	LEVEL 2
Deficiency Photo1

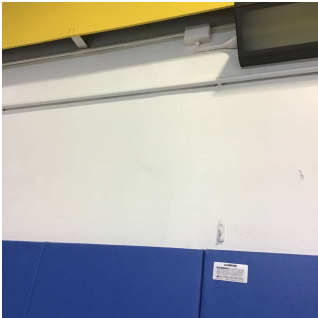
Question	Response
<b>INTERIOR</b>	
<b>GYMNASIUM</b>	
<b>Stage</b>	
<b>Stage Curtain Rigging</b>	Inspected
Instance on Basement	Inspected
Condition	2 - Between Good and Fair
Deficiency	No deficiencies recorded
<b>Stage Curtains</b>	Inspected
Instance on Basement	Inspected
Condition	2 - Between Good and Fair
Deficiency	No deficiencies recorded
<b>Walls</b>	
Instance on Basement	Inspected
Condition	2 - Between Good and Fair
Deficiency	PLASTER: CRACKS/SPALLING
Deficiency Location/Instance	Near center, Stair B
Deficiency Quantity	40
Quantity Uom	S.F.
Potential Action	REPLACE
Urgency of Action	PRIORITY 3
Purpose of Action	LEVEL 2
Deficiency Photo1

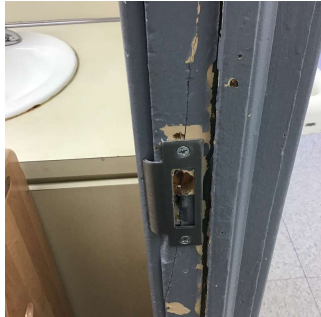
Room 302
Violations	No violations recorded.
<b>Door(s)</b>	Inspected
Condition	5 - Poor
Deficiency	WOOD: DETERIORATED DOOR AND FRAME
Deficiency Location/Instance	Room B06
Deficiency Quantity	1
Quantity Uom	EACH
Potential Action	MAINTENANCE

Urgency of Action	PRIORITY 3

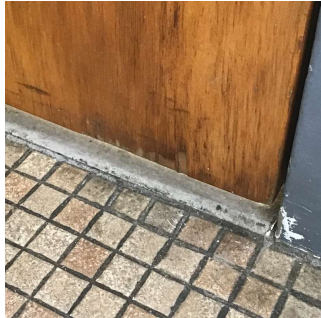
Violations	Room B06 No violations recorded.
Deficiency	WOOD: DETERIORATED DOOR
Deficiency Location/Instance	Room 302
Deficiency Quantity	1
Quantity Uom	EACH
Potential Action	MAINTENANCE
Urgency of Action	PRIORITY 3
Purpose of Action	LEVEL 2
Deficiency Photo1

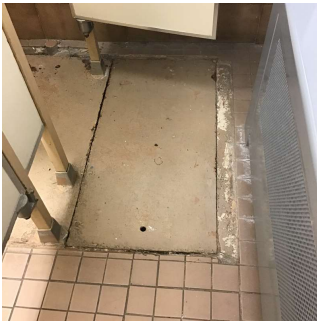
Violations	Room 302 No violations recorded.
<b>Floor Finish</b>	Inspected
Condition	2 - Between Good and Fair
Deficiency	CERAMIC TILE: BROKEN/MISSING TILES
Deficiency Location/Instance	Room B06
Deficiency Quantity	10
Quantity Uom	S.F.
Potential Action	REPLACE
Urgency of Action	PRIORITY 3
Purpose of Action	LEVEL 2

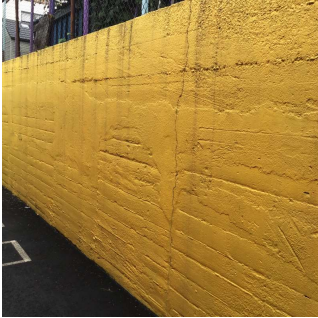
Near Playground
Violations	No violations recorded.
<b>SEATING</b>	
	Inspected

Are there any Retaining Walls 6' OR higher facing public street/sidewalk?	No
Condition	3 - Fair
Deficiency	CAST IN PLACE CONCRETE: CRACKS/SPALLING - MAJOR
Deficiency Location/Instance	Near Playground, Alley
Deficiency Quantity	60
Quantity Uom	S.F.
Potential Action	REPLACE
Urgency of Action	PRIORITY 3
Purpose of Action	LEVEL 2
Deficiency Photo1
