**NYC Department of Education**  
**Building Condition Assessment Survey 2023 - 2024**

Architectural Inspection

Q457

**Asset:**        **NEWTOWN AF - QUEENS, 90-20 56TH AVENUE, New York, 11373**

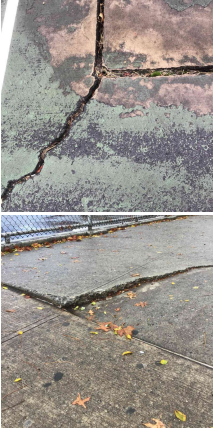
Yes	Tripping Hazard	Severely cracked asphalt surface is a potential tripping hazard.	ATHLETIC FIELDS   PLAYING SURFACE	Tennis Courts	Thomas Giardina	Custodian

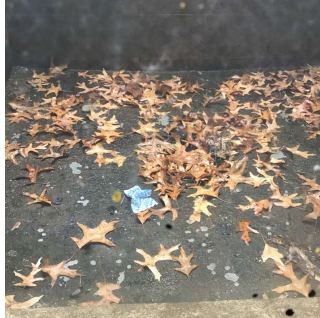
AW1, AW4
Violations	No violations recorded.
Deficiency	<b>AREAWAY WALLS: CRACKS AND SPALLING</b>
Roof Plan reference

Question	Response
<b>Architectural</b>	
<b>EXTERIOR</b>	Inspected
<b>AREAWAY</b>	Inspected
Instance on AW1 - AW4	Inspected
Instance Condition	5 - Poor
Instance Quantity	4
Instance Quantity Uom	EACH
Deficiency	AREAWAY DRAINS: DETERIORATED
Roof Plan reference	
Deficiency Quantity	4
Quantity Uom	EACH
Potential Action	REPLACE

Question	Response
<b>EXTERIOR</b>	
<b>AREAWAY</b>	
Urgency of Action	PRIORITY 4
Purpose of Action	LEVEL 2
Deficiency Photo1

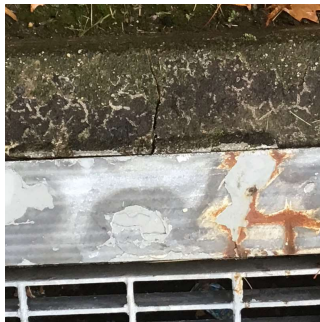
AW2
Violations	No violations recorded.
<b>AWNINGS AND CANOPIES</b>	
Condition	Inspected
Deficiency	3 - Fair CONCRETE: DETERIORATED

Deficiency Quantity	10
Quantity Uom	S.F.
Potential Action	REPLACE
Urgency of Action	PRIORITY 4
Purpose of Action	LEVEL 2
Deficiency Photo1

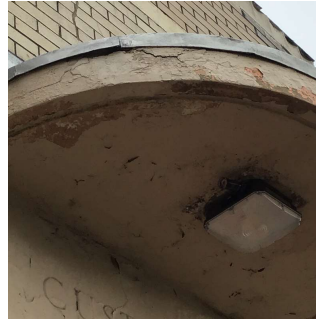
Facade A

70  
S.F.  
REPLACE  
PRIORITY 4  
LEVEL 2

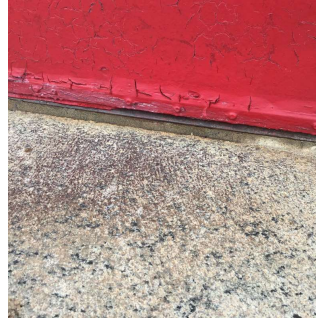
Facade A

METAL: DETERIORATED DOOR - MAJOR DETERIORATION

REPLACE  
PRIORITY 4  
LEVEL 2

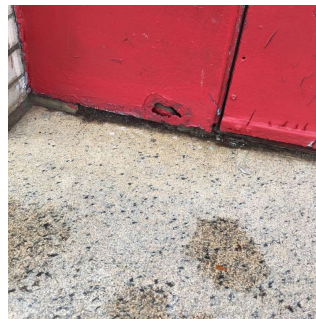
Facade A

METAL: DETERIORATED DOOR AND FRAME - MAJOR DETERIORATION

3  
EACH  
REPLACE  
PRIORITY 4  
LEVEL 2

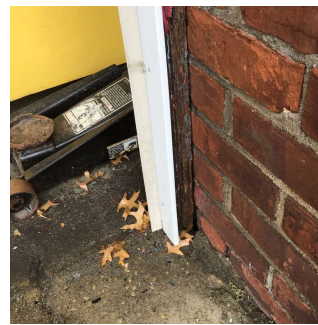
Facade E  
No violations recorded.

ROLL-UP DOOR: DETERIORATED DOOR AND FRAME - MINOR DETERIORATION

60  
S.F.  
MAINTENANCE  
PRIORITY 3  
LEVEL 2

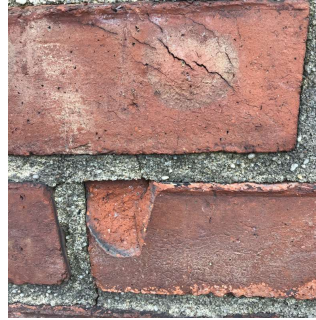
Facade E

Question	Response
<b>EXTERIOR</b>	
<b>DOORS</b>	
<b>TRANSOM/SIDE LIGHT</b>	
Urgency of Action	PRIORITY 4
Purpose of Action	LEVEL 2
Deficiency Photo1	 
Violations	Facade A No violations recorded.
<b>EXTERIOR WALLS</b>	
Material Type(s)	Inspected Masonry, Concrete
Replacement Quantity	3,000
Replacement Uom	S.F.
Instance on All Facades	Inspected
Instance Condition	4 - Between Fair and Poor
Instance Quantity	3,000
Instance Quantity Uom	S.F.
Deficiency	BRICK: MINOR CRACKS AND SPALLING
Roof Plan reference	 
Elevation	 
Deficiency Quantity	50
Quantity Uom	S.F.
Potential Action	RESTITCH
Urgency of Action	PRIORITY 3
Purpose of Action	LEVEL 2

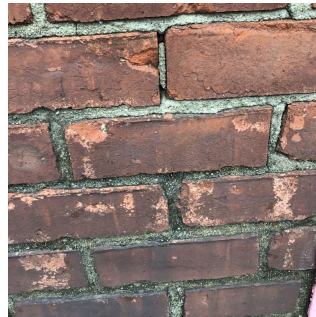
Facade E

**BRICK: DETERIORATED JOINTS**

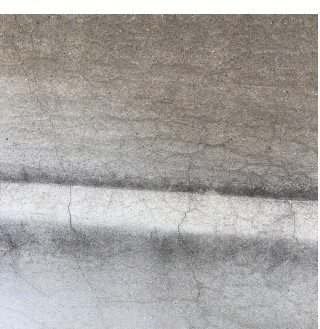
Question	Response
<b>EXTERIOR</b>	
<b>EXTERIOR WALLS</b>	
Deficiency	CAST IN PLACE / PRE-CAST CONCRETE: MINOR CRACKS/SPALLING
Roof Plan reference

Deficiency Quantity	30
Quantity Uom	S.F.
Potential Action	REPAIR
Urgency of Action	PRIORITY 3
Purpose of Action	LEVEL 2
Deficiency Photo1

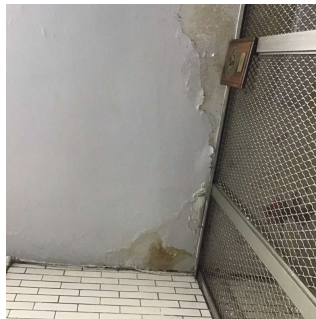
Roof 1 - Boys Locker Room near windows shown, Roof 1 - Visitors Locker Room inside the cage similar

Question	Response
<b>EXTERIOR</b>	
<b>ROOF</b>	
<b>Roofing</b>	
<b>ROOFING</b>	
Instance Photo	 
	Roof 1
Instance Quantity	2,700
Instance Quantity Uom	S.F.
Does the roof have major mechanical equipment sitting on Dunnage Steel less than 18" above the Roofing?	No
Does this roof instance have a Sustainable Roof System?	Yes
Sustainable Roof Type	White Roof
Sustainable Roof Location (Roof Number)	Roofs 1 and 2
Do solar panels exist on these roofs?	No
Is/Are the roof(s) suitable for Solar Panel installation?	No
Installation Year	1995
Source of Installation	Custodial Staff
Deficiency	<b>MODIFIED BITUMEN: ROOFING: DELAMINATION</b>
Roof Plan reference	 
Deficiency Quantity	1,800
Quantity Uom	S.F.
Potential Action	<b>REPLACE ROOFING WITHOUT MAJOR EQUIPMENT REMOVAL</b>
Urgency of Action	<b>PRIORITY 4</b>
Purpose of Action	<b>LEVEL 2</b>
Deficiency Photo1	 
	Roof 1
Violations	No violations recorded.
Deficiency	<b>MODIFIED BITUMEN: ROOFING: MAJOR ACTIVE ROOF LEAKS IN INSTRUCTIONAL SPACE</b>

200  
S.F.  
REPLACE ROOFING WITHOUT MAJOR EQUIPMENT  
REMOVAL  
PRIORITY 5  
LEVEL 2

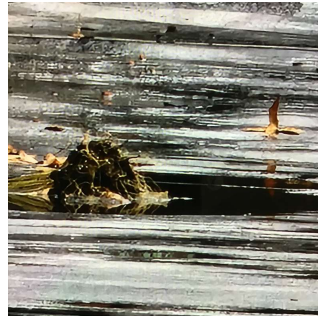
Roof 1

DETERIORATED

1  
EACH  
REPLACE  
PRIORITY 4  
LEVEL 2

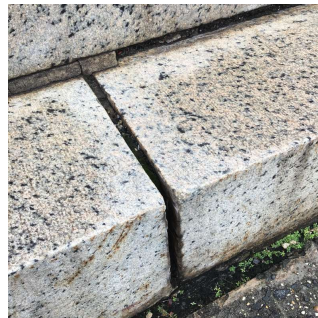
Facade A

STONE: DETERIORATED JOINTS

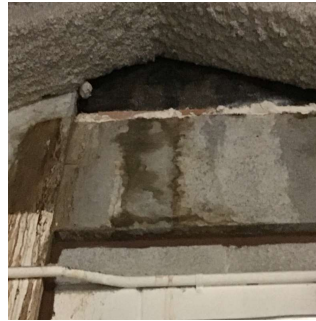
Basement - Electrical Panel Room

Question	Response
<b>INTERIOR</b>	
<b>STRUCTURAL</b>	
<b>FLOOR STRUCTURE</b>	
Quantity Uom	S.F.
Potential Action	REPAIR
Urgency of Action	PRIORITY 3
Purpose of Action	LEVEL 5
Deficiency Photo1	 
Violations	Basement - Boiler Room No violations recorded.
Deficiency	CONCRETE SLAB ON GRADE: THRU CRACKS
Deficiency Location/Instance	Garage, Basement - Oil Tank Room, Storage Room
Deficiency Quantity	60
Quantity Uom	S.F.
Potential Action	REPLACE
Urgency of Action	PRIORITY 4
Purpose of Action	LEVEL 5
Deficiency Photo1	 
Violations	Basement - Oil Tank Room No violations recorded.
<b>FOUNDATION WALLS</b>	
Material Type(s)	Inspected Concrete
Condition	4 - Between Fair and Poor
Deficiency	CONCRETE: WATER INFILTRATION IN ELECTRICAL PANEL ROOM
Deficiency Location/Instance	Basement - Electrical Room
Deficiency Quantity	100
Quantity Uom	S.F.
Potential Action	INSTALL WATERPROOFING
Urgency of Action	PRIORITY 5
Purpose of Action	LEVEL 6

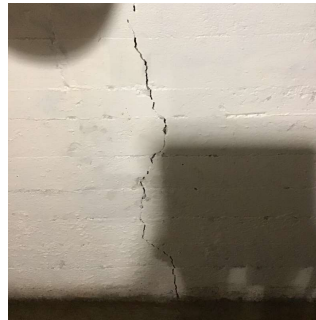
Basement - Boiler Room

**CONCRETE: CRACKED/SPALLED/REINFORCEMENT EXPOSED**

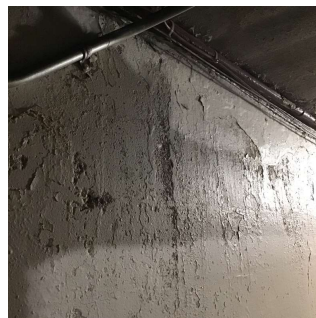
Basement - Storage

**CONCRETE: WATER INFILTRATION IN NON- INSTRUCTIONAL SPACE**

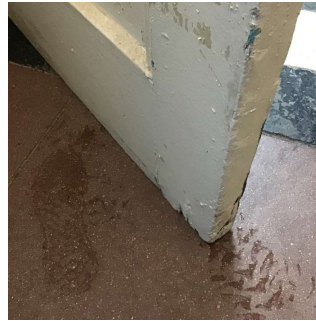
Question	Response
<b>INTERIOR</b>	
<b>LOCKER ROOM</b>	
<b>Ceiling</b>	
Quantity Uom	S.F.
Potential Action	REPLACE
Urgency of Action	PRIORITY 5
Purpose of Action	LEVEL 2
Deficiency Photo1	 
	Near Windows
Violations	No violations recorded.
<b>Door(s)</b>	
Instance on 1st Floor - Visitors (198 Lockers)	Inspected
Condition	3 - Fair
Deficiency	WOOD: DETERIORATED DOOR
Deficiency Location/Instance	Entrance
Deficiency Quantity	1
Quantity Uom	EACH
Potential Action	MAINTENANCE
Urgency of Action	PRIORITY 3
Purpose of Action	LEVEL 2
Deficiency Photo1	 
	Entrance
Violations	No violations recorded.
Instance on 1st Floor - Boys (300 Lockers)	Inspected
Condition	3 - Fair
Deficiency	WOOD: DETERIORATED DOOR
Deficiency Location/Instance	Entrance
Deficiency Quantity	1
Quantity Uom	EACH
Potential Action	MAINTENANCE
Urgency of Action	PRIORITY 3
Purpose of Action	LEVEL 2

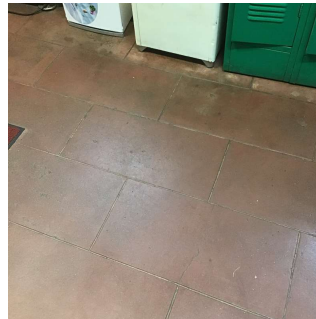
Instance on 1st Floor - Girls (44 Lockers)	Inspected
Condition	2 - Between Good and Fair
Deficiency	QUARRY TILE: BROKEN/MISSING TILES
Deficiency Location/Instance	Near center
Deficiency Quantity	20
Quantity Uom	S.F.
Potential Action	REPLACE
Urgency of Action	PRIORITY 3
Purpose of Action	LEVEL 2
Deficiency Photo1

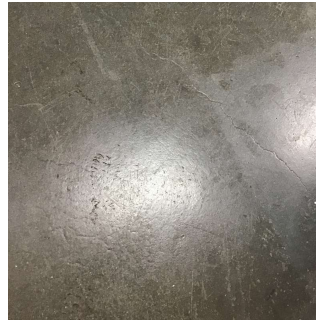
Instance on 1st Floor - Visitors (198 Lockers)	Inspected
Condition	2 - Between Good and Fair
Deficiency	CONCRETE: CRACKS
Deficiency Location/Instance	Near Entrance
Deficiency Quantity	30
Quantity Uom	S.F.
Potential Action	REPLACE
Urgency of Action	PRIORITY 3
Purpose of Action	LEVEL 2

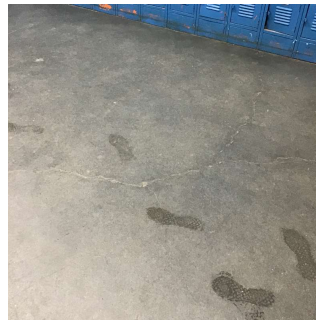
Near Entrance

CONCRETE: CRACKS

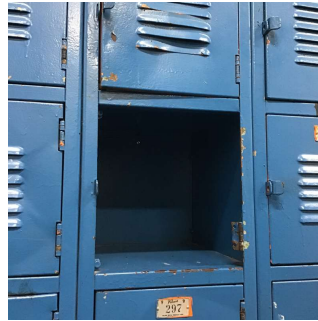
Locker 296

DAMAGED UNITS

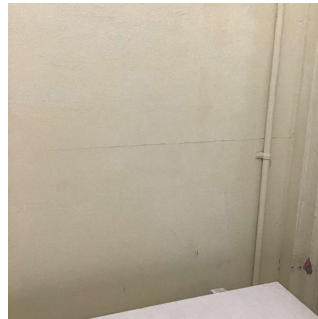
Instance on 1st Floor - Visitors (198 Lockers)	Inspected
Condition	2 - Between Good and Fair
Deficiency	PLASTER: CRACKS/SPALLING
Deficiency Location/Instance	Near Entrance
Deficiency Quantity	20
Quantity Uom	S.F.
Potential Action	REPLACE
Urgency of Action	PRIORITY 3
Purpose of Action	LEVEL 2
Deficiency Photo1

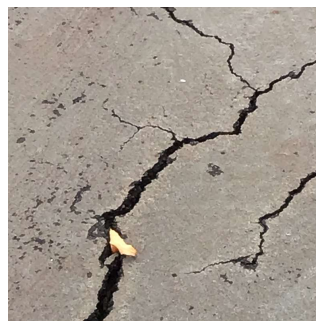
ASPHALT: DAMAGED/DETERIORATED

100

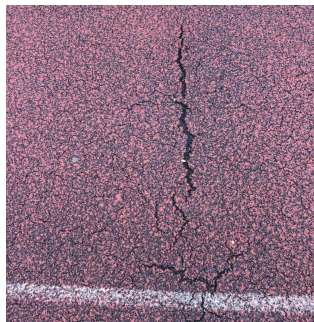
Deficiency ATHLETIC WEARING SURFACE: DAMAGED/DETERIORATED  
 Deficiency Location/Instance Running Track

Deficiency Quantity	500
Quantity Uom	S.F.
Potential Action	REPLACE
Urgency of Action	PRIORITY 4
Purpose of Action	LEVEL 2
Deficiency Photo1

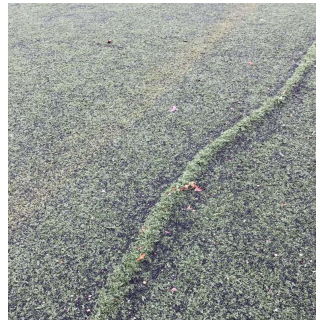
Deficiency ARTIFICIAL TURF: DAMAGED/WORN OUT  
 Deficiency Location/Instance Soccer Field

40  
S.F.  
REPLACE  
PRIORITY 4  
LEVEL 2

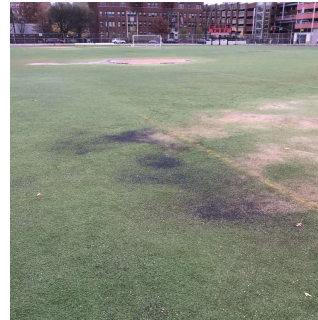
Soccer Field

ARTIFICIAL TURF: MISSING AREAS

1,200  
S.F.  
REPLACE  
PRIORITY 4  
LEVEL 2

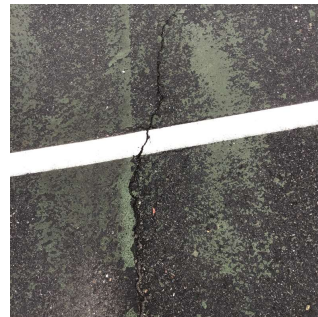
Tennis Courts

ASPHALT: DAMAGED/DETERIORATED

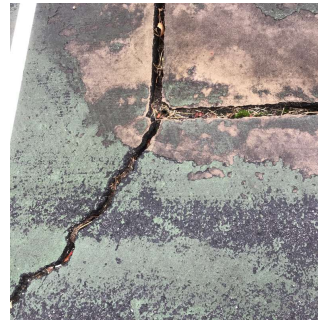
Tennis Courts  
No violations recorded.

350  
S.F.  
REPLACE  
PRIORITY 5  
LEVEL 6

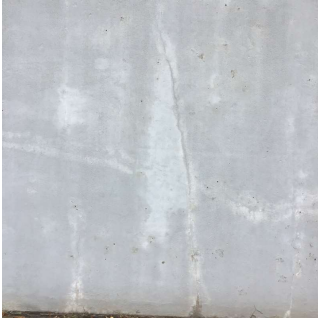
Question	Response
<b>SITE</b>	
<b>SITE WALLS (NOT RETAINING WALLS)</b>	
Deficiency	CAST IN PLACE CONCRETE: CRACKS/SPALLING - MAJOR
Deficiency Location/Instance	Handball Court
Deficiency Quantity	80
Quantity Uom	S.F.
Potential Action	REPLACE
Urgency of Action	PRIORITY 3
Purpose of Action	LEVEL 2
Deficiency Photo1
