**NYC Department of Education**  
**Building Condition Assessment Survey 2023 - 2024**

Architectural Inspection

Q461

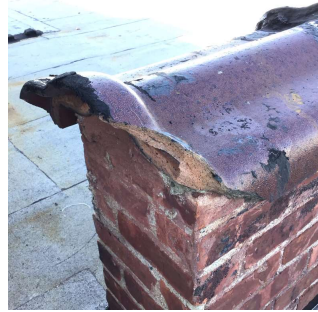
Roof 1

TERRA COTTA: CRACKED/BROKEN PIECES

Deficiency Quantity

10

L.F.

PRIORITY 4

REPLACE-IN-KIND

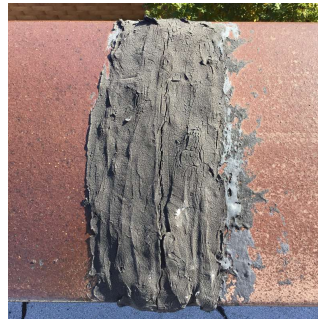
Roof 3

**TERRA COTTA: DETERIORATED TRANSVERSE JOINTS**

20

L.F.

PRIORITY 3

MAINTENANCE

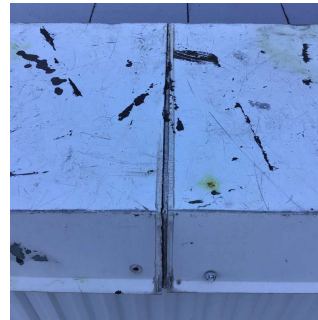
Roof 3

**METAL: DETERIORATED JOINTS**

10

L.F.

PRIORITY 3

REPAIR

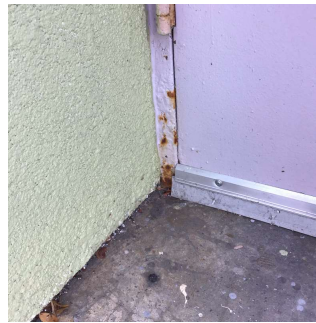
Facade A

4 - Between Fair and Poor

METAL: DETERIORATED DOOR AND FRAME - MAJOR DETERIORATION

1

PRIORITY 4

REPLACE

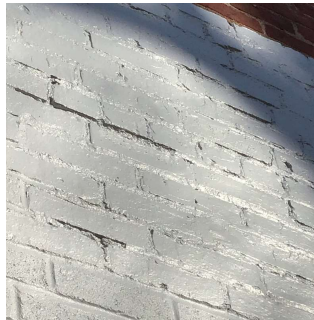
Facade E

BRICK: DETERIORATED JOINTS

50

PRIORITY 3

REPOINT

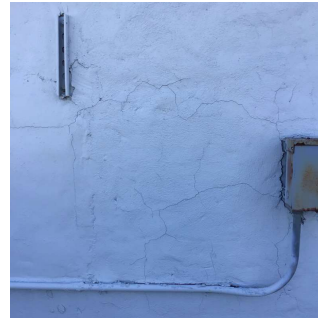
Facade B

STUCCO CEMENT SURFACE: CRACKS, SPALLING

60

PRIORITY 4  
LEVEL 2

REPLACE

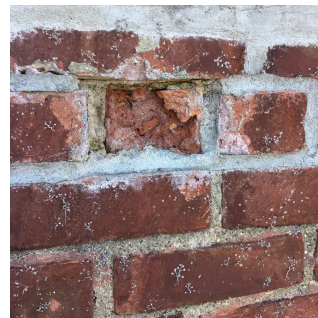
Facade E

**BRICK: MAJOR / THRU CRACKS**

10

PRIORITY 4

REMOVE AND REBUILD

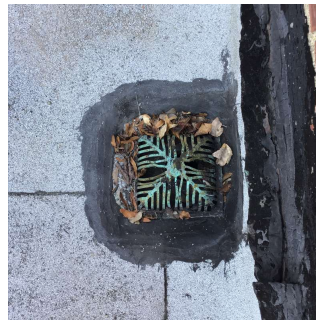
Roof 4  
 No violations recorded.

Question	Response
<b>EXTERIOR</b>	
<b>ROOF</b>	
<b>Roofing</b>	
<b>ROOFING</b>	
Deficiency Photo1	 
Violations	Roof 1 No violations recorded.
Deficiency	MODIFIED BITUMEN: ROOFING: MAJOR ACTIVE ROOF LEAKS IN INSTRUCTIONAL SPACE
Roof Plan reference	  <p>Q461</p> <p>187th Street</p> <p>Union Turnpike</p> <p>188th Street</p>
Deficiency Quantity	800
Quantity Uom	S.F.
Potential Action	REPLACE ROOFING WITHOUT MAJOR EQUIPMENT REMOVAL
Urgency of Action	PRIORITY 5
Purpose of Action	LEVEL 2
Deficiency Photo1	 
Violations	Roof 2 - Room 103B (Roof 1 - Corridor near Room 127, Room 127A, Roof 3 - Rooms 121, 122, Kitchen, Roof 4 - Rooms 105A, 105) No violations recorded.
<b>ROOFING DRAINS</b>	Inspected
Condition	3 - Fair
Deficiency	DETERIORATED

1  
 EACH  
 REPLACE  
 PRIORITY 4  
 LEVEL 2

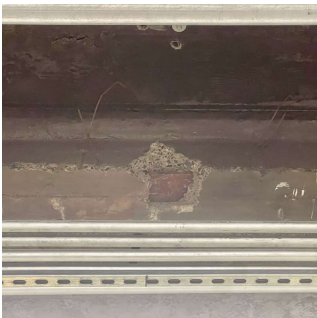
Question	Response
<b>EXTERIOR</b>	
<b>WINDOWS</b>	
<b>WINDOWS</b>	
Material Type(s)	Aluminum
Instance on Aluminum - Other: All Facades	Inspected
Instance Condition	1 - Good
Instance Quantity	800
Instance Quantity Uom	S.F.
Are these windows insulated	Yes
Installation Year	2022
Source of Installation	Custodial Staff
Deficiency	No deficiencies recorded
<b>INTERIOR</b>	Inspected
<b>POOLS</b>	Does not Exist
<b>STRUCTURAL</b>	Inspected
<b>COLUMNS/BEAMS/BEARING WALLS</b>	Inspected
Condition	3 - Fair
Deficiency	STEEL COLUMNS/BEAMS: DETERIORATED CONCRETE FIREPROOFING
Deficiency Location/Instance	Electrical Room
Deficiency Quantity	10
Quantity Uom	S.F.
Potential Action	REPLACE
Urgency of Action	PRIORITY 4
Purpose of Action	LEVEL 5
Deficiency Photo1

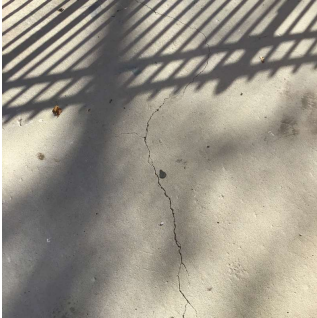
Question	Response
<b>SITE</b>	
<b>PAVING</b>	
<b>Site Sidewalks &amp; Walkways</b>	
<b>Asphalt</b>	Does not Exist
<b>Concrete</b>	Inspected
Condition	3 - Fair
Deficiency	CRACKS - MAJOR
Deficiency Location/Instance	Near Playground
Deficiency Quantity	100
Quantity Uom	S.F.
Potential Action	REPLACE
Urgency of Action	PRIORITY 3
Purpose of Action	LEVEL 2
Deficiency Photo1

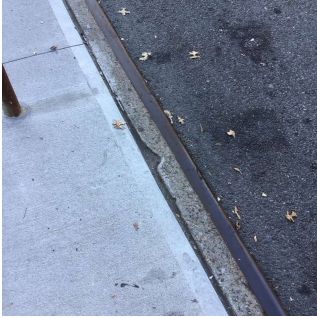
Near Playground
Violations	No violations recorded.
<b>Pavers</b>	Does not Exist
<b>DOT Sidewalk</b>	Inspected
<b>Asphalt</b>	Does not Exist
<b>Concrete</b>	Inspected
Condition	3 - Fair
Deficiency	DAMAGED CURBS
Deficiency Location/Instance	Union Turnpike
Deficiency Quantity	10
Quantity Uom	L.F.
Potential Action	REPLACE
Urgency of Action	PRIORITY 3
Purpose of Action	LEVEL 2
Deficiency Photo1
