NYC Department of Education
Building Condition Assessment Survey 2023 - 2024

Architectural Inspection

Q462

Asset: FLUSHING MEMORIAL AF - QUEENS, 27-01 149 STREET, New York, 11354

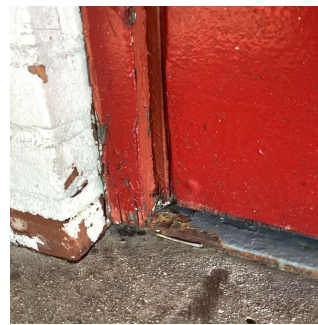
Facade A

Question	Response
Architectural	
EXTERIOR	Inspected
AREAWAY	Inspected
Instance on Facade C - AW1	Inspected
Instance Condition	2 - Between Good and Fair
Instance Quantity	1
Instance Quantity Uom	EACH
Deficiency	No deficiencies recorded
AWNINGS AND CANOPIES	Does not Exist
CHIMNEY	Inspected
Material Type(s)	Masonry
Condition	3 - Fair
Deficiency	BRICK: DETERIORATED JOINTS
Roof Plan reference	 
Deficiency Quantity	40
Quantity Uom	S.F.
Potential Action	REPOINT
Urgency of Action	PRIORITY 3
Purpose of Action	LEVEL 2
Deficiency Photo1	 
CH	
Violations	No violations recorded.
COPING	Inaccessible
CORNICE	Does not Exist
DOORS	Inspected
DOORS AND FRAMES	Inspected
Condition	4 - Between Fair and Poor
Deficiency	METAL CLAD: DETERIORATED DOOR AND FRAME - MAJOR DETERIORATION

2
EACH
REPLACE
PRIORITY 4
LEVEL 2

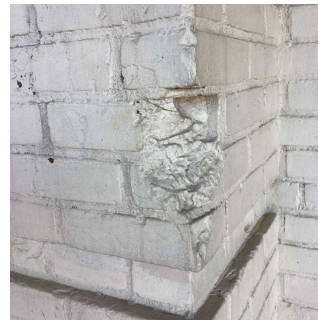
Facade A

BRICK: MAJOR / THRU CRACKS

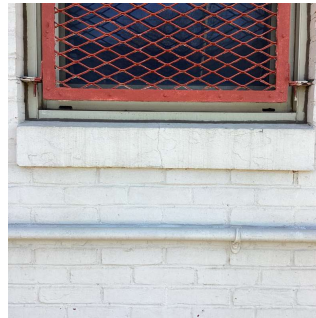
Facade C

BRICK: DETERIORATED MASONRY SILLS - MINOR

REPAIR

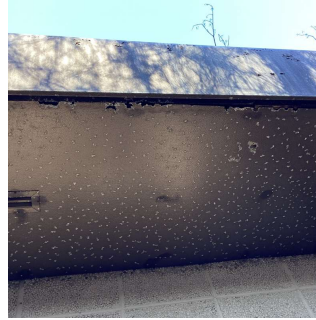
Facade C

EXTERIOR SOFFITS

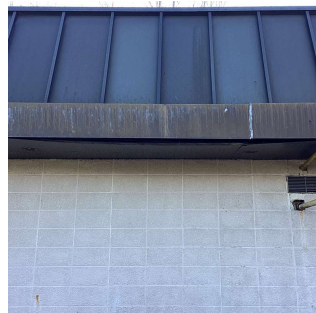
Facade E

Yes	Potential Falling Debris	Deteriorated and bowing exterior metal soffit is a potential falling debris hazard.	EXTERIOR EXTERIOR SOFFITS	1971 Field House - North facing soffit	Lee Roebuck	Fireman

METAL: DETERIORATION/DAMAGED/MISSING PIECES

REPLACE

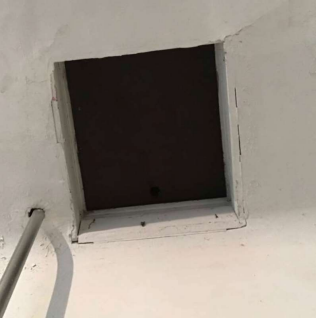
Question	Response
EXTERIOR	
LOUVER	Inspected
Condition	2 - Between Good and Fair
Deficiency	No deficiencies recorded
PARAPETS	Inspected
Material Type(s)	Masonry
Replacement Quantity	600
Replacement Uom	C.F.
Instance on Field House 1	Inaccessible
Instance Quantity	600
Instance Quantity Uom	C.F.
PLAZA DECK	Does not Exist
ROOF	Inspected
Roofing	Inspected
Replacement Quantity	4,500
Replacement Uom	S.F.
ROOF HATCH/SMOKE HATCH	Inspected
Condition	5 - Poor
Deficiency	DETERIORATED
Roof Plan reference

Violations	Roof 1 - RH No violations recorded.
LEADERS, GUTTERS, DOWNSPOUTS, SCUPPERS	Inspected
Condition	3 - Fair
Deficiency	DAMAGED/MISSING

Deficiency Quantity	1
Quantity Uom	EACH
Potential Action	REPLACE
Urgency of Action	PRIORITY 4
Purpose of Action	LEVEL 2
Deficiency Photo1

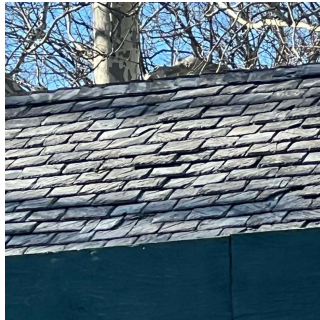
Roof 3
Instance Quantity	1,200
Instance Quantity Uom	S.F.
Does the roof have major mechanical equipment sitting on Dunnage Steel less than 18" above the Roofing?	No
Does this roof instance have a Sustainable Roof System?	No
Do solar panels exist on these roofs?	No
Is/Are the roof(s) suitable for Solar Panel installation?	No
Installation Year	1925
Source of Installation	Custodial Staff
Deficiency	SLATE ROOF: ROOFING: DAMAGED OR MISSING TILES
Roof Plan reference

Roof 3
Violations	No violations recorded.
Deficiency	SLATE ROOF: ROOFING: MAJOR ACTIVE ROOF LEAKS IN INSTRUCTIONAL SPACE

Deficiency Quantity	80
Quantity Uom	S.F.
Potential Action	REPLACE
Urgency of Action	PRIORITY 4
Purpose of Action	LEVEL 2
Deficiency Photo1

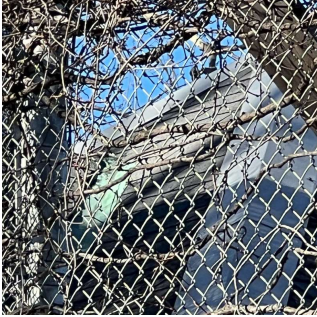
ASPHALT SHINGLE: ROOFING: DAMAGED, WORN-OUT OR MISSING SHINGLES CURLING UP

Violations	Roof 4 No violations recorded.
ROOFING DRAINS	Inspected
Condition	2 - Between Good and Fair
Deficiency	No deficiencies recorded
Specialties	Inspected
DUNNAGE STEEL	Does not Exist
SKYLIGHT/ROOF VENT	Does not Exist
STAIRS/RAMPS: EXTERIOR	Inspected
BUILDING CHEEK/FLANK WALLS	Does not Exist
RAILINGS	Does not Exist
STAIRS/RAMPS	Inspected
Condition	3 - Fair
Deficiency	CONCRETE: CRACKS/SPALLING - MINOR
Roof Plan reference

100
S.F.
REPLACE
PRIORITY 4
LEVEL 2

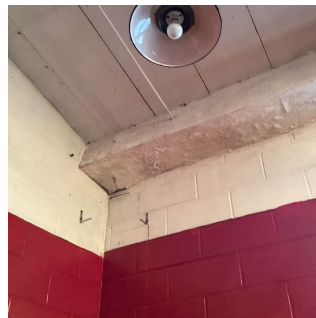
Field House 1 - Boys Locker Room

CONCRETE COLUMNS/BEAMS:
CRACKED/SPALLED/REINFORCEMENT EXPOSED

REPAIR

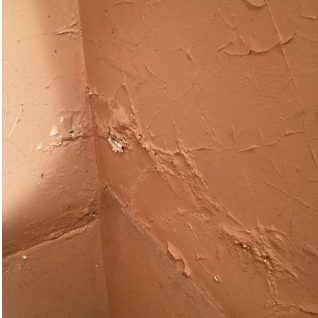
Violations	Facade C No violations recorded.
Deficiency	CONCRETE: WATER INFILTRATION IN NON- INSTRUCTIONAL SPACE

Violations	Stair/Basement No violations recorded.
ROOF STRUCTURE	
Condition	Inspected
Deficiency	2 - Between Good and Fair
VAULTS-BUNKERS	
Condition	No deficiencies recorded
CLASSROOMS/CORRIDORS/ADMIN SPACES	
Ceiling	
Condition	Does not Exist
Deficiency	Inspected
Door(s)	
Condition	2 - Between Good and Fair
Deficiency	No deficiencies recorded
Floor Finish	
Condition	Inspected
Deficiency	2 - Between Good and Fair
Walls	
Condition	No deficiencies recorded
Deficiency	2 - Between Good and Fair
INTERIOR DOOR HARDWARE	
Condition	Inspected
Deficiency	3 - Fair
LOCKER ROOM	
Instance on Field House 1 Boys - (140 Lockers)	Inspected
Alternative use	Yes
Instance on Field House 2 - Girls (54 Lockers)	Inspected
Alternative use	Yes
Ceiling	
Instance on Field House 2 - Girls (54 Lockers)	Inspected

Question	Response
INTERIOR	
STRUCTURAL	
FOUNDATION WALLS	
Quantity Uom	S.F.
Potential Action	INSTALL WATERPROOFING
Urgency of Action	PRIORITY 5
Purpose of Action	LEVEL 5
Deficiency Photo1

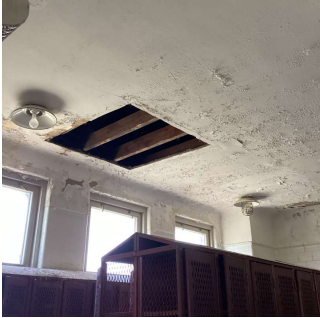
Yes	Potential Falling Debris	Severely damaged plaster Ceiling is a potential safety hazard.	INTERIOR LOCKER ROOM Ceiling	Near Entrance, Left and Right Side, Near Windows	Lee Roebuck	Fireman

Condition	5 - Poor
Deficiency	PLASTER: CRACKS/SPALLING - ACTIVE LEAK
Deficiency Location/Instance	Near Entrance, Left and Right Side, Near Windows
Deficiency Quantity	200
Quantity Uom	S.F.

Near Entrance
Violations	No violations recorded.
Door(s)	
Instance on Field House 2 - Girls (54 Lockers)	Inspected
Condition	2 - Between Good and Fair
Deficiency	No deficiencies recorded
Instance on Field House 1 Boys - (140 Lockers)	Not Required
Floor Finish	
Instance on Field House 2 - Girls (54 Lockers)	Inspected
Condition	2 - Between Good and Fair
Deficiency	CONCRETE: CRACKS
Deficiency Location/Instance	Left Side
Deficiency Quantity	25
Quantity Uom	S.F.
Potential Action	REPLACE
Urgency of Action	PRIORITY 3
Purpose of Action	LEVEL 2
Deficiency Photo1

Question	Response
INTERIOR	
LOCKER ROOM	
Ceiling	
Potential Action	REPLACE
Urgency of Action	PRIORITY 5
Purpose of Action	LEVEL 6
Deficiency Photo1

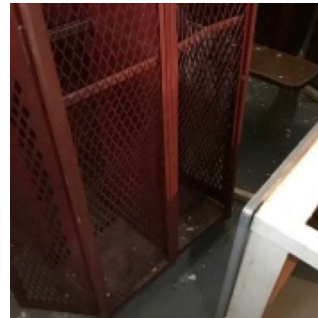
Locker/44

Deficiency	DAMAGED UNITS
Deficiency Location/Instance	Locker/44, 45
Deficiency Quantity	2
Quantity Uom	EACH
Potential Action	REPLACE
Urgency of Action	PRIORITY 3
Purpose of Action	LEVEL 2
Deficiency Photo1

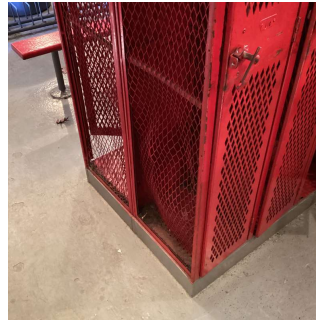
Locker 110

Deficiency	DAMAGED UNITS
Deficiency Location/Instance	Locker 110, 109, 118
Deficiency Quantity	3
Quantity Uom	EACH
Potential Action	REPLACE
Urgency of Action	PRIORITY 3
Purpose of Action	LEVEL 2

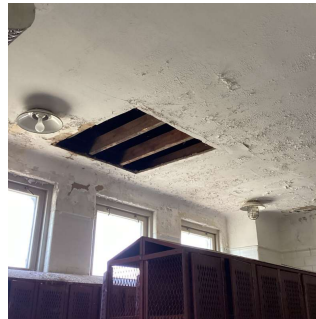
Instance on Field House 2 - Girls (54 Lockers)	Inspected
Condition	3 - Fair
Deficiency	PLASTER: CRACKS/SPALLING - ACTIVE LEAK
Deficiency Location/Instance	Near Windows
Deficiency Quantity	80
Quantity Uom	S.F.
Potential Action	REPLACE
Urgency of Action	PRIORITY 5
Purpose of Action	LEVEL 2
Deficiency Photo1

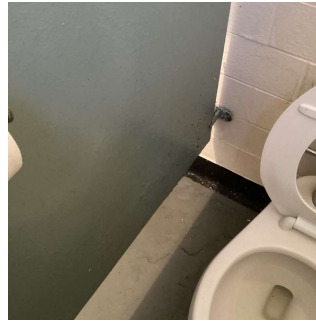
1st Floor - Men
Violations	No violations recorded.
Stalls	Inspected
Condition	5 - Poor
Deficiency	RUST - MAJOR
Deficiency Location/Instance	1st Floor - Men, 1st Floor - Women
Deficiency Quantity	2
Quantity Uom	EACH
Potential Action	REPLACE
Urgency of Action	PRIORITY 3
Purpose of Action	LEVEL 2

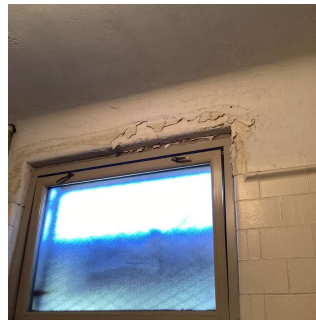
1st Floor - Men

PLASTER: CRACKS/SPALLING - ACTIVE LEAK

REPLACE

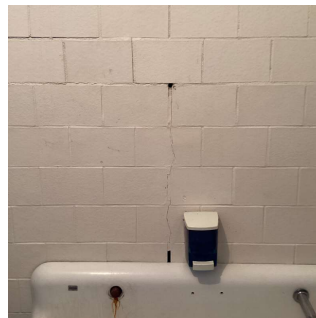
CERAMIC TILE: BROKEN/ MISSING

REPLACE

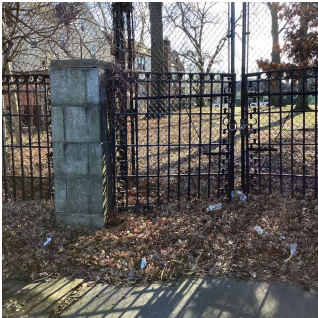
Yes	Potential Falling Debris	Leaning fence is a potential safety hazard.	SITE FENCES	150th Street	Lee Roebuck	Fireman

FENCES	Inspected
Condition	3 - Fair
Deficiency	WROUGHT IRON: DAMAGED/DETERIORATED
Deficiency Location/Instance	150th Street
Deficiency Quantity	80
Quantity Uom	S.F.
Potential Action	REPLACE
Urgency of Action	PRIORITY 5
Purpose of Action	LEVEL 6
Deficiency Photo1

Violations	150th Street No violations recorded.
Deficiency	CHAIN LINK: DAMAGED/DETERIORATED
Deficiency Location/Instance	Near NYC park, 149th Street

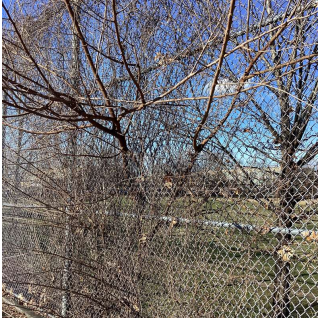
Violations	Near NYC park No violations recorded.
IRRIGATION SYSTEM	Does not Exist
PAVING	Inspected
Student Non-Use	Inspected
Gravel Exists?	No
Asphalt	Does not Exist
Concrete	Inspected
Condition	2 - Between Good and Fair
Deficiency	No deficiencies recorded
Pavers	Does not Exist
Student Use	Inspected
Gravel Exists?	No
Asphalt	Inspected
Condition	3 - Fair
Deficiency	CRACKS - MAJOR
Deficiency Location/Instance	Near field house, along Running Track
Deficiency Quantity	400
Quantity Uom	S.F.
Potential Action	REPLACE
Urgency of Action	PRIORITY 3
Purpose of Action	LEVEL 2
Deficiency Photo1

Question	Response
SITE	
FENCES	
Deficiency Quantity	200
Quantity Uom	S.F.
Potential Action	REPLACE
Urgency of Action	PRIORITY 3
Purpose of Action	LEVEL 2
Deficiency Photo1

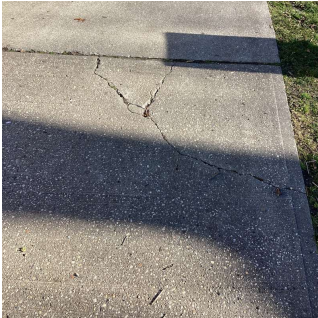
Violations	Near Entrance No violations recorded.
Concrete	Inspected
Condition	3 - Fair
Deficiency	CRACKS - MAJOR
Deficiency Location/Instance	149th Street, near Bleachers, Near Field House
Deficiency Quantity	125
Quantity Uom	S.F.
Potential Action	REPLACE
Urgency of Action	PRIORITY 3
Purpose of Action	LEVEL 2
Deficiency Photo1

Violations	149th Street No violations recorded.
Pavers	Does not Exist
DOT Sidewalk	Inspected
Asphalt	Does not Exist

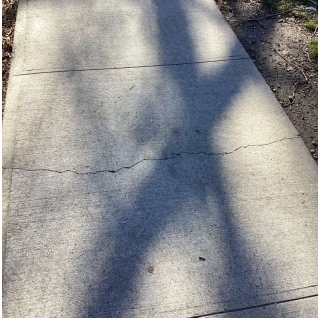
Question	Response
SITE	
PAVING	
DOT Sidewalk	
Concrete	Inspected
Condition	3 - Fair
Deficiency	DAMAGED/DETERIORATED/MISSING SECTIONS
Deficiency Location/Instance	149th Street
Deficiency Quantity	75
Quantity Uom	S.F.
Potential Action	REPLACE
Urgency of Action	PRIORITY 3
Purpose of Action	LEVEL 2
Deficiency Photo1

149th Street
Violations	No violations recorded.
Deficiency	DAMAGED CURBS
Deficiency Location/Instance	149th Street
Deficiency Quantity	20
Quantity Uom	L.F.
Potential Action	REPLACE
Urgency of Action	PRIORITY 3
Purpose of Action	LEVEL 2
Deficiency Photo1

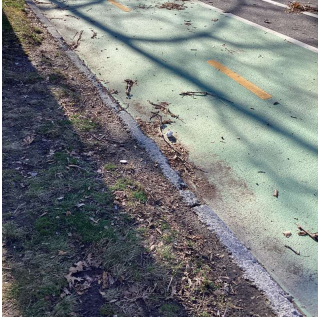
149th Street
Violations	No violations recorded.
Deficiency	HEAVING
Deficiency Location/Instance	149th Street
Deficiency Quantity	50
Quantity Uom	S.F.
Potential Action	REPLACE
Urgency of Action	PRIORITY 3
Purpose of Action	LEVEL 2
