NYC Department of Education
Building Condition Assessment Survey 2023 - 2024

Architectural Inspection

Q463

Asset: FLUSHING AF (LEVITTS FIELD)-Q, 34-42 LEAVITT STREET, New York, 11355

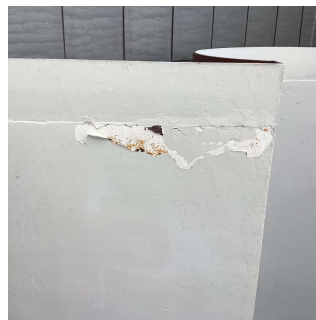
Facade A

Deficiency	CONCRETE: WATER PENETRATION
------------	-----------------------------

Potential Action

REPAIR

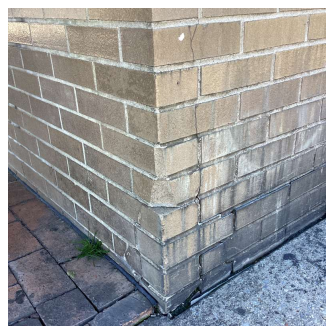
BRICK: CRACKS/DISPLACED/SPALLED BRICK AT BUILDING CORNERS

Question	Response
EXTERIOR	
EXTERIOR WALLS	
Potential Action	REMOVE AND REBUILD
Urgency of Action	PRIORITY 4
Purpose of Action	LEVEL 2
Deficiency Photo1

Violations	Facade D No violations recorded.
EXTERIOR SOFFITS	
LOUVER	Does not Exist
Condition	Inspected
Deficiency	3 - Fair
Roof Plan reference	MAJOR RUSTING
Elevation	 
Deficiency Quantity

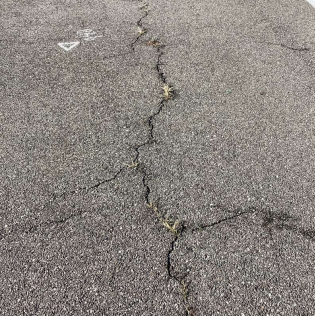
Question	Response
ATHLETIC FIELDS	
PLAYING SURFACE	
Instance Quantity Uom	S.F.
Deficiency	ASPHALT: DAMAGED/DETERIORATED
Deficiency Location/Instance	Basketball Court
Roof Plan reference

Deficiency Quantity	300
Quantity Uom	S.F.
Potential Action	REPLACE
Urgency of Action	PRIORITY 4
Purpose of Action	LEVEL 2
Deficiency Photo1

Violations	Basketball Court No violations recorded.
Instance on Handball Courts	Inspected
Instance Condition	4 - Between Fair and Poor
Instance Quantity	15,000
Instance Quantity Uom	S.F.
Deficiency	ASPHALT: DAMAGED/DETERIORATED
Deficiency Location/Instance	Handball Courts
Roof Plan reference

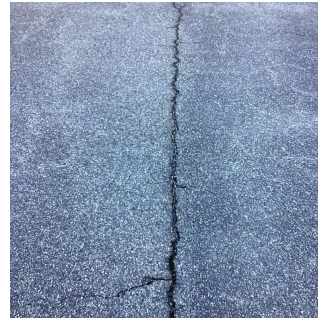
Handball Courts

Deficiency Quantity	600
Quantity Uom	S.F.
Potential Action	REPLACE

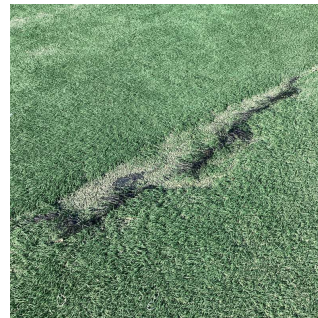
Yes	Tripping Hazard	Deteriorated Artificial Turf Playing Surface is a potential tripping hazard.	ATHLETIC FIELDS PLAYING SURFACE	Soccer and Football Field	Dave Secharran	Fireman

ARTIFICIAL TURF: DAMAGED/WORN OUT

Potential Action

REPLACE

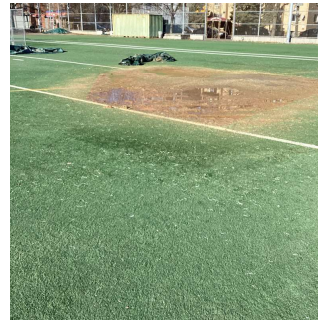
Soccer and Football Field

ARTIFICIAL TURF: DAMAGED/WORN OUT

Potential Action

REPLACE

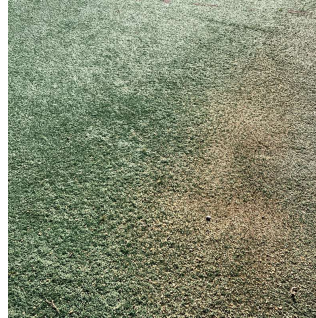
Softball Field

ARTIFICIAL TURF: DAMAGED/WORN OUT

Potential Action

REPLACE

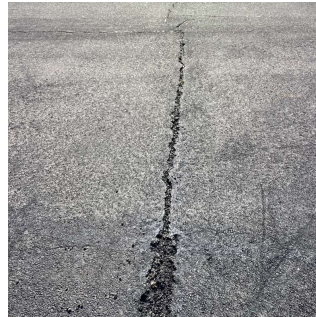
Tennis Courts

Deficiency ASPHALT: DAMAGED/DETERIORATED

Potential Action

REPLACE

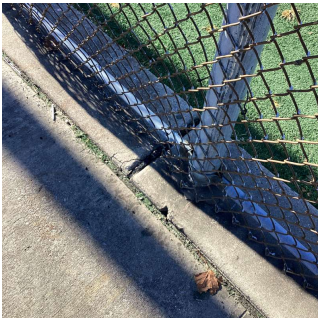
Question	Response
SITE	
Drainage System for Soil	Inspected
Catch Basins/Manhole - Surrounded by Soil	Inspected
Deficiency	No deficiencies recorded
Culverts - Soil Covering	Does not Exist
DRINKING FOUNTAINS	
Condition	2 - Between Good and Fair
Deficiency	No deficiencies recorded
FENCES	
Condition	4 - Between Fair and Poor
Deficiency	CONCRETE CURB: DAMAGED/DETERIORATED
Deficiency Location/Instance	Near Softball field, 137th Street, 32nd Avenue, Leavitt Street
Deficiency Quantity	100
Quantity Uom	S.F.
Potential Action	REPLACE
Urgency of Action	PRIORITY 3
Purpose of Action	LEVEL 2
Deficiency Photo1

Near Softball field	
Violations	No violations recorded.
Deficiency	CHAIN LINK: DAMAGED POST/RAIL
Deficiency Location/Instance	Near Parking lot
Deficiency Quantity	30
Quantity Uom	L.F.
Potential Action	REPLACE
Urgency of Action	PRIORITY 3
Purpose of Action	LEVEL 2
Deficiency Photo1

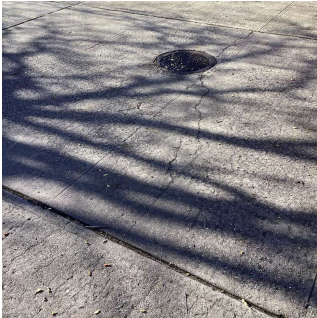
Violations	Parking lot No violations recorded.
Concrete	Inspected
Condition	3 - Fair
Deficiency	CRACKS - MAJOR
Deficiency Location/Instance	Rear of Field house
Deficiency Quantity	250
Quantity Uom	S.F.
Potential Action	REPLACE
Urgency of Action	PRIORITY 3
Purpose of Action	LEVEL 2
Deficiency Photo1

Violations	Rear of Field house No violations recorded.
Deficiency	HEAVING
Deficiency Location/Instance	Rear of Field house
Deficiency Quantity	25
Quantity Uom	S.F.
Potential Action	REPLACE
Urgency of Action	PRIORITY 3
Purpose of Action	LEVEL 2

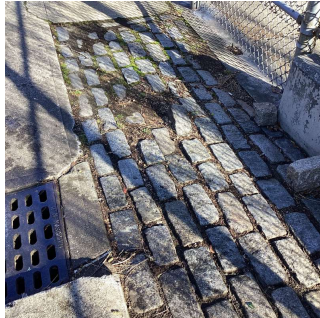
Violations	Rear of Field house No violations recorded.
Pavers	
Condition	Inspected 3 - Fair
Deficiency	DAMAGED/MISSING
Deficiency Location/Instance	Rear of Field house, Near Parking Lot
Deficiency Quantity	120
Quantity Uom	S.F.
Potential Action	REPLACE
Urgency of Action	PRIORITY 3
Purpose of Action	LEVEL 2
Deficiency Photo1

Violations	Rear of Field house No violations recorded.
Deficiency	HEAVING
Deficiency Location/Instance	Rear of Field house, Near Parking Lot
Deficiency Quantity	80
Quantity Uom	S.F.
Potential Action	REPLACE
Urgency of Action	PRIORITY 3
Purpose of Action	LEVEL 2

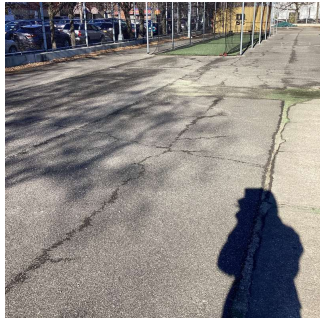
Violations	Rear of Field house No violations recorded.
Student Use	Inspected
Gravel Exists?	No
Asphalt	Inspected
Condition	4 - Between Fair and Poor
Deficiency	CRACKS - MAJOR
Deficiency Location/Instance	Along 137th Street, 32nd Avenue
Deficiency Quantity	800
Quantity Uom	S.F.
Potential Action	REPLACE
Urgency of Action	PRIORITY 3
Purpose of Action	LEVEL 2
Deficiency Photo1

Violations	Along 137th Street No violations recorded.
Concrete	Inspected
Condition	3 - Fair
Deficiency	CRACKS - MAJOR
Deficiency Location/Instance	Near Softball field, Near Field House
Deficiency Quantity	275
Quantity Uom	S.F.
Potential Action	REPLACE
Urgency of Action	PRIORITY 3
Purpose of Action	LEVEL 2

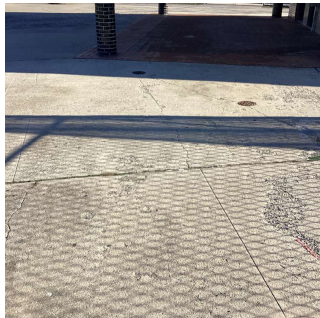
Violations	Near Softball field No violations recorded.
Pavers	Inspected
Condition	2 - Between Good and Fair
Deficiency	No deficiencies recorded
Site Sidewalks & Walkways	Inspected
Asphalt	Does not Exist
Concrete	Inspected
Condition	4 - Between Fair and Poor
Deficiency	CRACKS - MAJOR
Deficiency Location/Instance	Near field house, Near Softball Field, Near 137th Street, Main Entrance
Deficiency Quantity	650
Quantity Uom	S.F.
Potential Action	REPLACE
Urgency of Action	PRIORITY 3
Purpose of Action	LEVEL 2
Deficiency Photo1

Violations	Near field house No violations recorded.
Pavers	Inspected
Condition	2 - Between Good and Fair
Deficiency	DAMAGED/MISSING
Deficiency Location/Instance	Near field house
Deficiency Quantity	10
Quantity Uom	S.F.
Potential Action	REPLACE
Urgency of Action	PRIORITY 3
Purpose of Action	LEVEL 2

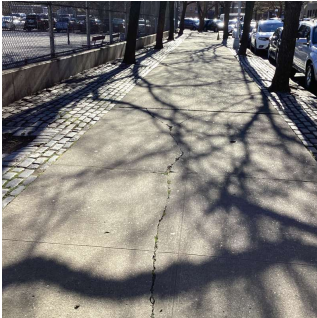
Yes	Tripping Hazard	Severely damaged Sidewalk is a potential tripping hazard.	SITE PAVING DOT Sidewalk Concrete	137th Street	Dave Secharran	Fireman

Question	Response
SITE	
PAVING	
DOT Sidewalk	
Concrete	
Violations	No violations recorded.
Deficiency	DAMAGED/DETERIORATED/MISSING SECTIONS
Deficiency Location/Instance	Leavitt Street, 137th Street, 32nd Avenue
Deficiency Quantity	2,750
Quantity Uom	S.F.
Potential Action	REPLACE
Urgency of Action	PRIORITY 3
Purpose of Action	LEVEL 2
Deficiency Photo1

137th Street
Violations	No violations recorded.
Pavers	Inspected
Condition	4 - Between Fair and Poor
Deficiency	HEAVING
Deficiency Location/Instance	Leavitt Street, 137th Street, 32nd Avenue
Deficiency Quantity	300
Quantity Uom	S.F.
Potential Action	REPLACE
Urgency of Action	PRIORITY 3
Purpose of Action	LEVEL 2
Deficiency Photo1

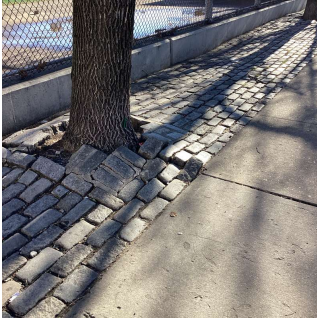
Yes	Tripping Hazard	Severely heaving concrete sidewalk is a potential tripping hazard	SITE PAVING DOT Sidewalk Concrete	32nd Avenue	Dave Secharran	Fireman

137th Street
Violations	No violations recorded.
Deficiency	DAMAGED/MISSING
Deficiency Location/Instance	Leavitt Street, 137th Street, 32nd Avenue
Deficiency Quantity	250
Quantity Uom	S.F.
Potential Action	REPLACE
Urgency of Action	PRIORITY 3

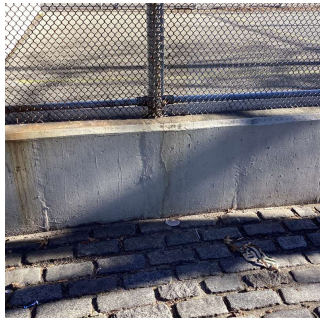
Question	Response
SITE	
PAVING	
DOT Sidewalk	
Pavers	
Deficiency Photo1	 
Violations	32nd Avenue No violations recorded.
PLAYGROUNDS	Does not Exist
RETAINING WALLS	Inspected
Are there any Retaining Walls 6' OR higher facing public street/sidewalk?	No
Condition	3 - Fair
Deficiency	CAST IN PLACE CONCRETE: CRACKS/SPALLING - MAJOR
Deficiency Location/Instance	137th Street
Deficiency Quantity	80
Quantity Uom	S.F.
Potential Action	REPLACE
Urgency of Action	PRIORITY 3
Purpose of Action	LEVEL 2
Deficiency Photo1

Violations	137th Street No violations recorded.
SEATING	Does not Exist
SITE WALLS (NOT RETAINING WALLS)	Inspected
Condition	2 - Between Good and Fair
Deficiency	No deficiencies recorded
STAIRS/RAMPS: EXTERIOR	Does not Exist
ARTWORK	Does not Exist
