**NYC Department of Education**  
**Building Condition Assessment Survey 2023 - 2024**

Architectural Inspection

**Asset: 3K CENTER @ 185 BEACH 99TH STREET - QUEENS, 185 BEACH 99TH STREET, 11694**

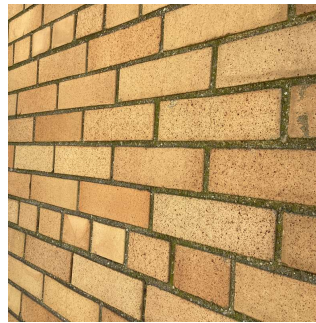
Facade D

Question	Response
<b>Architectural</b>	
<b>EXTERIOR</b>	Inspected
<b>AREAWAY</b>	Does not Exist
<b>AWNINGS AND CANOPIES</b>	Does not Exist
<b>CHIMNEY</b>	Inspected
Material Type(s)	Masonry
Condition	3 - Fair
Deficiency	BRICK: DETERIORATED JOINTS

200  
 S.F.  
 REPOINT  
 PRIORITY 3  
 LEVEL 2

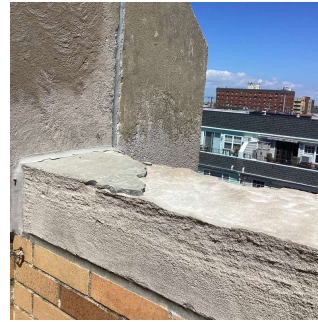
Roof 1

CAST STONE: CRACKED/BROKEN PIECES

10  
 L.F.  
 REPLACE-IN-KIND  
 PRIORITY 4  
 LEVEL 2

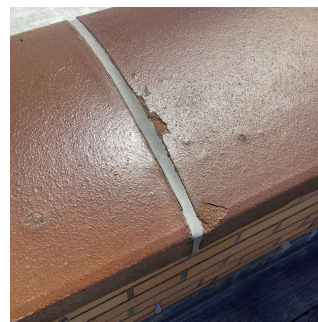
Roof 1

TERRA COTTA: CRACKED/BROKEN PIECES

10

REPLACE-IN-KIND

PRIORITY 4

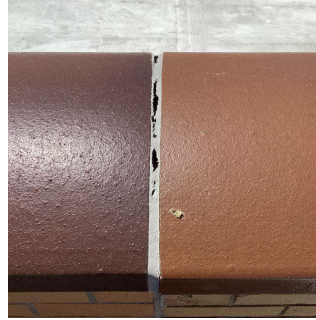
Roof 1  
No violations recorded.

TERRA COTTA: DETERIORATED TRANSVERSE JOINTS

L.F.  
MAINTENANCE  
PRIORITY 3  
LEVEL 2

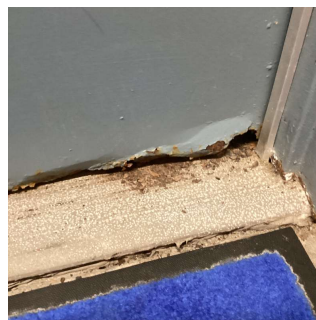
Facade B  
No violations recorded.

METAL: DETERIORATED DOOR AND FRAME - MAJOR DETERIORATION

2  
EACH  
REPLACE  
PRIORITY 4  
LEVEL 2

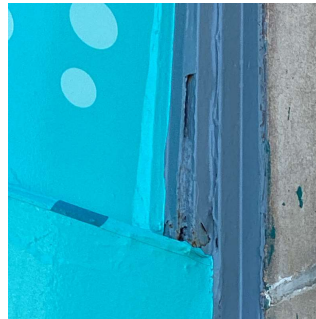
Facade A

METAL: DENTED, MAJOR RUSTING

REPLACE

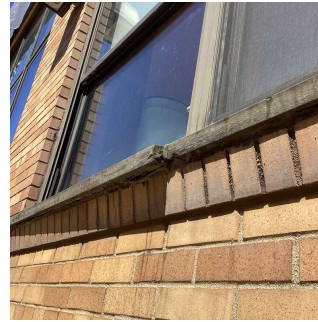
Facade C

Deficiency Quantity	10
Quantity Uom	L.F.
Potential Action	REPAIR
Urgency of Action	PRIORITY 3
Purpose of Action	LEVEL 2

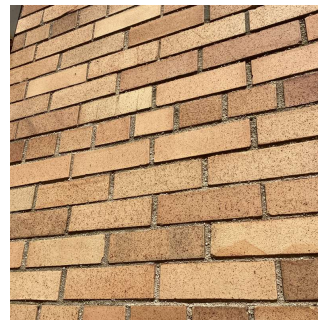
Facade C

**BRICK: DETERIORATED JOINTS**

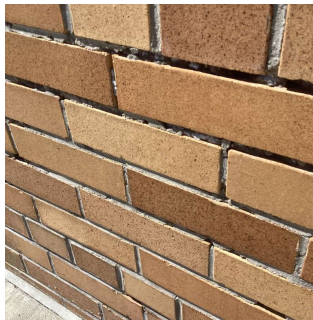
Facade B

**BRICK: DETERIORATED JOINTS**

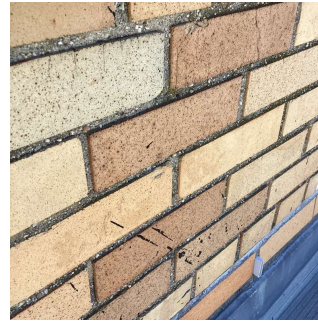
Roof 1

Deficiency	BRICK: DETERIORATED JOINTS
------------	----------------------------

Deficiency Quantity	100
Quantity Uom	S.F.
Potential Action	REPOINT
Urgency of Action	PRIORITY 3
Purpose of Action	LEVEL 2

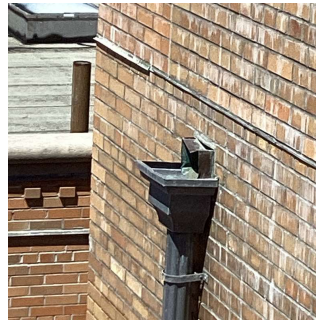
Facade E

DAMAGED/MISSING

Quantity Uom	L.F.
Potential Action	REPLACE
Urgency of Action	PRIORITY 4
Purpose of Action	LEVEL 2
Deficiency Photo1

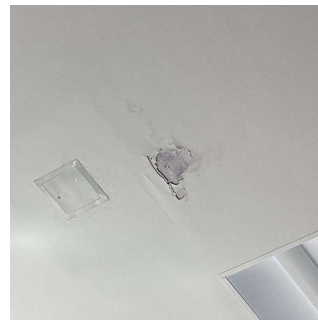
Roof 2 - Multipurpose Room, also Room 111, Corridor near Room 115

Deficiency **MODIFIED BITUMEN: ROOFING: MAJOR ACTIVE ROOF LEAKS IN INSTRUCTIONAL SPACE**

Deficiency	MODIFIED BITUMEN; ROOFING; MAJOR ACTIVE ROOF LEAKS IN INSTRUCTIONAL SPACE

300  
S.F.  
REPLACE ROOFING WITHOUT MAJOR EQUIPMENT  
REMOVAL  
PRIORITY 5  
LEVEL 2

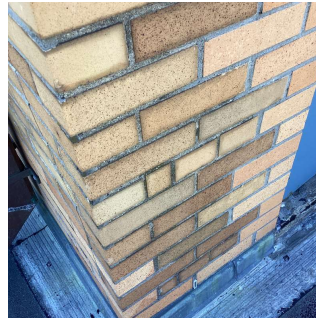
Roof 1 - Bulkhead 1

BULKHEAD/PENTHOUSE WALLS/EXTERIOR: DETERIORATED JOINTS

10  
S.F.  
REPOINT  
PRIORITY 3  
LEVEL 2

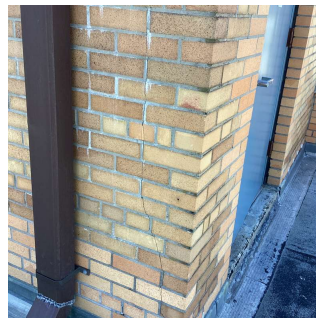
Roof 1 - Bulkhead 1

**BULKHEAD/PENTHOUSE WALLS/EXTERIOR:  
CRACKS/SPALLING - MAJOR**

REPLACE

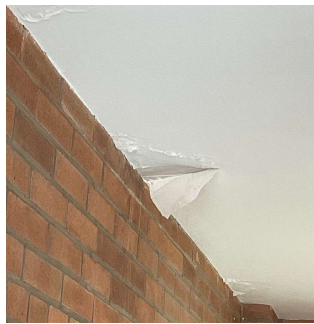
Roof 1 - Bulkhead 1

**BULKHEAD/PENTHOUSE WALLS/INTERIOR: PLASTER  
CRACKS/SPALLING**

30  
S.F.  
REPLACE  
PRIORITY 3  
LEVEL 2

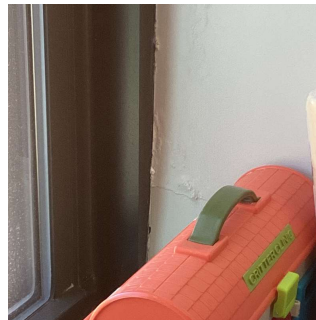
Facade D - Room 210 (two locations) also Facade A - Room 206  
No violations recorded.

Material Type(s)	Aluminum
Instance on Aluminum - Double Hung: All Facades	Inspected
Instance Condition	3 - Fair
Instance Quantity	2,600
Instance Quantity Uom	S.F.
Are these windows insulated	No
Installation Year	2005
Source of Installation	Custodial Staff
Deficiency	ALUMINUM - DOUBLE HUNG: AIR/WATER INFILTRATION

90  
L.F.  
REPLACE TRIM, SILLS OR WEATHERSTRIPPING  
PRIORITY 5  
LEVEL 2

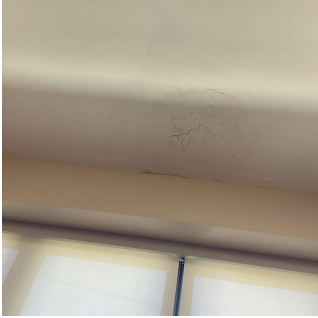
Question	Response
<b>INTERIOR</b>	
<b>STRUCTURAL</b>	
<b>COLUMNS/BEAMS/BEARING WALLS</b>	Inspected
Condition	2 - Between Good and Fair
Deficiency	No deficiencies recorded
<b>FLOOR STRUCTURE</b>	Inspected
Condition	2 - Between Good and Fair
Deficiency	No deficiencies recorded
<b>FOUNDATION WALLS</b>	Inspected
Material Type(s)	Concrete
Condition	2 - Between Good and Fair
Deficiency	No deficiencies recorded
<b>ROOF STRUCTURE</b>	Inspected
Condition	2 - Between Good and Fair
Deficiency	No deficiencies recorded
<b>VAULTS-BUNKERS</b>	Does not Exist
<b>AUDITORIUM</b>	Does not Exist
<b>CAFETERIA</b>	Does not Exist
<b>CLASSROOMS/CORRIDORS/ADMIN SPACES</b>	Inspected
<b>Ceiling</b>	Inspected
Condition	2 - Between Good and Fair
Deficiency	GYPSUM BOARD: DAMAGED/DETERIORATED - ACTIVE LEAK
Deficiency Location/Instance	Room 205, Corridor near Room 115
Deficiency Quantity	40
Quantity Uom	S.F.
Potential Action	REPLACE
Urgency of Action	PRIORITY 5

Purpose of Action	LEVEL 2
Deficiency Photo1

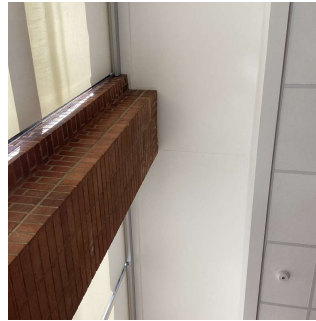
Violations	Room 205 No violations recorded.
Deficiency	GYPSUM BOARD: DAMAGED/DETERIORATED
Deficiency Location/Instance	Room 111
Deficiency Quantity	10
Quantity Uom	S.F.
Potential Action	REPLACE
Urgency of Action	PRIORITY 3
Purpose of Action	LEVEL 2

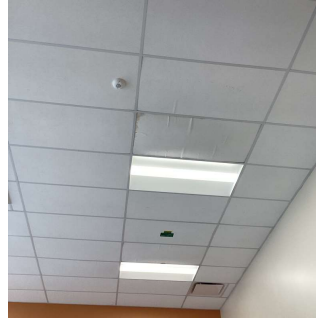
Room 111

ACOUSTIC TILES: DAMAGED/MISSING

REPLACE

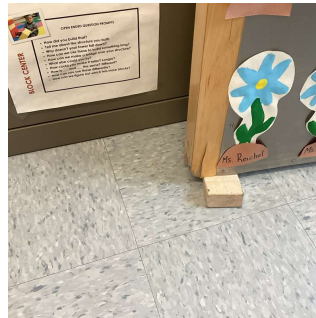
WOOD: DETERIORATED DOOR

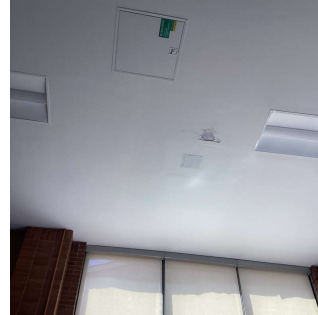
Room 111

<b>Ceiling</b>	
Instance on 1st Floor	Inspected
Condition	2 - Between Good and Fair
Deficiency	GYPSUM BOARD: DAMAGED/DETERIORATED - ACTIVE LEAK
Deficiency Location/Instance	Near Windows
Deficiency Quantity	20
Quantity Uom	S.F.
Potential Action	REPLACE

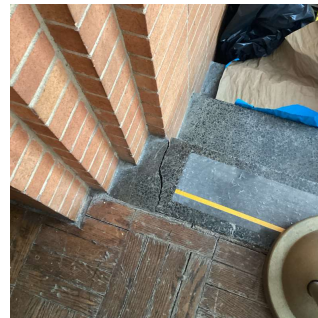
Left Side

DAMAGED STEPS

REPLACE

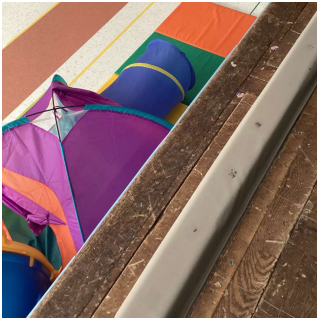
Question	Response
<b>INTERIOR</b>	
<b>MULTI-PURPOSE ROOM</b>	
<b>Stage</b>	
<b>Stage</b>	
Violations	No violations recorded.
Deficiency	DAMAGED FLOOR
Deficiency Location/Instance	Front Stage, Near Back Stairs
Deficiency Quantity	30
Quantity Uom	S.F.
Potential Action	REPLACE
Urgency of Action	PRIORITY 3
Purpose of Action	LEVEL 2
Deficiency Photo1

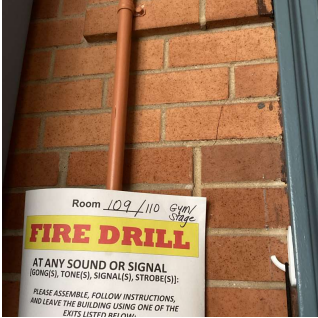
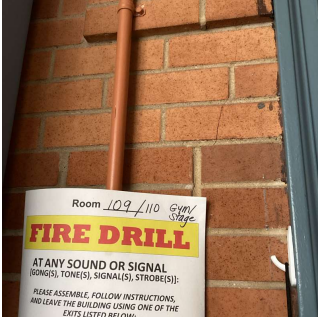
Condition	2 - Between Good and Fair
Deficiency	BRICK: CRACKS/SPALLING
Deficiency Location/Instance	Near Entrance
Deficiency Quantity	10
Quantity Uom	S.F.
Potential Action	REPLACE
Urgency of Action	PRIORITY 3
Purpose of Action	LEVEL 2
Deficiency Photo1

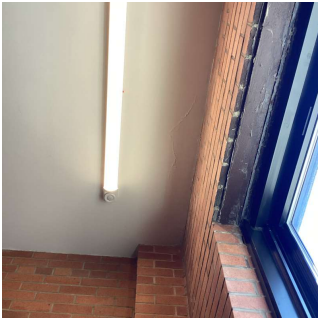
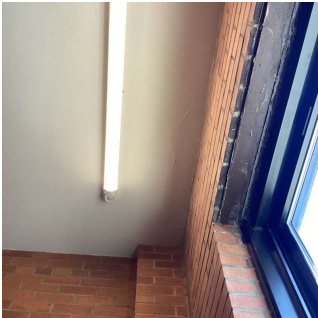
Condition	2 - Between Good and Fair
Deficiency	PLASTER: CRACKS/SPALLING
Deficiency Location/Instance	Stair B/1
Deficiency Quantity	10
Quantity Uom	S.F.
Potential Action	REPLACE
Urgency of Action	PRIORITY 3
Purpose of Action	LEVEL 2
Deficiency Photo1

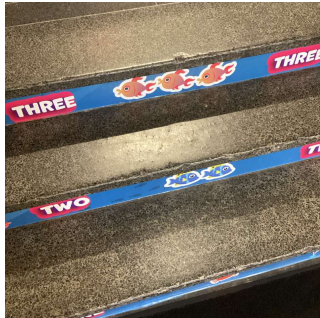
Violations	Stair A/1 No violations recorded.
<b>Stairs and Landings</b>	Inspected
Condition	4 - Between Fair and Poor
Deficiency	TERRAZZO: CRACKS
Deficiency Location/Instance	Stairs A/1, 2, B/1, 2, Bulkhead
Deficiency Quantity	80
Quantity Uom	S.F.
Potential Action	REPLACE
Urgency of Action	PRIORITY 3
Purpose of Action	LEVEL 2
Deficiency Photo1

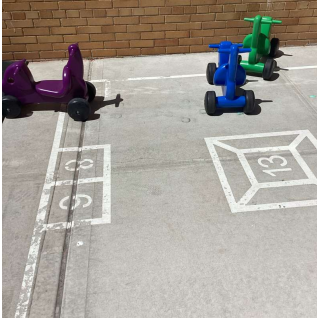
Question	Response
<b>SITE</b>	
<b>PLAYGROUNDS</b>	
<b>Pavement</b>	
Condition	3 - Fair
Deficiency	CONCRETE: DAMAGED/DETERIORATED/MISSING SECTIONS
Deficiency Location/Instance	Near Exit 2
Deficiency Quantity	50
Quantity Uom	S.F.
Potential Action	REPLACE
Urgency of Action	PRIORITY 3
Purpose of Action	LEVEL 2
Deficiency Photo1

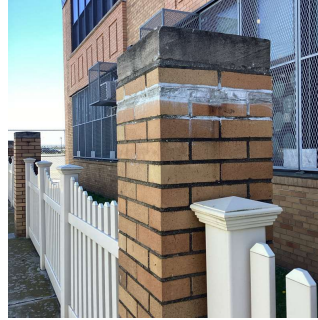
Near Exit 2
Violations	No violations recorded.
<b>Play Equipment</b>	
Instance on Northeast Side of the building	Inspected
Condition	1 - Good
Deficiency	No deficiencies recorded
<b>Safety Surfacing</b>	
Instance on Northeast Side of the building	Inspected
Condition	1 - Good
Deficiency	No deficiencies recorded
<b>Unpaved Area</b>	
Instance on Northeast Side of the building	Does not Exist
<b>PLAYING SURFACE</b>	Does not Exist
<b>RETAINING WALLS</b>	Does not Exist
<b>SEATING</b>	Does not Exist
<b>SITE WALLS (NOT RETAINING WALLS)</b>	Inspected
Condition	3 - Fair
Deficiency	BRICK: CRACKS/SPALLING - MAJOR

Deficiency Location/Instance	Beach 99th Street
Deficiency Quantity	40
Quantity Uom	S.F.
Potential Action	REPLACE
Urgency of Action	PRIORITY 3
Purpose of Action	LEVEL 2
