**NYC Department of Education**  
**Building Condition Assessment Survey 2023 - 2024**

Architectural Inspection

Q466

**Asset: FAR ROCKAWAY AF - QUEENS, 8-21 BEACH 25 STREET, New York, 11691**

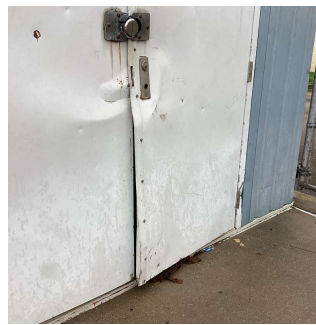
Question	Response
<b>Architectural</b>	
<b>EXTERIOR</b>	Inspected
<b>AREAWAY</b>	Does not Exist
<b>AWNINGS AND CANOPIES</b>	Does not Exist
<b>CHIMNEY</b>	Does not Exist
<b>COPING</b>	Does not Exist
<b>CORNICE</b>	Does not Exist
<b>DOORS</b>	Inspected
<b>DOORS AND FRAMES</b>	Inspected
Condition	5 - Poor
Deficiency	METAL: DETERIORATED DOOR AND FRAME - MAJOR DETERIORATION

Facade A  
No violations recorded.

2  
EACH  
REPLACE  
PRIORITY 4  
LEVEL 2

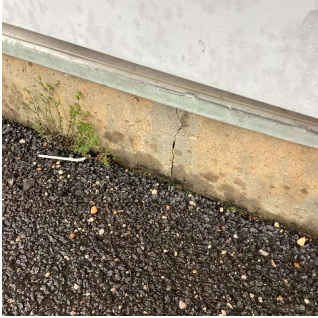
<b>COLUMNS/BEAMS/BEARING WALLS</b>	Inspected
Condition	2 - Between Good and Fair
Deficiency	No deficiencies recorded
<b>FLOOR STRUCTURE</b>	Inspected
Condition	3 - Fair
Deficiency	CONCRETE SLAB ON GRADE: THRU CRACKS
Deficiency Location/Instance	Storage Shed
Deficiency Quantity	40
Quantity Uom	S.F.

Question	Response
<b>INTERIOR</b>	
<b>STRUCTURAL</b>	
<b>FLOOR STRUCTURE</b>	
Potential Action	REPAIR
Urgency of Action	PRIORITY 3
Purpose of Action	LEVEL 5
Deficiency Photo1

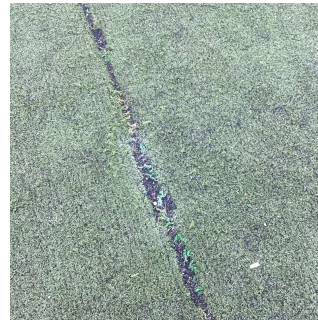
Instance Quantity	76,000
Instance Quantity Uom	S.F.
Deficiency	ARTIFICIAL TURF: DAMAGED/WORN OUT
Deficiency Location/Instance	Football/Baseball Field

2,600

REPLACE

PRIORITY 4

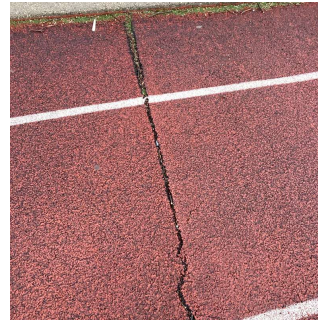
Running Track

5 - Poor

ATHLETIC WEARING SURFACE: DAMAGED/DETERIORATED

5,000

REPLACE

PRIORITY 4

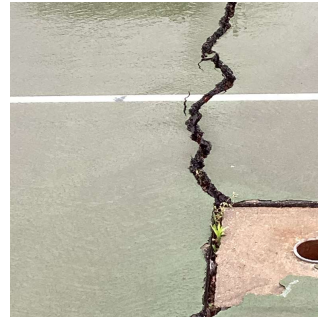
Tennis Courts

5 - Poor

ASPHALT: DAMAGED/DETERIORATED

6,200

REPLACE

PRIORITY 4

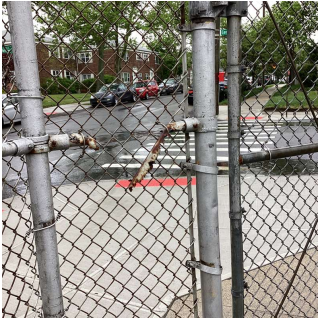
Question	Response
<b>SITE</b>	
<b>CONTAINERIZATION</b>	Does not Exist
<b>Drainage System for Asphalt</b>	Inspected
<b>Catch Basins/Manhole - Surrounded by asphalt</b>	Inspected
Condition	2 - Between Good and Fair
Deficiency	No deficiencies recorded
<b>Culverts - Asphalt Covering</b>	Does not Exist
<b>Drainage System for Concrete</b>	Does not Exist
<b>Drainage System for Soil</b>	Does not Exist
<b>DRINKING FOUNTAINS</b>	Does not Exist
<b>FENCES</b>	Inspected
Condition	4 - Between Fair and Poor
Deficiency	CHAIN LINK: DAMAGED POST/RAIL
Deficiency Location/Instance	Cornaga Avenue
Deficiency Quantity	10
Quantity Uom	L.F.
Potential Action	REPLACE
Urgency of Action	PRIORITY 5
Purpose of Action	LEVEL 6
Deficiency Photo1

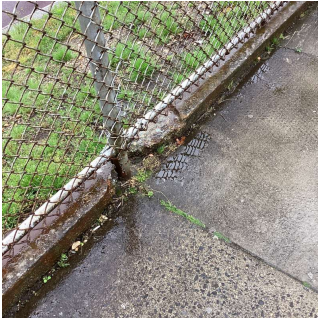
Violations	Cornaga Avenue No violations recorded.
Deficiency	CONCRETE CURB: DAMAGED/DETERIORATED
Deficiency Location/Instance	Tennis Courts, Cornaga Avenue, Ocean Crest Boulevard
Deficiency Quantity	180

Quantity Uom	S.F.
Potential Action	REPLACE
Urgency of Action	PRIORITY 3
Purpose of Action	LEVEL 2
Deficiency Photo1

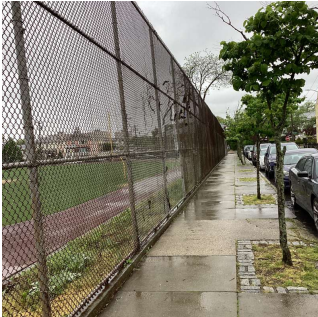
Violations	Cornaga Avenue No violations recorded.
Deficiency	CHAIN LINK: RUST - MAJOR

Question	Response
<b>SITE</b>	
<b>FENCES</b>	
Deficiency Location/Instance	Tennis Courts, Hartman Lane, Cornaga Avenue
Deficiency Quantity	2,700
Quantity Uom	S.F.
Potential Action	REPLACE
Urgency of Action	PRIORITY 3
Purpose of Action	LEVEL 2
Deficiency Photo1

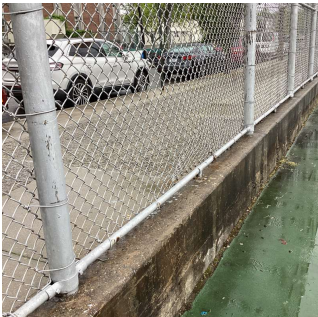
Violations	Cornaga Avenue No violations recorded.
Deficiency	CHAIN LINK: DAMAGED/DETERIORATED
Deficiency Location/Instance	Ocean Crest Boulevard, Hartman Lane, Cornaga Avenue
Deficiency Quantity	400
Quantity Uom	S.F.
Potential Action	REPLACE
Urgency of Action	PRIORITY 3
Purpose of Action	LEVEL 2
Deficiency Photo1

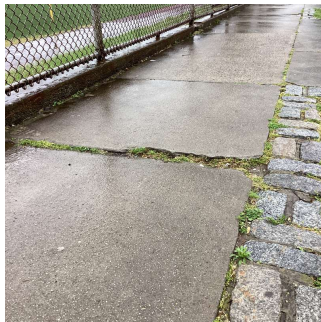
Question	Response
<b>SITE</b>	
<b>PAVING</b>	
<b>DOT Sidewalk</b>	
<b>Concrete</b>	Inspected
Condition	4 - Between Fair and Poor
Deficiency	HEAVING
Deficiency Location/Instance	Cornaga Avenue, Ocean Crest Boulevard, Hartman Lane
Deficiency Quantity	250
Quantity Uom	S.F.
Potential Action	REPLACE
Urgency of Action	PRIORITY 3
Purpose of Action	LEVEL 2
Deficiency Photo1

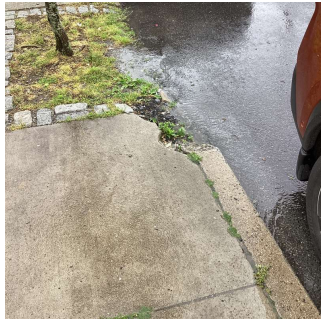
Violations	Cornaga Avenue No violations recorded.
Deficiency	DAMAGED CURBS
Deficiency Location/Instance	Cornaga Avenue, Ocean Crest Boulevard, Hartman Lane
Deficiency Quantity	340
Quantity Uom	L.F.
Potential Action	REPLACE
Urgency of Action	PRIORITY 3
Purpose of Action	LEVEL 2
Deficiency Photo1

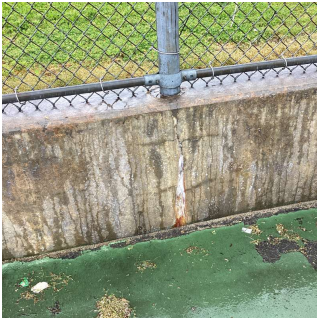
Question	Response
<b>SITE</b>	
<b>PAVING</b>	
<b>DOT Sidewalk</b>	
<b>Concrete</b>	
Deficiency Photo1	 
Violations	Cornaga Avenue No violations recorded.
<b>Pavers</b>	Does not Exist
<b>PLAYGROUNDS</b>	Does not Exist
<b>RETAINING WALLS</b>	Inspected
Are there any Retaining Walls 6' OR higher facing public street/sidewalk?	Yes
Condition	3 - Fair
Deficiency	MASONRY UNIT: CRACKS/SPALLING - MAJOR
Deficiency Location/Instance	Near Ocean Crest Boulevard, Cornaga Avenue
Deficiency Quantity	100
Quantity Uom	S.F.
Potential Action	REPLACE
Urgency of Action	PRIORITY 3
Purpose of Action	LEVEL 2
Deficiency Photo1
