NYC Department of Education
Building Condition Assessment Survey 2023 - 2024

Architectural Inspection

Q471

Asset: JAMAICA AF - QUEENS, 167-01 GOTHIC DRIVE, New York, 11432

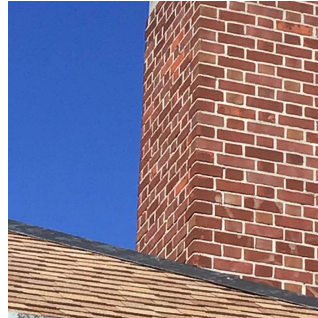
Roof 1

Deficiency: BRICK: DETERIORATED JOINTS
 Roof Plan reference

Deficiency Quantity	30
Quantity Uom	S.F.
Potential Action	REPOINT
Urgency of Action	PRIORITY 3
Purpose of Action	LEVEL 2
Deficiency Photo1

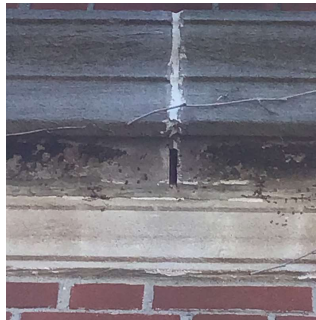
STONE: DETERIORATED JOINTS

10
L.F.
REPOINT
PRIORITY 4
LEVEL 2

Facade B
No violations recorded.

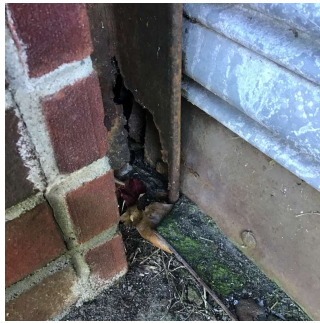
ROLL-UP DOOR: DETERIORATED DOOR AND FRAME - MAJOR DETERIORATION

300
S.F.
REPLACE
PRIORITY 4
LEVEL 2

Violations	Facade E No violations recorded.
Deficiency	METAL CLAD: DETERIORATED DOOR AND FRAME - MAJOR DETERIORATION
Roof Plan reference

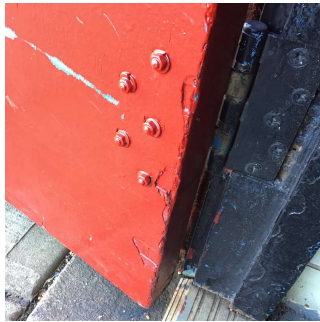
Deficiency Quantity	2
Quantity Uom	EACH
Potential Action	REPLACE
Urgency of Action	PRIORITY 4
Purpose of Action	LEVEL 2
Deficiency Photo1

Violations	Facade A No violations recorded.
DOOR HARDWARE	Inspected
Condition	3 - Fair
Deficiency	No deficiencies recorded
LINTELS	Inspected
Condition	2 - Between Good and Fair
Deficiency	No deficiencies recorded
TRANSOM/SIDE LIGHT	Inspected
Condition	2 - Between Good and Fair
Deficiency	No deficiencies recorded

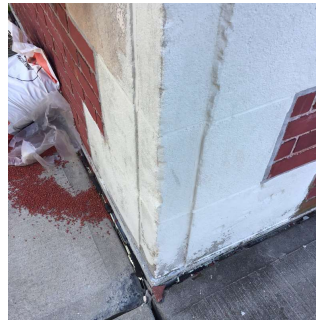
Facade A

Question	Response
EXTERIOR	
EXTERIOR WALLS	Inspected
Material Type(s)	Masonry
Replacement Quantity	3,500
Replacement Uom	S.F.
Instance on All Facades	Inspected
Instance Condition	3 - Fair
Instance Quantity	3,500
Instance Quantity Uom	S.F.
Deficiency	BRICK: MINOR CRACKS AND SPALLING
Roof Plan reference	<p>Q471</p>  
Elevation	 
Deficiency Quantity	10
Quantity Uom	S.F.
Potential Action	RESTITCH
Urgency of Action	PRIORITY 3
Purpose of Action	LEVEL 2
Deficiency Photo1	 
Violations	Facade E No violations recorded.
Deficiency	STONE: CRACKS AT BUILDING CORNERS

10

REPLACE

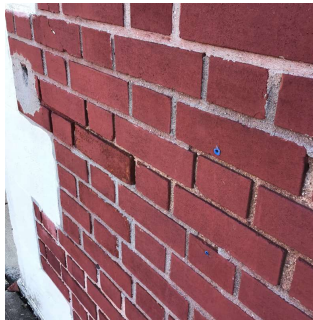
Facade A

BRICK: DETERIORATED JOINTS

10

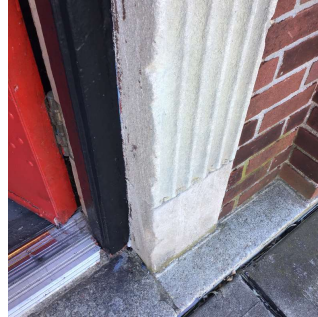
Facade A

STONE: CHIPPED/SPALLED/BROKEN PIECES - MINOR

20

REPAIR

PRIORITY 3
LEVEL 2

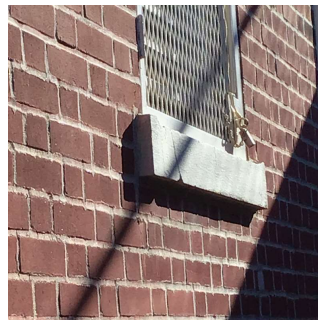
Facade D

BRICK: DETERIORATED MASONRY SILLS - MINOR

10

REPAIR

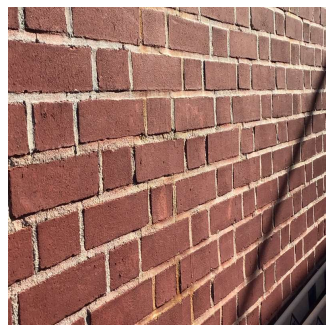
Question	Response
EXTERIOR	
EXTERIOR WALLS	
Violations	No violations recorded.
Deficiency	BRICK: DETERIORATED JOINTS
Roof Plan reference	<p>Q471</p>

Deficiency Quantity	200
Quantity Uom	S.F.
Potential Action	REPOINT
Urgency of Action	PRIORITY 3
Purpose of Action	LEVEL 2
Deficiency Photo1

<p>Facade D</p>
Violations	No violations recorded.
EXTERIOR SOFFITS	
Does not Exist	
LOUVER	
Inspected	
Condition	2 - Between Good and Fair
Deficiency	No deficiencies recorded
PARAPETS	
Inspected	
Material Type(s)	Masonry
Replacement Quantity	700
Replacement Uom	C.F.
Instance on All Facades	Inspected
Instance Condition	5 - Poor

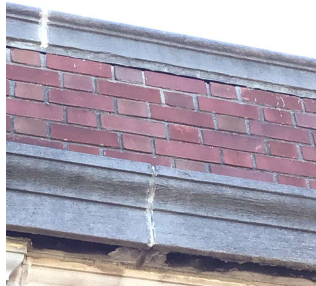
Roof 1

Deficiency BRICK: DETERIORATED JOINTS

Deficiency Quantity	100
Quantity Uom	S.F.
Potential Action	REPOINT
Urgency of Action	PRIORITY 3
Purpose of Action	LEVEL 2
Deficiency Photo1

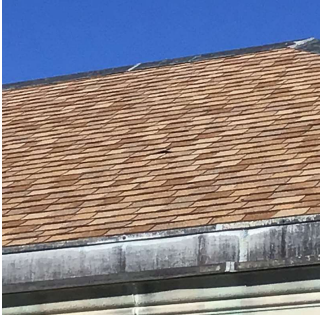
Violations	Roof 2 No violations recorded.
PLAZA DECK	Does not Exist
ROOF	Inspected
Roofing	Inspected
Replacement Quantity	2,800
Replacement Uom	S.F.
ROOF HATCH/SMOKE HATCH	Does not Exist
LEADERS, GUTTERS, DOWNSPOUTS, SCUPPERS	Inspected
Condition	2 - Between Good and Fair
Deficiency	No deficiencies recorded
ROOFING	Inspected
Instance on Asphalt Shingle: Roof 1	Inspected
Instance Condition	4 - Between Fair and Poor
Instance Quantity	800
Instance Quantity Uom	S.F.
Does the roof have major mechanical equipment sitting on Dunnage Steel less than 18" above the Roofing?	No
Does this roof instance have a Sustainable Roof System?	No
Do solar panels exist on these roofs?	No
Is/Are the roof(s) suitable for Solar Panel installation?	No
Installation Year	2000
Source of Installation	Custodial Staff
Deficiency	ASPHALT SHINGLE: ROOFING: DAMAGED, WORN-OUT OR MISSING SHINGLES CURLING UP

Deficiency Quantity	10
Quantity Uom	S.F.
Potential Action	REPLACE
Urgency of Action	PRIORITY 4
Purpose of Action	LEVEL 2

Roof 1	
Violations	No violations recorded.
Instance on Metal: Roof 4	Inspected
Instance Condition	1 - Good
Instance Quantity	500
Instance Quantity Uom	S.F.
Does the roof have major mechanical equipment sitting on Dunnage Steel less than 18" above the Roofing?	No
Does this roof instance have a Sustainable Roof System?	No
Do solar panels exist on these roofs?	No
Is/Are the roof(s) suitable for Solar Panel installation?	No
Installation Year	2011
Source of Installation	Custodial Staff
Deficiency	No deficiencies recorded
Instance on Built-Up: Roofs 2, 3	Inspected
Instance Condition	3 - Fair
Instance Quantity	1,500
Instance Quantity Uom	S.F.
Does the roof have major mechanical equipment sitting on Dunnage Steel less than 18" above the Roofing?	No
Does this roof instance have a Sustainable Roof System?	No
Do solar panels exist on these roofs?	No
Is/Are the roof(s) suitable for Solar Panel installation?	No

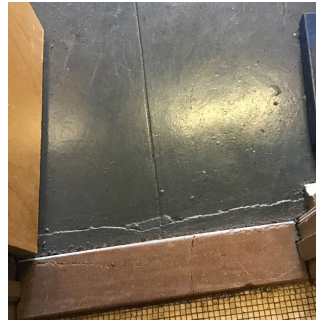
Near Girls Restrooms

Deficiency Photo1

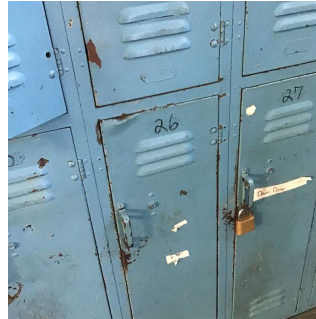
Instance on 1st Floor - Boys (76 Lockers)	Inspected
Condition	3 - Fair
Deficiency	DAMAGED UNITS
Deficiency Location/Instance	Locker 26
Deficiency Quantity	1
Quantity Uom	EACH
Potential Action	REPLACE
Urgency of Action	PRIORITY 3
Purpose of Action	LEVEL 2
Deficiency Photo1

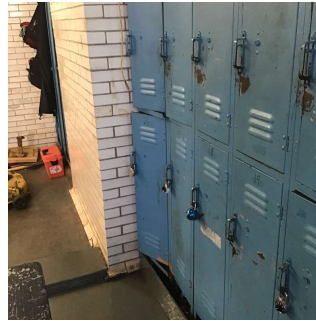
Locker 16

Yes	Protruding Elements	Broken locker, resulting in potential safety hazard	INTERIOR LOCKER ROOM Locker Room Lockers	Lockers 16, 1	Eric Daus	Fireman

Deficiency	DAMAGED UNITS
Deficiency Location/Instance	Lockers 16, 1
Deficiency Quantity	2
Quantity Uom	EACH
Potential Action	REPLACE
Urgency of Action	PRIORITY 5
Purpose of Action	LEVEL 6

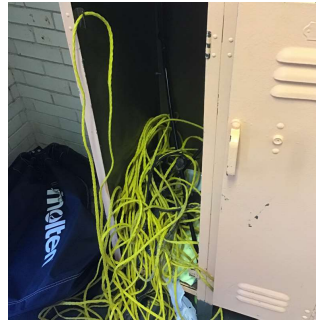
Girls Locker Room

DAMAGED UNITS

REPLACE

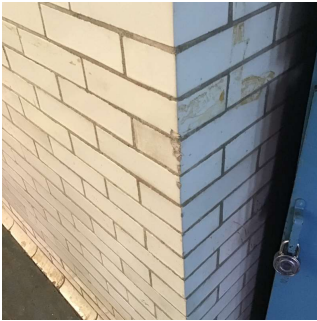
BRICK: CRACKS/SPALLING

REPLACE

Near Shower Room
Violations	No violations recorded.
Instance on 1st Floor - Girls (20 Lockers)	Inspected
Condition	2 - Between Good and Fair
Deficiency	BRICK: CRACKS/SPALLING
Deficiency Location/Instance	Near Entrance
Deficiency Quantity	10
Quantity Uom	S.F.
Potential Action	REPLACE
Urgency of Action	PRIORITY 3
Purpose of Action	LEVEL 2
Deficiency Photo1

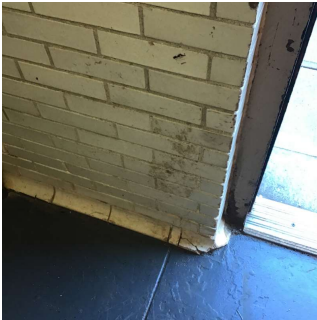
Near Entrance
Violations	No violations recorded.
SHOWER ROOM	Inspected
Instance on 1st Floor Boys	Inaccessible
STAIRS/RAMPS: INTERIOR	Does not Exist
TOILET ROOMS - STAFF	Inspected
Ceiling	Inspected
Condition	5 - Poor
Deficiency	PLASTER: CRACKS/SPALLING
Deficiency Location/Instance	Staff Restroom
Deficiency Quantity	10
Quantity Uom	S.F.
Potential Action	REPLACE
Urgency of Action	PRIORITY 3
Purpose of Action	LEVEL 2

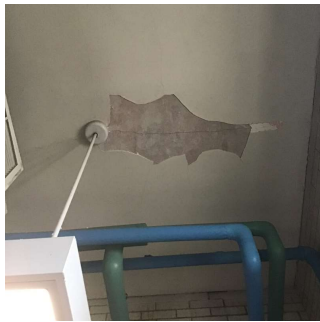
Violations	Staff Restroom No violations recorded.
TOILET ROOMS - STUDENTS	
Ceiling	Inspected
Condition	3 - Fair
Deficiency	PLASTER: CRACKS/SPALLING
Deficiency Location/Instance	Girls Restroom, Boys Restroom
Deficiency Quantity	30
Quantity Uom	S.F.
Potential Action	REPLACE
Urgency of Action	PRIORITY 3
Purpose of Action	LEVEL 2
Deficiency Photo1

Violations	Girls Restroom No violations recorded.
Door(s)	
Condition	3 - Fair
Deficiency	WOOD: MISSING DOOR
Deficiency Location/Instance	Inside Room Boys Locker Room
Deficiency Quantity	1
Quantity Uom	EACH
Potential Action	MAINTENANCE
Urgency of Action	PRIORITY 3
Purpose of Action	LEVEL 2

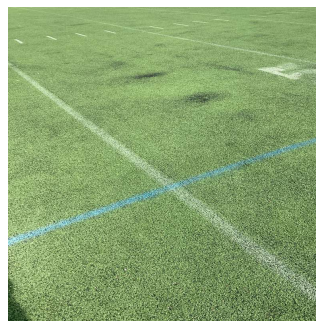
ARTIFICIAL TURF: DAMAGED/WORN OUT

2,000

REPLACE

Violations	South of field No violations recorded.
Instance on Handball Courts	Inspected
Instance Condition	3 - Fair
Instance Quantity	2,000
Instance Quantity Uom	S.F.

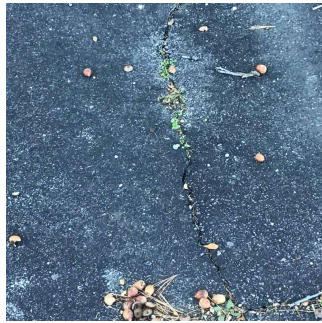
Deficiency ASPHALT: DAMAGED/DETERIORATED
 Deficiency Location/Instance Handball Courts

Deficiency Quantity	200
Quantity Uom	S.F.
Potential Action	REPLACE
Urgency of Action	PRIORITY 4
Purpose of Action	LEVEL 2
Deficiency Photo1

Violations	Handball Courts No violations recorded.
------------	--------------------------------------------

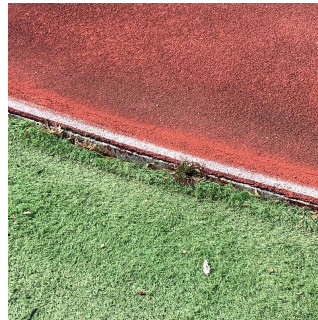
East side of track

Deficiency ATHLETIC WEARING SURFACE: DAMAGED/DETERIORATED
 Deficiency Location/Instance Running Track

50
S.F.
REPLACE
PRIORITY 5
LEVEL 6

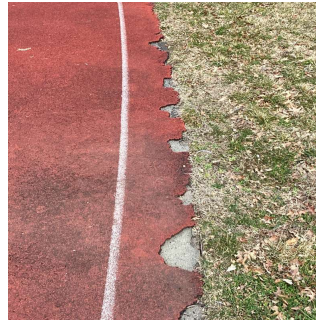
East side of track

ATHLETIC WEARING SURFACE: DAMAGED/DETERIORATED

2,000
S.F.
REPLACE
PRIORITY 4
LEVEL 2

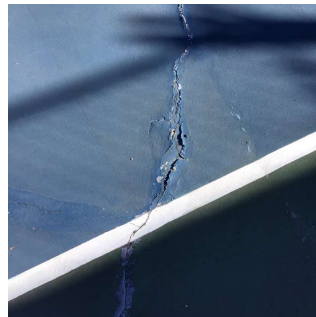
Tennis Courts

ASPHALT: DAMAGED/DETERIORATED

200

REPLACE

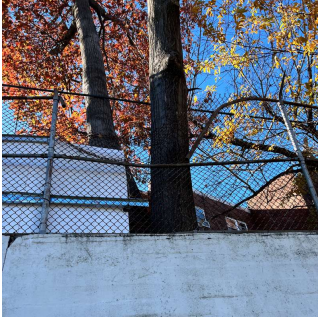
Yes	Protruding Elements	Broken Chain Link Fence resulting in potential safety hazard	SITE FENCES	Rear Wall	Eric Daus	Fireman

Question	Response
SITE	
Drainage System for Concrete	Inspected
Catch Basins/Manhole - Surrounded by concrete	Inspected
Condition	2 - Between Good and Fair
Deficiency	No deficiencies recorded
Culverts - Concrete Covering	Does not Exist
Drainage System for Soil	Inspected
Catch Basins/Manhole - Surrounded by Soil	Inspected
Condition	2 - Between Good and Fair
Deficiency	No deficiencies recorded
Culverts - Soil Covering	Does not Exist
DRINKING FOUNTAINS	Inspected
Condition	2 - Between Good and Fair
Deficiency	No deficiencies recorded
FENCES	Inspected
Condition	4 - Between Fair and Poor
Deficiency	CHAIN LINK: DAMAGED/DETERIORATED
Deficiency Location/Instance	Rear Wall
Deficiency Quantity	100
Quantity Uom	S.F.
Potential Action	REPLACE
Urgency of Action	PRIORITY 5
Purpose of Action	LEVEL 6
Deficiency Photo1

Violations	Rear Wall No violations recorded.
Deficiency	WROUGHT IRON: DAMAGED/DETERIORATED
Deficiency Location/Instance	Near Parking Lot

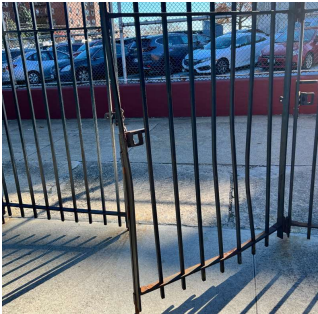
Deficiency Quantity	160
Quantity Uom	S.F.
Potential Action	REPLACE
Urgency of Action	PRIORITY 3
Purpose of Action	LEVEL 2
Deficiency Photo1

Question	Response
SITE	
FENCES	
Violations	Near Parking Lot No violations recorded.
Deficiency	CHAIN LINK: DAMAGED POST/RAIL
Deficiency Location/Instance	Rear Wall
Deficiency Quantity	140
Quantity Uom	L.F.
Potential Action	REPLACE
Urgency of Action	PRIORITY 3
Purpose of Action	LEVEL 2
Deficiency Photo1	 
Violations	Rear Wall No violations recorded.
Deficiency	CHAIN LINK: RUST - MAJOR
Deficiency Location/Instance	Rear Wall
Deficiency Quantity	900
Quantity Uom	S.F.
Potential Action	REPLACE
Urgency of Action	PRIORITY 3
Purpose of Action	LEVEL 2
Deficiency Photo1	 
Violations	Rear Wall No violations recorded.
Deficiency	CONCRETE CURB: DAMAGED/DETERIORATED
Deficiency Location/Instance	Along Tennis Court, 168th Street
Deficiency Quantity	15
Quantity Uom	S.F.
Potential Action	REPLACE
Urgency of Action	PRIORITY 3
Purpose of Action	LEVEL 2

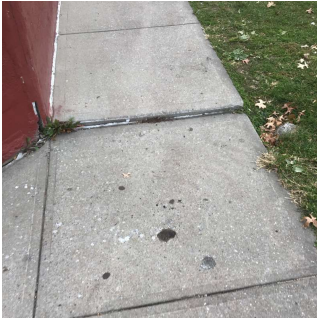
Question	Response
SITE	
FENCES	
Deficiency Photo1	 
Violations	Along Tennis Court No violations recorded.
IRRIGATION SYSTEM	Does not Exist
PAVING	Inspected
Student Non-Use	Does not Exist
Student Use	Inspected
Gravel Exists?	No
Asphalt	Inspected
Condition	3 - Fair
Deficiency	CRACKS - MAJOR
Deficiency Location/Instance	Along 84th Avenue
Deficiency Quantity	100
Quantity Uom	S.F.
Potential Action	REPLACE
Urgency of Action	PRIORITY 3
Purpose of Action	LEVEL 2
Deficiency Photo1	 
Violations	Along 84th Avenue No violations recorded.
Concrete	Inspected
Condition	2 - Between Good and Fair
Deficiency	No deficiencies recorded
Pavers	Does not Exist
Site Sidewalks & Walkways	Inspected
Asphalt	Does not Exist
Concrete	Inspected
Condition	4 - Between Fair and Poor
Deficiency	HEAVING
Deficiency Location/Instance	Near Tennis Court, near benches
Deficiency Quantity	100

Question	Response
SITE	
PAVING	
Site Sidewalks & Walkways	
Concrete	
Quantity Uom	S.F.
Potential Action	REPLACE
Urgency of Action	PRIORITY 3
Purpose of Action	LEVEL 2
Deficiency Photo1

Near Tennis Court
Violations	No violations recorded.
Deficiency	CRACKS - MAJOR
Deficiency Location/Instance	168th Street, Near Handball Court, Tennis, Near Track
Deficiency Quantity	1,800
Quantity Uom	S.F.
Potential Action	REPLACE
Urgency of Action	PRIORITY 3
Purpose of Action	LEVEL 2
Deficiency Photo1

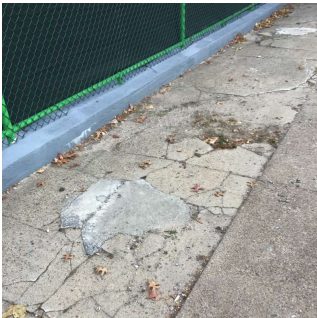
168th Street
Violations	No violations recorded.
Pavers	Does not Exist
DOT Sidewalk	Inspected
Asphalt	Does not Exist
Concrete	Inspected
Condition	2 - Between Good and Fair
Deficiency	No deficiencies recorded
Pavers	Does not Exist
PLAYGROUNDS	Does not Exist
RETAINING WALLS	Inspected
Are there any Retaining Walls 6' OR higher facing public street/sidewalk?	Yes
Condition	4 - Between Fair and Poor
Deficiency	CAST IN PLACE CONCRETE: BULGING/DISPLACED

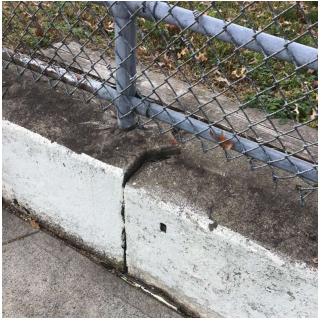
Question	Response
SITE	
RETAINING WALLS	
Deficiency Location/Instance	84th Avenue
Deficiency Quantity	15
Quantity Uom	S.F.
Potential Action	REPLACE
Urgency of Action	PRIORITY 4
Purpose of Action	LEVEL 4
Deficiency Photo1

Violations	84th Avenue 35674932Z
Deficiency	CAST IN PLACE CONCRETE: CRACKS/SPALLING - MAJOR
Deficiency Location/Instance	Along 84th Avenue, Near Tennis Court
Deficiency Quantity	600
Quantity Uom	S.F.
Potential Action	REPLACE
Urgency of Action	PRIORITY 4
Purpose of Action	LEVEL 4
Deficiency Photo1

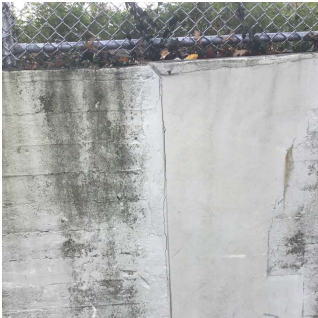
Violations	Along 84th Avenue 35674932Z
SEATING	Does not Exist
SITE WALLS (NOT RETAINING WALLS)	Inspected
Condition	4 - Between Fair and Poor
Deficiency	CAST IN PLACE CONCRETE: CRACKS/SPALLING - MAJOR
Deficiency Location/Instance	Near Tennis Court, Alone 84th Avenue, rear wall
Deficiency Quantity	260
Quantity Uom	S.F.
Potential Action	REPLACE
Urgency of Action	PRIORITY 3
Purpose of Action	LEVEL 2

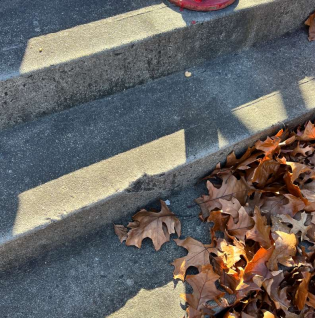
Near Handball Court
Violations	No violations recorded.
<hr/>	
Stairs/ramps	Inspected
Condition	2 - Between Good and Fair
Deficiency	CAST IN PLACE CONCRETE: CRACKS/SPALLING - MAJOR
Deficiency Location/Instance	Near Handball Court
Deficiency Quantity	15
Quantity Uom	S.F.
Potential Action	REPLACE
Urgency of Action	PRIORITY 3
Purpose of Action	LEVEL 2
Deficiency Photo1

Near Handball Court
Violations	No violations recorded.
<hr/>	
ARTWORK	Does not Exist
