**NYC Department of Education**  
**Building Condition Assessment Survey 2023 - 2024**

Architectural Inspection

Q473

**Asset:**        **3K CENTER @ 133-40 79TH STREET -QUEENS, 133-40 79TH STREET, New York, 11414**

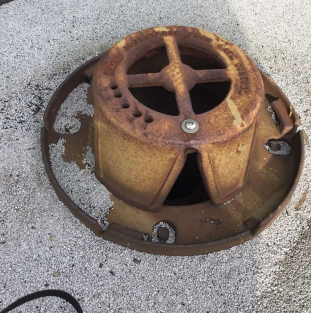
Question	Response
<b>EXTERIOR</b>	
<b>ROOF</b>	
<b>Roofing</b>	
<b>ROOFING</b>	Inspected
Source of Installation	Custodial Staff
Deficiency	No deficiencies recorded
<b>ROOFING DRAINS</b>	Inspected
Condition	5 - Poor
Deficiency	DETERIORATED
Roof Plan reference

Deficiency Quantity	5
Quantity Uom	EACH
Potential Action	REPLACE
Urgency of Action	PRIORITY 4
Purpose of Action	LEVEL 2
Deficiency Photo1

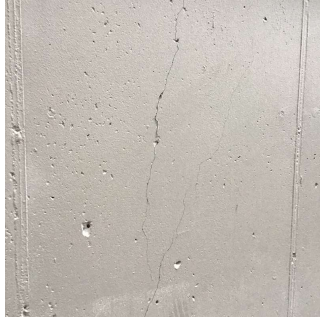
<b>FLOOR STRUCTURE</b>	Inspected
Condition	2 - Between Good and Fair
Deficiency	No deficiencies recorded
<b>FOUNDATION WALLS</b>	Inspected
Material Type(s)	Concrete
Condition	3 - Fair
Deficiency	CONCRETE: CRACKED/SPALLED/REINFORCEMENT EXPOSED
Deficiency Location/Instance	Basement - Garage
Deficiency Quantity	30
Quantity Uom	S.F.

Question	Response
<b>INTERIOR</b>	
<b>STRUCTURAL</b>	
<b>FOUNDATION WALLS</b>	
Potential Action	REPAIR
Urgency of Action	PRIORITY 3
Purpose of Action	LEVEL 5
Deficiency Photo1

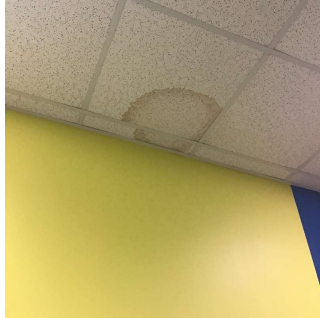
Violations	Corridor near Custodian Office
	No violations recorded.
<b>Door(s)</b>	
Condition	Inspected
Deficiency	2 - Between Good and Fair

Basement - Garage
Violations	No violations recorded.
<b>ROOF STRUCTURE</b>	
Condition	Inspected
Deficiency	2 - Between Good and Fair
	No deficiencies recorded
<b>VAULTS-BUNKERS</b>	
	Does not Exist
<b>AUDITORIUM</b>	
	Does not Exist
<b>CAFETERIA</b>	
	Does not Exist
<b>CLASSROOMS/CORRIDORS/ADMIN SPACES</b>	
<b>Ceiling</b>	
Condition	Inspected
Deficiency	2 - Between Good and Fair
Deficiency Location/Instance	ACOUSTIC TILES: DAMAGED/MISSING
Deficiency Quantity	Corridor near Room 37, near Custodian Office
Quantity Uom	15
Potential Action	S.F.
Urgency of Action	REPLACE
Purpose of Action	PRIORITY 3
Deficiency Photo1	LEVEL 2

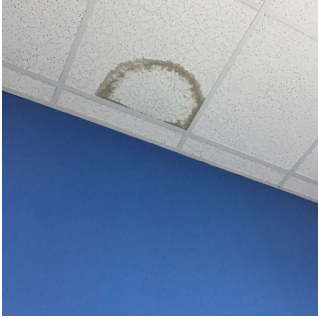
Violations	Room 231 No violations recorded.
<b>Door(s)</b>	Inspected
Condition	2 - Between Good and Fair
Deficiency	No deficiencies recorded
<b>Floor Finish</b>	Inspected
Condition	2 - Between Good and Fair

Question	Response
<b>INTERIOR</b>	
<b>TOILET ROOMS - STAFF</b>	
<b>Door(s)</b>	Inspected
Deficiency	No deficiencies recorded
<b>Floor Finish</b>	Inspected
Condition	2 - Between Good and Fair
Deficiency	No deficiencies recorded
<b>Stalls</b>	Inspected
Condition	2 - Between Good and Fair
Deficiency	No deficiencies recorded
<b>Walls</b>	Inspected
Condition	2 - Between Good and Fair
Deficiency	No deficiencies recorded
<b>TOILET ROOMS - STUDENTS</b>	
<b>Ceiling</b>	Inspected
Condition	2 - Between Good and Fair
Deficiency	ACOUSTIC TILES: DAMAGED/MISSING
Deficiency Location/Instance	Room 231
Deficiency Quantity	10
Quantity Uom	S.F.
Potential Action	REPLACE
Urgency of Action	PRIORITY 3
Purpose of Action	LEVEL 2
Deficiency Photo1
