NYC Department of Education
Building Condition Assessment Survey 2023 - 2024

Architectural Inspection

Q474

Asset: **3K CENTER @ 104-06 101 AVENUE - QUEENS, 104-06 101 AVENUE, New York, 11416**

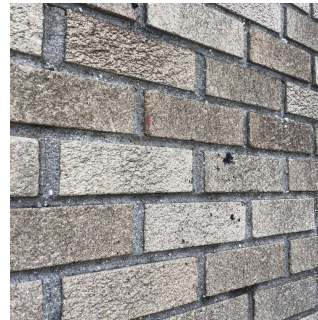
Roof 1
 No violations recorded.

Question	Response
Architectural	
EXTERIOR	Inspected
AREAWAY	Does not Exist
AWNINGS AND CANOPIES	Inspected
Condition	2 - Between Good and Fair
Deficiency	No deficiencies recorded
CHIMNEY	Inspected
Material Type(s)	Masonry
Condition	3 - Fair
Deficiency	BRICK: DETERIORATED JOINTS

100
 S.F.
 REPOINT
 PRIORITY 3
 LEVEL 2

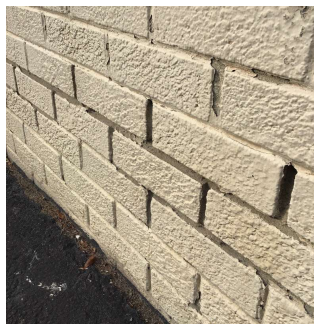
Facade B
 No violations recorded.

Instance Condition 3 - Fair
 Instance Quantity 16,000
 Instance Quantity Uom S.F.
 Deficiency
 Roof Plan reference

BRICK: DETERIORATED JOINTS

Deficiency Quantity 100
 Quantity Uom S.F.
 Potential Action REPOINT
 Urgency of Action PRIORITY 4
 Purpose of Action LEVEL 2

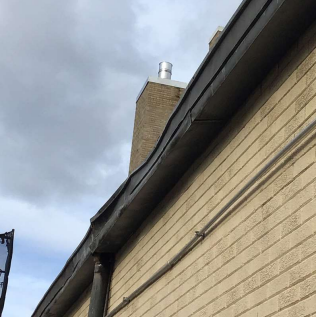
Violations	Facade C No violations recorded.
ROOF BARRIER/FENCE	Does not Exist
ROOF CAGE	Does not Exist
ROOFING	Inspected
Instance on Modified Bitumen: Roof 1	Inspected
Instance Condition	1 - Good

Question	Response
EXTERIOR	
PARAPETS	
Instance on All Facades	Inspected
Instance Condition	2 - Between Good and Fair
Instance Quantity	3,000
Instance Quantity Uom	C.F.
Deficiency	No deficiencies recorded
PLAZA DECK	Does not Exist
ROOF	Inspected
Roofing	Inspected
Replacement Quantity	12,000
Replacement Uom	S.F.
ROOF HATCH/SMOKE HATCH	Does not Exist
LEADERS, GUTTERS, DOWNSPOUTS, SCUPPERS	Inspected
Condition	3 - Fair
Deficiency	DAMAGED/MISSING
Roof Plan reference

Deficiency Quantity	40
Quantity Uom	L.F.
Potential Action	REPLACE
Urgency of Action	PRIORITY 4
Purpose of Action	LEVEL 2
Deficiency Photo1

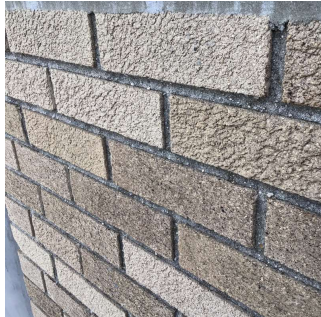
Roof 1
Instance Quantity	12,000
Instance Quantity Uom	S.F.
Does the roof have major mechanical equipment sitting on Dunnage Steel less than 18" above the Roofing?	No
Does this roof instance have a Sustainable Roof System?	Yes
Sustainable Roof Type	White Roof
Sustainable Roof Location (Roof Number)	All Roofs
Do solar panels exist on these roofs?	No
Is/Are the roof(s) suitable for Solar Panel installation?	Yes
Installation Year	2023
Source of Installation	Custodial Staff
Deficiency	No deficiencies recorded
ROOFING DRAINS	Does not Exist
Specialties	Inspected
BULKHEAD/PENTHOUSE	Inspected
Condition	3 - Fair
Deficiency	BULKHEAD/PENTHOUSE WALLS/EXTERIOR: DETERIORATED JOINTS
Roof Plan reference

Deficiency Quantity	200
Quantity Uom	S.F.
Potential Action	REPOINT
Urgency of Action	PRIORITY 3
Purpose of Action	LEVEL 2

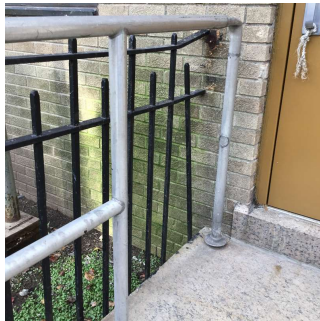
Violations	Facade D No violations recorded.
STAIRS/RAMPS	
Condition	Inspected 4 - Between Fair and Poor
Deficiency	STONE: DETERIORATED JOINTS
Roof Plan reference

Violations	Roof 1 - Bulkhead 2 No violations recorded.
CUPOLA/ SPIRES/ TOWERS	Does not Exist
DORMER	Does not Exist
DUNNAGE STEEL	Does not Exist
SKYLIGHT/ROOF VENT	Does not Exist
ROOF/GRAVITY TANK	Does not Exist
STAIRS/RAMPS: EXTERIOR	Inspected
BUILDING CHEEK/FLANK WALLS	Inspected
Condition	2 - Between Good and Fair
Deficiency	No deficiencies recorded
RAILINGS	Inspected
Condition	3 - Fair
Deficiency	DAMAGED
Roof Plan reference

Deficiency Quantity	10
Quantity Uom	L.F.
Potential Action	REPLACE
Urgency of Action	PRIORITY 4
Purpose of Action	LEVEL 2

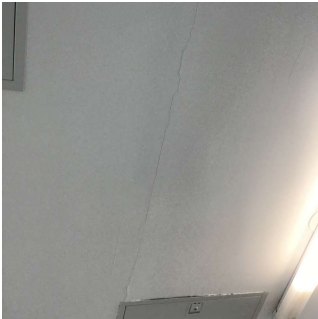
Question	Response
INTERIOR	
AUDITORIUM	Does not Exist
CAFETERIA	Does not Exist
CLASSROOMS/CORRIDORS/ADMIN SPACES	Inspected
Ceiling	Inspected
Condition	2 - Between Good and Fair
Deficiency	GYPSUM BOARD: DAMAGED/DETERIORATED
Deficiency Location/Instance	Corridor near rooms 201, 203, 206, 208
Deficiency Quantity	50
Quantity Uom	S.F.
Potential Action	REPLACE
Urgency of Action	PRIORITY 3
Purpose of Action	LEVEL 2
Deficiency Photo1

Corridor near room 201
Violations	No violations recorded.
Door(s)	Inspected
Condition	5 - Poor
Deficiency	WOOD: DETERIORATED DOOR
Deficiency Location/Instance	Main Entrance Vestibule
Deficiency Quantity	2
Quantity Uom	EACH
Potential Action	MAINTENANCE
Urgency of Action	PRIORITY 3
Purpose of Action	LEVEL 2
Deficiency Photo1

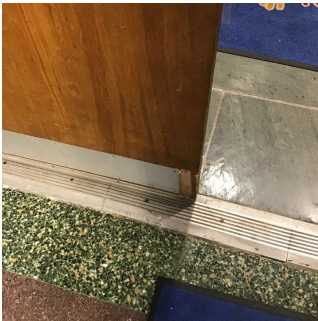
Main Entrance Vestibule
Violations	No violations recorded.
Floor Finish	Inspected
Condition	2 - Between Good and Fair
Deficiency	No deficiencies recorded
Walls	Inspected

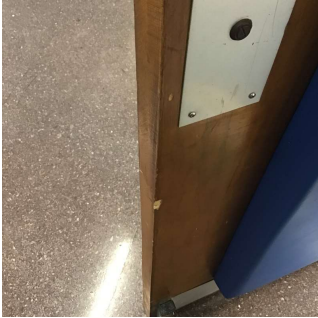
Question	Response
INTERIOR	
CLASSROOMS/CORRIDORS/ADMIN SPACES	Inspected
Specialties	Does not Exist
GYMNASIUM	Inspected
Instance on 1st Floor	Inspected
Ceiling	
Instance on 1st Floor	Inspected
Condition	2 - Between Good and Fair
Deficiency	No deficiencies recorded
Door(s)	
Instance on 1st Floor	Inspected
Condition	5 - Poor
Deficiency	WOOD: DAMAGED LOUVER
Deficiency Location/Instance	Storage Rooms
Deficiency Quantity	2
Quantity Uom	EACH
Potential Action	MAINTENANCE
Urgency of Action	PRIORITY 3
Purpose of Action	LEVEL 2
Deficiency Photo1	 
	Storage Room
Violations	No violations recorded.
Deficiency	WOOD: DETERIORATED DOOR
Deficiency Location/Instance	Main Entrance
Deficiency Quantity	2
Quantity Uom	EACH
Potential Action	MAINTENANCE
Urgency of Action	PRIORITY 3
Purpose of Action	LEVEL 2
Deficiency Photo1

Main Entrance
Violations	No violations recorded.
Deficiency	WOOD: DETERIORATED DOOR AND FRAME
Deficiency Location/Instance	Main Entrance

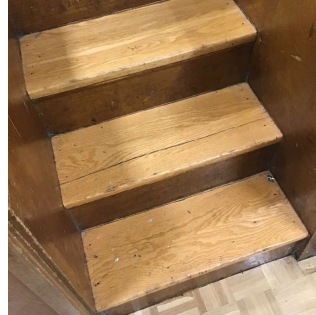
Left of Stage

Question	Response
INTERIOR	
GYMNASIUM	Inspected
Door(s)	
Deficiency Quantity	1
Quantity Uom	EACH
Potential Action	MAINTENANCE
Urgency of Action	PRIORITY 3
Purpose of Action	LEVEL 2
Deficiency Photo1	 
	Main Entrance
Violations	No violations recorded.
Fixed Equipment	
Instance on 1st Floor	Inspected
Condition	2 - Between Good and Fair
Deficiency	No deficiencies recorded
Floor Finish	
Instance on 1st Floor	Inspected
Condition	2 - Between Good and Fair
Deficiency	No deficiencies recorded
Seating	
Instance on 1st Floor	Inspected
Condition	2 - Between Good and Fair
Deficiency	No deficiencies recorded
Sliding-folding Partition	
Instance on 1st Floor	Does not Exist
Stage	
Instance on 1st Floor	Inspected
Stage	
Instance on 1st Floor	Inspected
Condition	2 - Between Good and Fair
Deficiency	DAMAGED STEPS
Deficiency Location/Instance	Left Side
Deficiency Quantity	10
Quantity Uom	S.F.
Potential Action	REPLACE
Urgency of Action	PRIORITY 3

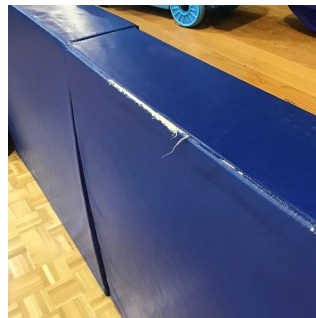
In Front of Stage

2 - Between Good and Fair

WALL PADDING: DETERIORATED

PRIORITY 3

REPLACE

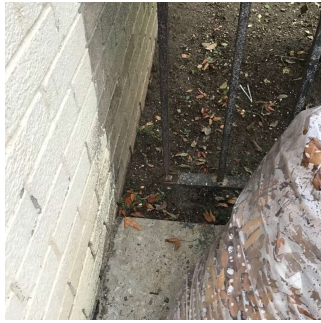
Question	Response
SITE	
CONTAINERIZATION	Does not Exist
Drainage System for Asphalt	Inspected
Catch Basins/Manhole - Surrounded by asphalt	Inspected
Condition	2 - Between Good and Fair
Deficiency	No deficiencies recorded
Culverts - Asphalt Covering	Does not Exist
Drainage System for Concrete	Inspected
Catch Basins/Manhole - Surrounded by concrete	Inspected
Condition	2 - Between Good and Fair
Deficiency	No deficiencies recorded
Culverts - Concrete Covering	Does not Exist
Drainage System for Soil	Inspected
Catch Basins/Manhole - Surrounded by Soil	Inspected
Condition	2 - Between Good and Fair
Deficiency	No deficiencies recorded
Culverts - Soil Covering	Does not Exist
DRINKING FOUNTAINS	Does not Exist
FENCES	Inspected
Condition	3 - Fair
Deficiency	WROUGHT IRON: RUST - MAJOR
Deficiency Location/Instance	Near Exit 3/4
Deficiency Quantity	40
Quantity Uom	S.F.
Potential Action	REPLACE
Urgency of Action	PRIORITY 3
Purpose of Action	LEVEL 2

Near Exit 3/4
Violations	No violations recorded.
Deficiency	WROUGHT IRON: DAMAGED/DETERIORATED
Deficiency Location/Instance	Near Exit 1/2
Deficiency Quantity	40
Quantity Uom	S.F.
Potential Action	REPLACE
Urgency of Action	PRIORITY 3
Purpose of Action	LEVEL 2

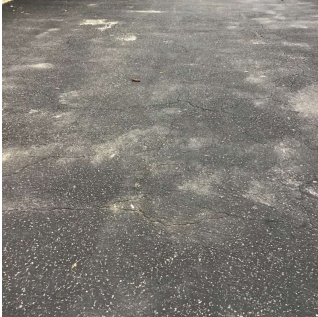
Question	Response
SITE	
FENCES	
Deficiency Photo1	 
	Near Exit 1/2
Violations	No violations recorded.
Deficiency	CONCRETE CURB: DAMAGED/DETERIORATED
Deficiency Location/Instance	Near Exit 3/4, Along 105st Street
Deficiency Quantity	40
Quantity Uom	S.F.
Potential Action	REPLACE
Urgency of Action	PRIORITY 3
Purpose of Action	LEVEL 2
Deficiency Photo1	 
	Near Exit 3/4
Violations	No violations recorded.
IRRIGATION SYSTEM	Inspected
Condition	2 - Between Good and Fair
Deficiency	No deficiencies recorded
PAVING	Inspected
Student Non-Use	Does not Exist
Student Use	Does not Exist
Site Sidewalks & Walkways	Inspected
Asphalt	Inspected
Condition	4 - Between Fair and Poor
Deficiency	CRACKS - MAJOR
Deficiency Location/Instance	Near Exits 3/4, 5/6
Deficiency Quantity	500
Quantity Uom	S.F.
Potential Action	REPLACE
Urgency of Action	PRIORITY 3
Purpose of Action	LEVEL 2

Violations	Near Exit 5/6 No violations recorded.
Concrete	Inspected
Condition	3 - Fair
Deficiency	CRACKS - MAJOR
Deficiency Location/Instance	Along 105st Street
Deficiency Quantity	300
Quantity Uom	S.F.
Potential Action	REPLACE
Urgency of Action	PRIORITY 3
Purpose of Action	LEVEL 2
Deficiency Photo1

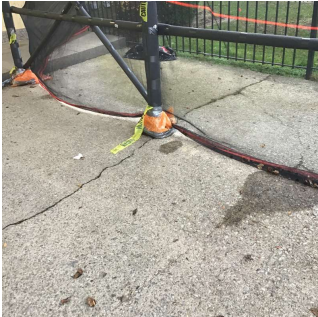
Violations	Along 105st Street No violations recorded.
Pavers	Does not Exist
DOT Sidewalk	Inspected
Asphalt	Does not Exist
Concrete	Inspected
Condition	4 - Between Fair and Poor
Deficiency	HEAVING
Deficiency Location/Instance	Along 105st Street
Deficiency Quantity	50
Quantity Uom	S.F.
Potential Action	REPLACE
Urgency of Action	PRIORITY 5
Purpose of Action	LEVEL 6

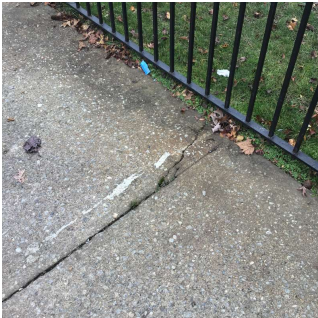
Question	Response
SITE	
PAVING	Inspected
DOT Sidewalk	
Concrete	Inspected
Violations	No violations recorded.
Pavers	Does not Exist
PLAYGROUNDS	Inspected
Instance on 105th Street	Inspected
Benches	
Instance on 105th Street	Inspected
Condition	2 - Between Good and Fair
Deficiency	No deficiencies recorded
Fence	
Instance on 105th Street	Inspected
Condition	2 - Between Good and Fair
Deficiency	No deficiencies recorded
Pavement	
Instance on 105th Street	Inspected
Condition	3 - Fair
Deficiency	CONCRETE: CRACKS - MAJOR
Deficiency Location/Instance	105th Street
Deficiency Quantity	50
Quantity Uom	S.F.
Potential Action	REPLACE
Urgency of Action	PRIORITY 3
Purpose of Action	LEVEL 2
Deficiency Photo1

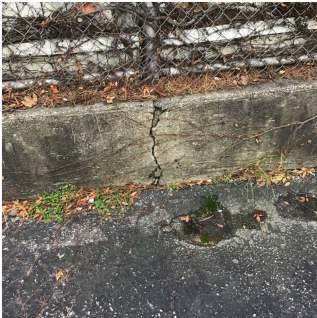
Question	Response
SITE	
RETAINING WALLS	
street/sidewalk?	
Condition	3 - Fair
Deficiency	CAST IN PLACE CONCRETE: CRACKS/SPALLING - MAJOR
Deficiency Location/Instance	Near Exit 5/6
Deficiency Quantity	50
Quantity Uom	S.F.
Potential Action	REPLACE
Urgency of Action	PRIORITY 3
Purpose of Action	LEVEL 2
Deficiency Photo1

Near Exit 5/6
Violations	No violations recorded.
SEATING	Does not Exist
SITE WALLS (NOT RETAINING WALLS)	Does not Exist
STAIRS/RAMPS: EXTERIOR	Does not Exist
ARTWORK	Does not Exist
