NYC Department of Education
Building Condition Assessment Survey 2023 - 2024

Architectural Inspection

Q477

Asset: **DISTRICT 27 PRE-K CENTER @ 87-40 88 STREET - QUEENS, 87-40 88 STREET, New York, 11421**

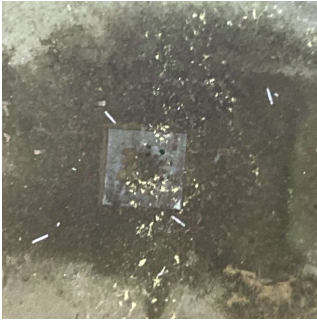
Question	Response
Architectural	
EXTERIOR	Inspected
AREAWAY	Inspected
Instance on AW1, AW2	Inspected
Instance Condition	3 - Fair
Instance Quantity	2
Instance Quantity Uom	EACH
Deficiency	AREAWAY DRAINS: CLOGGED
Roof Plan reference	
Deficiency Quantity	1
Quantity Uom	EACH
Potential Action	MAINTENANCE
Urgency of Action	PRIORITY 5
Purpose of Action	LEVEL 2

Violations	Facade C - AW1 No violations recorded.
AWNINGS AND CANOPIES	
	Does not Exist
CHIMNEY	
Material Type(s)	Inspected Masonry
Condition	4 - Between Fair and Poor
Deficiency	BRICK: DETERIORATED JOINTS
Roof Plan reference	<p>Q477</p>

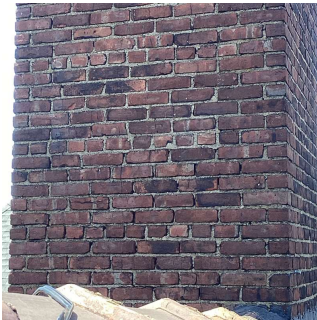
Deficiency Quantity	200
Quantity Uom	S.F.
Potential Action	REPOINT
Urgency of Action	PRIORITY 4
Purpose of Action	LEVEL 2
Deficiency Photo1

Violations	Roof 1 No violations recorded.
COPING	
Condition	Inspected 2 - Between Good and Fair
Deficiency	No deficiencies recorded
CORNICE	
Condition	Inspected 2 - Between Good and Fair
Deficiency	No deficiencies recorded

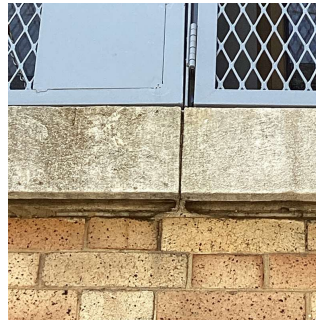
Facade A

BRICK: MASONRY SILLS - DETERIORATED JOINTS

20

REPOINT

PRIORITY 3

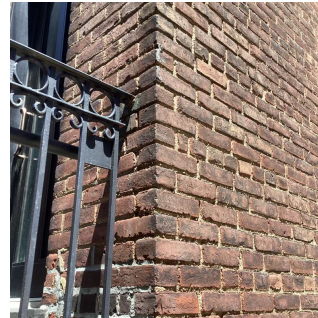
Facade C

BRICK: DETERIORATED JOINTS

1,000

REPOINT

PRIORITY 4
LEVEL 2

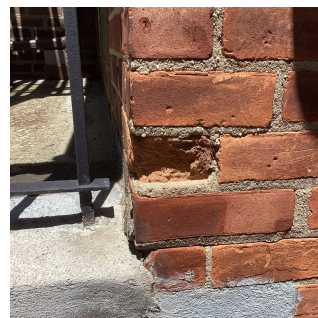
BRICK: CRACKS/DISPLACED/SPALLED BRICK AT BUILDING CORNERS

10
S.F.
REMOVE AND REBUILD
PRIORITY 4
LEVEL 2

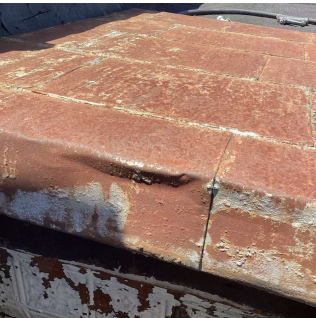
Question	Response
EXTERIOR	
PARAPETS	
Instance on Roof 1	Inspected
Instance Condition	2 - Between Good and Fair
Instance Quantity	1,000
Instance Quantity Uom	C.F.
Deficiency	No deficiencies recorded
PLAZA DECK	Does not Exist
ROOF	Inspected
Roofing	Inspected
Replacement Quantity	5,000
Replacement Uom	S.F.
ROOF HATCH/SMOKE HATCH	Inspected
Condition	5 - Poor
Deficiency	DETERIORATED
Roof Plan reference	<p align="center">Q477</p>

Deficiency Quantity	1
Quantity Uom	EACH
Potential Action	REPLACE
Urgency of Action	PRIORITY 4
Purpose of Action	LEVEL 2
Deficiency Photo1

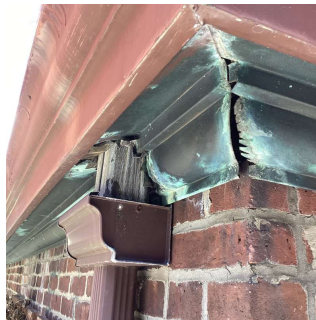
Facade C

Violations	Roof 1 No violations recorded.
LEADERS, GUTTERS, DOWNSPOUTS, SCUPPERS	Inspected
Condition	3 - Fair
Deficiency	DAMAGED/MISSING

20
L.F.
REPLACE
PRIORITY 4
LEVEL 2

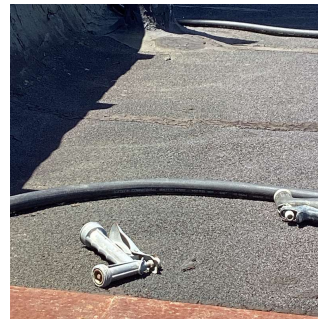
Roof 1

MODIFIED BITUMEN: ROOFING: DELAMINATION

100

REPLACE ROOFING WITH MAJOR EQUIPMENT REMOVAL

PRIORITY 4

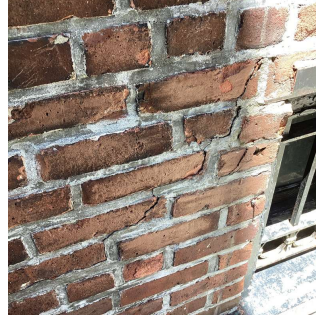
Facade C

BRICK: CRACKS/SPALLING - MINOR

10

REPAIR

PRIORITY 3
 LEVEL 2

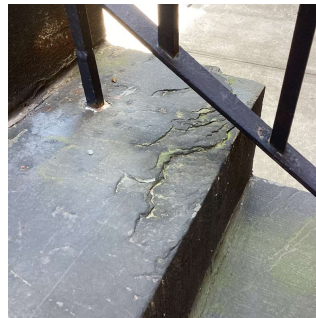
Facade C

STONE: WORN-OUT TREAD/RISER/NOSING

20
 S.F.
 REPLACE
 PRIORITY 4
 LEVEL 2

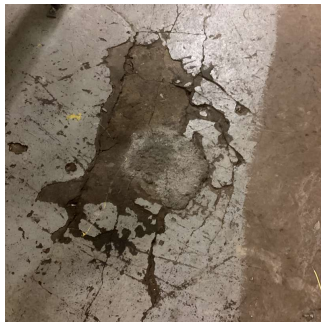
Question	Response
EXTERIOR	
WINDOWS	
Replacement Uom	S.F.
EXTERIOR GUARDS	
Condition	2 - Between Good and Fair
Deficiency	No deficiencies recorded
LINTELS	
Condition	2 - Between Good and Fair
Deficiency	No deficiencies recorded
WINDOWS	
Material Type(s)	Aluminum
Instance on Aluminum - Double Hung: Facades A, B, C	Inspected
Instance Condition	2 - Between Good and Fair
Instance Quantity	2,000
Instance Quantity Uom	S.F.
Are these windows insulated	Yes
Installation Year	2010
Source of Installation	Custodial Staff
Deficiency	No deficiencies recorded
INTERIOR	
POOLS	
	Does not Exist
STRUCTURAL	
COLUMNS/BEAMS/BEARING WALLS	
Condition	2 - Between Good and Fair
Deficiency	No deficiencies recorded
FLOOR STRUCTURE	
Condition	3 - Fair
Deficiency	CONCRETE SLAB ON GRADE: THRU CRACKS
Deficiency Location/Instance	Basement - Boiler Room
Deficiency Quantity	30
Quantity Uom	S.F.
Potential Action	REPAIR
Urgency of Action	PRIORITY 3
Purpose of Action	LEVEL 5

Basement - Boiler Room
Violations	No violations recorded.
CLAY TILE: PLASTER MISSING	
Deficiency	CLAY TILE: PLASTER MISSING
Deficiency Location/Instance	Basement - Boiler Room
Deficiency Quantity	30
Quantity Uom	S.F.

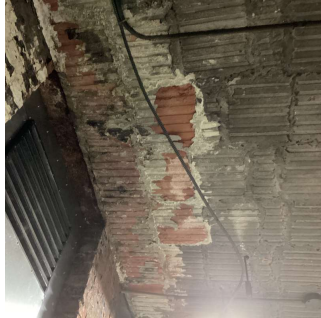
Basement - Boiler Room

Potential Action	REPLACE
Urgency of Action	PRIORITY 3
Purpose of Action	LEVEL 5
Deficiency Photo1

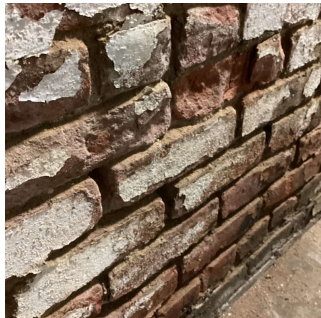
Deficiency	BRICK: DETERIORATED JOINTS
Deficiency Location/Instance	Basement - Boiler Room
Deficiency Quantity	100
Quantity Uom	S.F.
Potential Action	REPOINT
Urgency of Action	PRIORITY 4
Purpose of Action	LEVEL 5
Deficiency Photo1

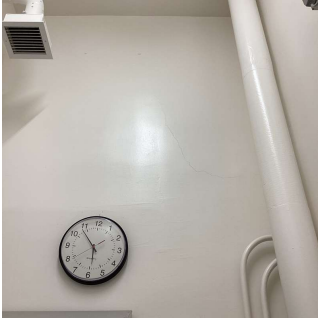
Question	Response
INTERIOR	
KITCHEN	
Ceiling	
Deficiency	No deficiencies recorded
Door(s)	
Instance on 1st Floor	Inspected
Condition	1 - Good
Deficiency	No deficiencies recorded
Floor Finish	
Instance on 1st Floor	Inspected
Condition	1 - Good
Deficiency	No deficiencies recorded
Walls	
Instance on 1st Floor	Inspected
Condition	2 - Between Good and Fair
Deficiency	PLASTER: CRACKS/SPALLING
Deficiency Location/Instance	Room 111
Deficiency Quantity	10
Quantity Uom	S.F.
Potential Action	REPLACE
Urgency of Action	PRIORITY 3
Purpose of Action	LEVEL 2
Deficiency Photo1

Violations	No violations recorded.
LIBRARY	Does not Exist
LOCKER ROOM	Does not Exist
MULTI-PURPOSE ROOM	Inspected
Instance on Basement	Inspected
Ceiling	
Instance on Basement	Inspected
Condition	2 - Between Good and Fair
Deficiency	PLASTER: CRACKS/SPALLING
Deficiency Location/Instance	Storage Room
Deficiency Quantity	10
Quantity Uom	S.F.
Potential Action	REPLACE
Urgency of Action	PRIORITY 3

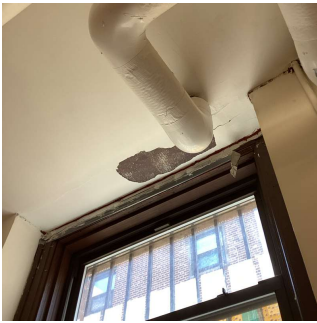
Question	Response
INTERIOR	
MULTI-PURPOSE ROOM	
Ceiling	
Deficiency Photo1

Violations	Storage Room No violations recorded.
Door(s)	
Instance on Basement	Inspected
Condition	3 - Fair
Deficiency	WOOD: DETERIORATED DOOR
Deficiency Location/Instance	Storage Room
Deficiency Quantity	1
Quantity Uom	EACH
Potential Action	MAINTENANCE
Urgency of Action	PRIORITY 3
Purpose of Action	LEVEL 2
Deficiency Photo1	 
Violations	Storage Room No violations recorded.
Fixed Equipment	
Instance on Basement	Does not Exist
Floor Finish	
Instance on Basement	Inspected
Condition	1 - Good
Deficiency	No deficiencies recorded
Sliding-folding Partition	
Instance on Basement	Does not Exist
Stage	
Instance on Basement	Inspected
Stage	Inspected
Instance on Basement	Inspected
Condition	3 - Fair
Deficiency	DAMAGED FLOOR
Deficiency Location/Instance	Near center

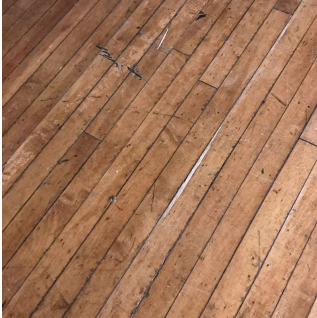
Question	Response
INTERIOR	
MULTI-PURPOSE ROOM	
Stage	
Stage	
Deficiency Quantity	60
Quantity Uom	S.F.
Potential Action	REPLACE
Urgency of Action	PRIORITY 3
Purpose of Action	LEVEL 2
Deficiency Photo1

Violations	Near center No violations recorded.
Stage Curtain Rigging	Inspected
Instance on Basement	Inspected
Condition	2 - Between Good and Fair
Deficiency	No deficiencies recorded
Stage Curtains	Does not Exist
Instance on Basement	Does not Exist
Walls	
Instance on Basement	Inspected
Condition	2 - Between Good and Fair
Deficiency	PLASTER: CRACKS/SPALLING
Deficiency Location/Instance	Storage Room
Deficiency Quantity	10
Quantity Uom	S.F.
Potential Action	REPLACE
Urgency of Action	PRIORITY 3
Purpose of Action	LEVEL 2
Deficiency Photo1

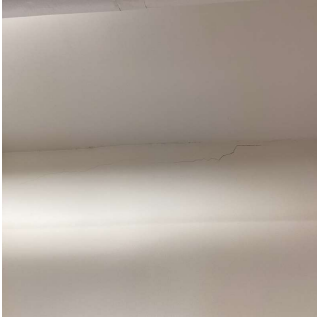
Violations	Storage Room No violations recorded.
Deficiency	GYPSUM BOARD: DETERIORATED
Deficiency Location/Instance	Near Exit 4, Storage Room
Deficiency Quantity	50

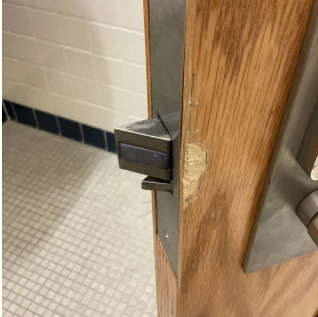
Question	Response
INTERIOR	
TOILET ROOMS - STAFF	
Ceiling	Inspected
Condition	1 - Good
Deficiency	No deficiencies recorded
Door(s)	Inspected
Condition	5 - Poor
Deficiency	WOOD: DETERIORATED DOOR
Deficiency Location/Instance	Room 206
Deficiency Quantity	1
Quantity Uom	EACH
Potential Action	MAINTENANCE
Urgency of Action	PRIORITY 3
Purpose of Action	LEVEL 2
Deficiency Photo1

Room 206
Violations	No violations recorded.
Floor Finish	Inspected
Condition	1 - Good
Deficiency	No deficiencies recorded
Stalls	Does not Exist
Walls	Inspected
Condition	2 - Between Good and Fair
Deficiency	No deficiencies recorded
TOILET ROOMS - STUDENTS	
Ceiling	Inspected
Condition	2 - Between Good and Fair
Deficiency	No deficiencies recorded
Door(s)	Inspected
Condition	2 - Between Good and Fair
Deficiency	No deficiencies recorded
Floor Finish	Inspected
Condition	2 - Between Good and Fair
Deficiency	TERRAZZO: CRACKS
Deficiency Location/Instance	Boys - Basement

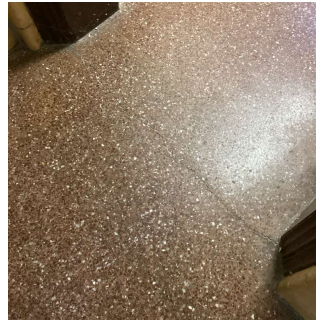
Basement,
No violations recorded.

Deficiency Quantity	10
Quantity Uom	S.F.
Potential Action	REPLACE
Urgency of Action	PRIORITY 3
Purpose of Action	LEVEL 2

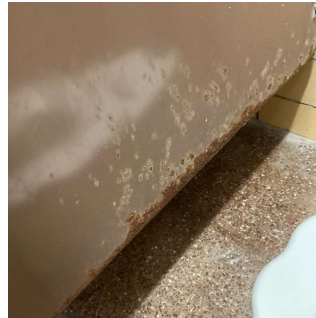
Boys - Basement

RUST - MAJOR

Boys - Basement, Girls - Basement

8

REPLACE

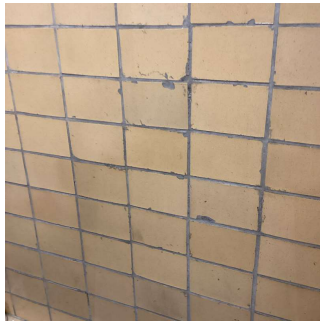
GLAZED BLOCK: CRACKS/SPALLING

10

REPLACE

Boys - Basement
Violations	No violations recorded.
Deficiency	CERAMIC TILE: BROKEN/ MISSING
Deficiency Location/Instance	Girls - Basement
Deficiency Quantity	10
Quantity Uom	S.F.
Potential Action	REPLACE
Urgency of Action	PRIORITY 3
Purpose of Action	LEVEL 2
Deficiency Photo1

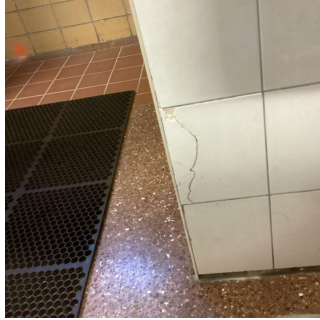
Girls - Basement
Violations	No violations recorded.
LIFE SAFETY	Inspected
F.D. HOLDING AREA	Does not Exist
STEEL STAIRS	Inspected
Condition	5 - Poor
Deficiency	MAJOR RUSTING
Deficiency Location/Instance	Facade C
Deficiency Quantity	30
Quantity Uom	S.F.
Potential Action	REPLACE
Urgency of Action	PRIORITY 4
Purpose of Action	LEVEL 2

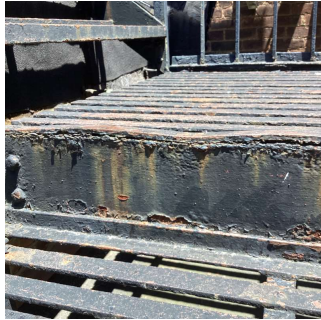
Violations	Facade C No violations recorded.
SITE	Inspected
CONTAINERIZATION	Does not Exist
Drainage System for Asphalt	Does not Exist
Drainage System for Concrete	Inspected
Catch Basins/Manhole - Surrounded by concrete	Inspected
Condition	2 - Between Good and Fair
Deficiency	No deficiencies recorded
Culverts - Concrete Covering	Inspected
Condition	2 - Between Good and Fair
Deficiency	No deficiencies recorded
Drainage System for Soil	Does not Exist
DRINKING FOUNTAINS	Does not Exist
FENCES	Inspected
Condition	2 - Between Good and Fair
Deficiency	CONCRETE CURB: DAMAGED/DETERIORATED
Deficiency Location/Instance	88th Street
Deficiency Quantity	20
Quantity Uom	S.F.
Potential Action	REPLACE
Urgency of Action	PRIORITY 3
Purpose of Action	LEVEL 2
Deficiency Photo1	 
Violations	88th Street No violations recorded.
IRRIGATION SYSTEM	Does not Exist
PAVING	Inspected

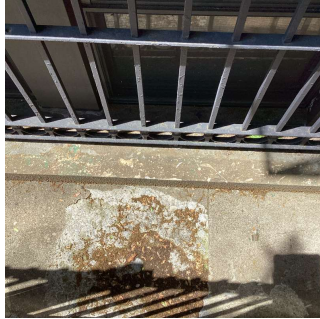
Question	Response
SITE	
PAVING	
Student Non-Use	
Asphalt	Does not Exist
Concrete	Inspected
Condition	3 - Fair
Deficiency	DAMAGED/DETERIORATED/MISSING SECTIONS
Deficiency Location/Instance	88th Street
Deficiency Quantity	75
Quantity Uom	S.F.
Potential Action	REPLACE
Urgency of Action	PRIORITY 3
Purpose of Action	LEVEL 2
Deficiency Photo1

88th Street
Violations	No violations recorded.
Pavers	Does not Exist
Student Use	Does not Exist
Site Sidewalks & Walkways	Does not Exist
DOT Sidewalk	Does not Exist
PLAYGROUNDS	Inspected
Instance on Schoolyard	Inspected
Benches	
Instance on Schoolyard	Does not Exist
Fence	
Instance on Schoolyard	Inspected
Condition	1 - Good
Deficiency	No deficiencies recorded
Pavement	
Instance on Schoolyard	Inspected
Condition	1 - Good
Deficiency	No deficiencies recorded
Play Equipment	
Instance on Schoolyard	Inspected
Condition	1 - Good
Deficiency	No deficiencies recorded
Safety Surfacing	
Instance on Schoolyard	Inspected
