NYC Department of Education
Building Condition Assessment Survey 2023 - 2024

Architectural Inspection

Q486

**Asset: DISTRICT 27 PRE-K CENTER @ 160-06 CROSS BAY BOULEVARD - QUEENS, 160-06
 CROSS BAY BOULEVARD, New York, 11414**

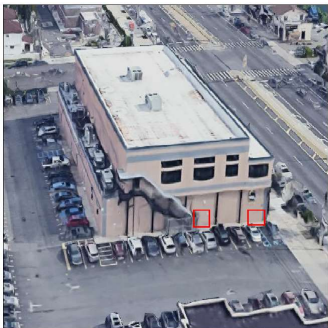
Deficiency STUCCO CEMENT SURFACE: CRACKS, SPALLING

20
S.F.
REPLACE
PRIORITY 4
LEVEL 2

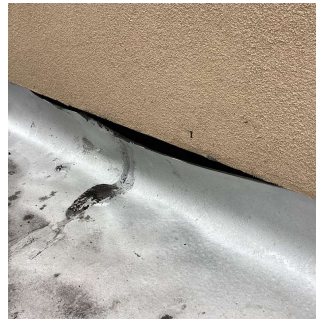
Roof 1	No violations recorded.
--------	-------------------------

Deficiency	MODIFIED BITUMEN: FLASHING: BASE FLASHING DETERIORATED
------------	--

Deficiency Quantity	20
Quantity Uom	S.F.
Potential Action	REPAIR
Urgency of Action	PRIORITY 3
Purpose of Action	LEVEL 2
Deficiency Photo1

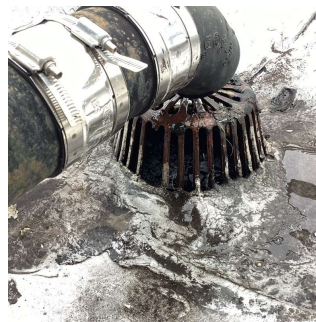
Roof 1
 No violations recorded.

ROOFING DRAINS	Inspected
Condition	3 - Fair
Deficiency	DETERIORATED

1
 EACH
 REPLACE
 PRIORITY 4
 LEVEL 2

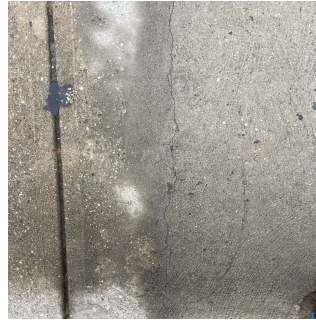
Facade A
 No violations recorded.

CONCRETE: CRACKS/SPALLING - MINOR

S.F.
 REPAIR
 PRIORITY 3
 LEVEL 2

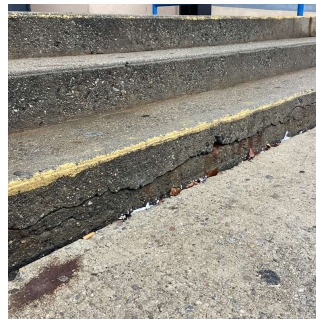
Facade A
 No violations recorded.

CONCRETE: CRACKS/SPALLING - MAJOR

10
 S.F.
 REPLACE
 PRIORITY 4
 LEVEL 2

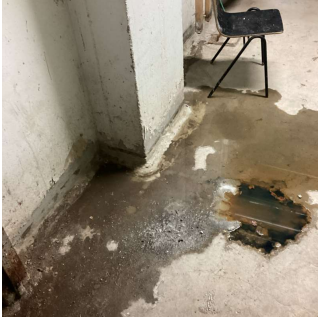
Question	Response
INTERIOR	
STRUCTURAL	
FLOOR STRUCTURE	Inspected
Deficiency	No deficiencies recorded
FOUNDATION WALLS	Inspected
Material Type(s)	Concrete
Condition	4 - Between Fair and Poor
Deficiency	CONCRETE: WATER INFILTRATION IN ELECTRICAL PANEL ROOM
Deficiency Location/Instance	Shopping Center Basement - Electrical Meter Room
Deficiency Quantity	100
Quantity Uom	S.F.
Potential Action	INSTALL WATERPROOFING
Urgency of Action	PRIORITY 5
Purpose of Action	LEVEL 6
Deficiency Photo1

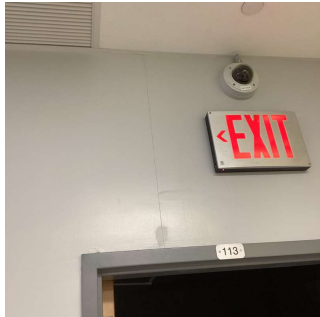
Floor Finish	Inspected
Condition	1 - Good
Deficiency	No deficiencies recorded
Walls	Inspected
Condition	2 - Between Good and Fair
Deficiency	GYPSUM BOARD: DETERIORATED
Deficiency Location/Instance	Corridor near Room 113
Deficiency Quantity	10
Quantity Uom	S.F.
Potential Action	REPLACE
Urgency of Action	PRIORITY 3

Question	Response
INTERIOR	
CLASSROOMS/CORRIDORS/ADMIN SPACES	
Walls	
Purpose of Action	LEVEL 2
Deficiency Photo1

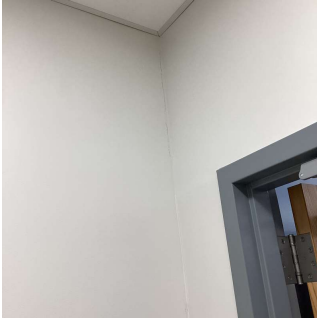
Question	Response
INTERIOR	
TOILET ROOMS - STUDENTS	
Walls	Inspected
Condition	2 - Between Good and Fair
Deficiency	GYPSUM BOARD: DETERIORATED
Deficiency Location/Instance	Room 102A
Deficiency Quantity	10
Quantity Uom	S.F.
Potential Action	REPLACE
Urgency of Action	PRIORITY 3
Purpose of Action	LEVEL 2
Deficiency Photo1
