NYC Department of Education
Building Condition Assessment Survey 2023 - 2024

Architectural Inspection

Q487

Asset: CLEVELAND AF NO. 1 - QUEENS, 21-27 HIMROD STREET, New York, 11385

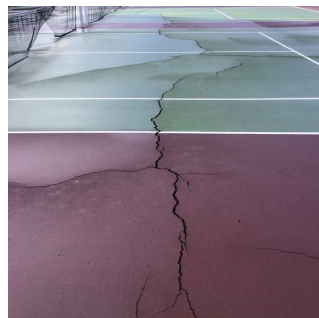
| Question | Response |
|---|---|
| Deficiency | ASPHALT: DAMAGED/DETERIORATED |
| Deficiency Location/Instance | Tennis Courts |

| Question | Response |
|---|--|
| Deficiency Quantity | 3,000 |

| Question | Response |
|---|--|
| Potential Action | REPLACE |
| Urgency of Action | PRIORITY 4 |

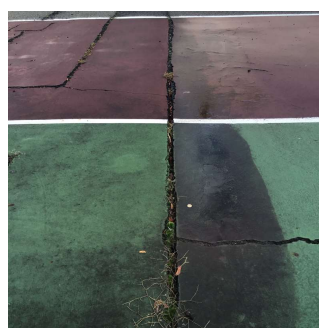
| Question | Response |
|---|--|
| Deficiency | ASPHALT: DAMAGED/DETERIORATED |
| Deficiency Location/Instance | Tennis Courts |
| Deficiency Quantity | 100 |

| Question | Response |
|---|--|
| Potential Action | REPLACE |
| Urgency of Action | PRIORITY 5 |

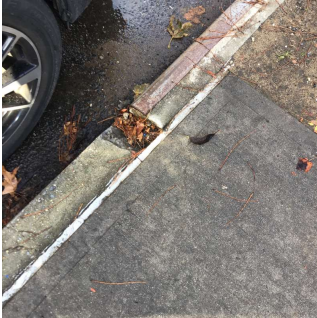
| Question | Response |
|---|--|
| Deficiency | DAMAGED CURBS |
| Deficiency Location/Instance | Amory court, Metropolitan Avenue, Tonsor Street |
| Deficiency Quantity | 180 |

| Question | Response |
|---|--|
| Potential Action | REPLACE |
| Urgency of Action | PRIORITY 3 |

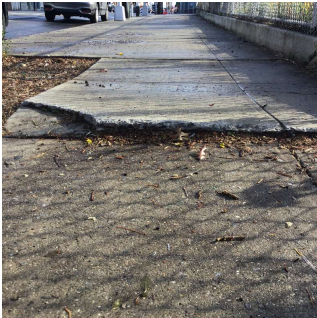
| Priority Condition Exist Last Year? | Priority Category | Condition Description | Component Affected | Location Description | Person(s) Notified | Person(s) Title | PhotoImage |
|---|---|--|---|---|---|---|---|
| No | Tripping Hazard | Severely heaving concrete DOT sidewalk is a potential tripping hazard. | SITE PAVING DOT Sidewalk Concrete | Metropolitan Avenue, Amory Court | Mario Ferrer | Custodian | |

| Question | Response |
|---|--|
| Deficiency | HEAVING |
| Deficiency Location/Instance | Metropolitan Avenue, Amory Court |
| Deficiency Quantity | 100 |

| Question | Response |
|---|--|
| Potential Action | REPLACE |
| Urgency of Action | PRIORITY 5 |

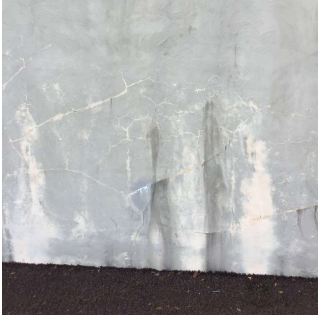
| Question | Response |
|---|---|
| Deficiency | CAST IN PLACE CONCRETE: CRACKS/SPALLING - MAJOR |
| Deficiency Location/Instance | Between Softball Field and Tennis Courts, Metropolitan Avenue, Tonsor Street |
| Deficiency Quantity | 350 |

| Question | Response |
|---|---|
| Potential Action | REPLACE |
| Urgency of Action | PRIORITY 3 |
