NYC Department of Education
Building Condition Assessment Survey 2023 - 2024

Architectural Inspection

Q491

Asset: JACKSON AF - QUEENS, 207-01 116TH AVENUE, New York, 11411

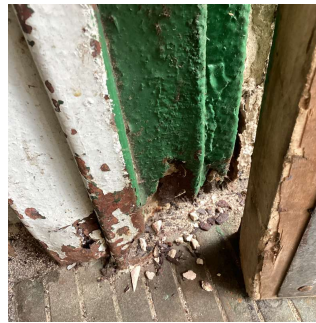
Facade A

5 - Poor

METAL CLAD: DETERIORATED DOOR AND FRAME - MAJOR DETERIORATION

REPLACE

PRIORITY 4

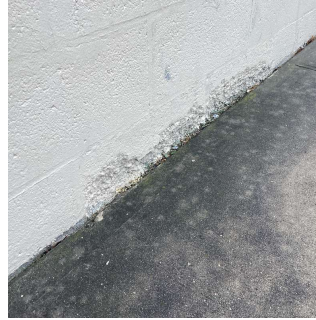
Facade A

4 - Between Fair and Poor

CONCRETE MASONRY UNIT: MAJOR / THRU CRACKS

S.F.
REMOVE AND REBUILD
PRIORITY 4
LEVEL 2

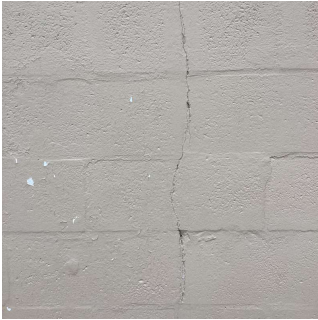
CONCRETE MASONRY UNIT: MINOR CRACKS AND SPALLING

30
S.F.
RESTITCH
PRIORITY 3
LEVEL 2

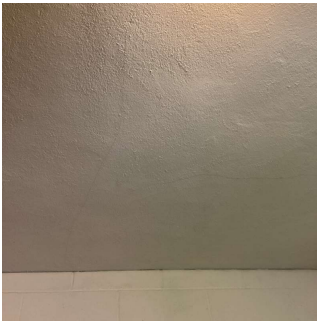
Condition	2 - Between Good and Fair
Deficiency	No deficiencies recorded
SHOWER ROOM	Does not Exist
STAIRS/RAMPS: INTERIOR	Does not Exist
TOILET ROOMS - STAFF	Inspected
Ceiling	Inspected
Condition	4 - Between Fair and Poor
Deficiency	PLASTER: CRACKS/SPALLING
Deficiency Location/Instance	Women
Deficiency Quantity	10
Quantity Uom	S.F.
Potential Action	REPLACE
Urgency of Action	PRIORITY 3
Purpose of Action	LEVEL 2

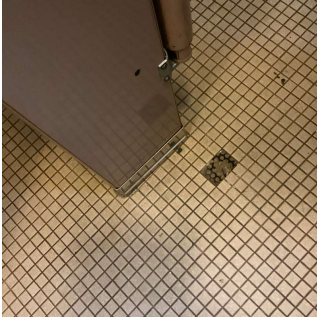
Violations	Women No violations recorded.
Door(s)	Does not Exist
Floor Finish	Inspected
Condition	4 - Between Fair and Poor
Deficiency	CERAMIC TILE: BROKEN/MISSING TILES
Deficiency Location/Instance	Women, Men
Deficiency Quantity	10
Quantity Uom	S.F.
Potential Action	REPLACE
Urgency of Action	PRIORITY 3
Purpose of Action	LEVEL 2
Deficiency Photo1

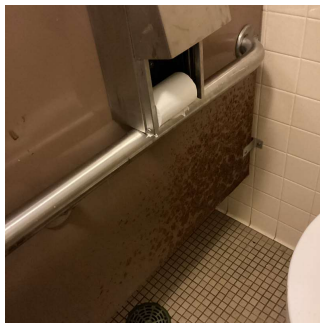
Violations	Women No violations recorded.
Stalls	Inspected
Condition	5 - Poor
Deficiency	RUST - MAJOR
Deficiency Location/Instance	Women, Men
Deficiency Quantity	2
Quantity Uom	EACH
Potential Action	REPLACE
Urgency of Action	PRIORITY 3
Purpose of Action	LEVEL 2

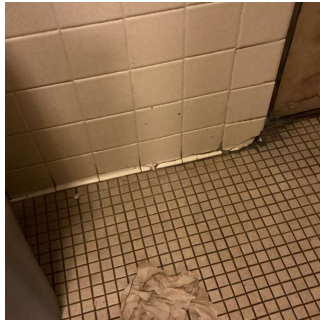
Violations	Men No violations recorded.
Walls	Inspected
Condition	2 - Between Good and Fair
Deficiency	CERAMIC TILE: BROKEN/ MISSING
Deficiency Location/Instance	Men
Deficiency Quantity	10
Quantity Uom	S.F.
Potential Action	REPLACE
Urgency of Action	PRIORITY 3
Purpose of Action	LEVEL 2
Deficiency Photo1

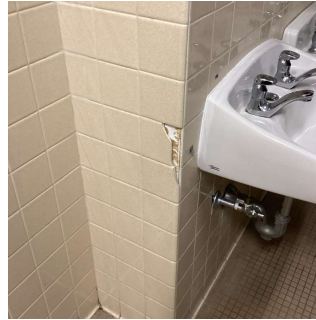
Violations	Men No violations recorded.
TOILET ROOMS - STUDENTS	
Ceiling	Inspected
Condition	2 - Between Good and Fair
Deficiency	No deficiencies recorded
Door(s)	Not Required
Floor Finish	Inspected
Condition	2 - Between Good and Fair
Deficiency	No deficiencies recorded
Stalls	Inspected
Condition	1 - Good
Deficiency	No deficiencies recorded
Walls	Inspected
Condition	2 - Between Good and Fair
Deficiency	CERAMIC TILE: BROKEN/ MISSING
Deficiency Location/Instance	Girls Locker Room
Deficiency Quantity	10

Quantity Uom	S.F.
Potential Action	REPLACE
Urgency of Action	PRIORITY 3
Purpose of Action	LEVEL 2
Deficiency Photo1

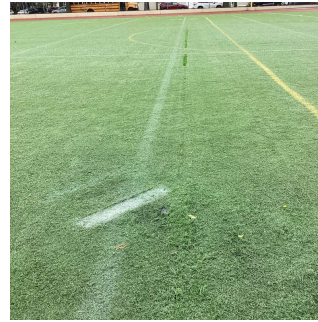
Football/Soccer/Softball Field

ARTIFICIAL TURF: DAMAGED/WORN OUT

REPAIR

PRIORITY 3

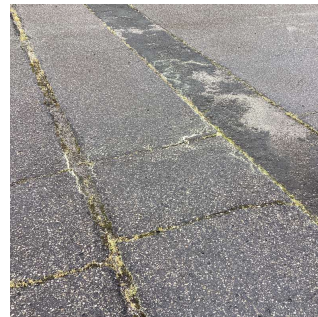
Handball Courts

4 - Between Fair and Poor

ASPHALT: DAMAGED/DETERIORATED

REPLACE

PRIORITY 4

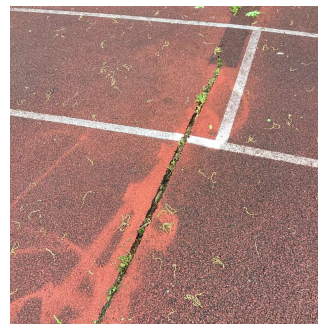
Running Track

ATHLETIC WEARING SURFACE: DAMAGED/DETERIORATED

REPLACE

PRIORITY 4

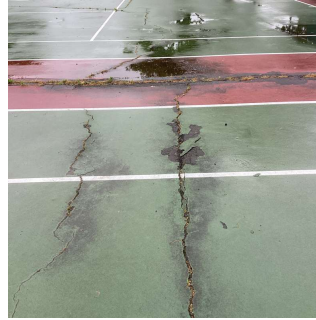
Tennis Courts

ASPHALT: DAMAGED/DETERIORATED

REPLACE

PRIORITY 4

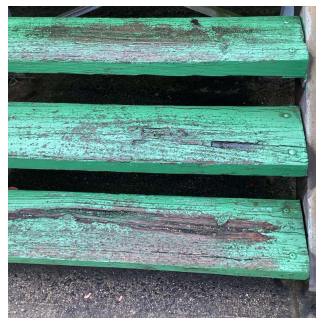
Priority Condition Exist Last Year?	Priority Category	Condition Description	Component Affected	Location Description	Person(s) Notified	Person(s) Title	PhotoImage
Yes	Protruding Elements	Severely Damaged seating with missing wood pieces and protruding metal is a hazardous condition.	ATHLETIC FIELDS SEATING Bleachers Metal/Wood/Plastic	Right and Left Side, Middle	Carl Swygert	Fireman

Yes	Tripping Hazard	Severely Damage wood step Tread is a potential tripping hazard condition	ATHLETIC FIELDS SEATING Bleachers Metal/Wood/Plastic	Right and Left Side	Carl Swygert	Fireman

5 - Poor

DAMAGED STEPS

REPLACE

PRIORITY 5

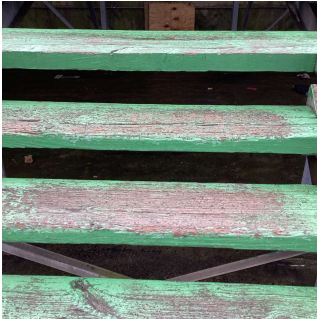
Question	Response
ATHLETIC FIELDS	
SEATING	
Bleachers	
Metal/Wood/Plastic	
Violations	Left Side No violations recorded.
Deficiency	DAMAGED STEPS
Deficiency Location/Instance	Left Side
Deficiency Quantity	100
Quantity Uom	S.F.
Potential Action	REPLACE
Urgency of Action	PRIORITY 3
Purpose of Action	LEVEL 2
Deficiency Photo1

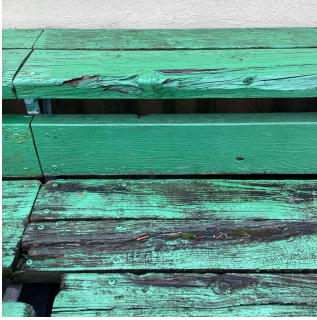
Violations	Left Side No violations recorded.
Deficiency	DAMAGED
Deficiency Location/Instance	Right and Left Side, Middle
Deficiency Quantity	500
Quantity Uom	S.F.
Potential Action	REPLACE
Urgency of Action	PRIORITY 3
Purpose of Action	LEVEL 2
Deficiency Photo1

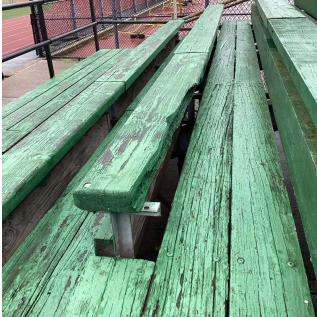
Violations	Right Side No violations recorded.
Deficiency	DAMAGED
Deficiency Location/Instance	Right and Left Side, Middle
Deficiency Quantity	40
Quantity Uom	S.F.
Potential Action	REPLACE
Urgency of Action	PRIORITY 5
Purpose of Action	LEVEL 6

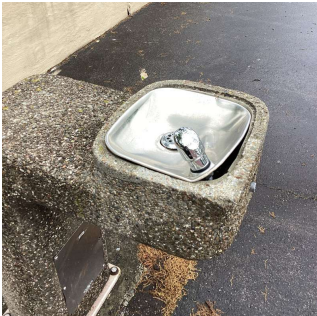
Violations	Right Side No violations recorded.
SITE	Inspected
CONTAINERIZATION	Does not Exist
Drainage System for Asphalt	Inspected
Catch Basins/Manhole - Surrounded by asphalt	Inspected
Condition	2 - Between Good and Fair
Deficiency	No deficiencies recorded
Culverts - Asphalt Covering	Does not Exist
Drainage System for Concrete	Inspected
Catch Basins/Manhole - Surrounded by concrete	Inspected
Condition	2 - Between Good and Fair
Deficiency	No deficiencies recorded
Culverts - Concrete Covering	Does not Exist
Drainage System for Soil	Inspected
Catch Basins/Manhole - Surrounded by Soil	Inspected
Condition	2 - Between Good and Fair
Deficiency	No deficiencies recorded
Culverts - Soil Covering	Does not Exist
DRINKING FOUNTAINS	Inspected
Condition	5 - Poor
Deficiency	DAMAGED
Deficiency Location/Instance	Near Francis Lewis Boulevard

Deficiency Quantity	1
Quantity Uom	EACH
Potential Action	REPLACE
Urgency of Action	PRIORITY 3
Purpose of Action	LEVEL 2
Deficiency Photo1

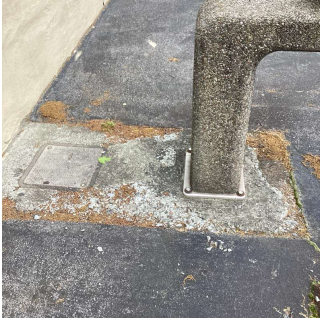
Question	Response
SITE	
PAVING	
Student Non-Use	
Concrete	
Deficiency Photo1	 
Violations	Under Bleachers No violations recorded.
Pavers	Does not Exist
Student Use	Inspected
Gravel Exists?	No
Asphalt	Inspected
Condition	4 - Between Fair and Poor
Deficiency	CRACKS - MAJOR
Deficiency Location/Instance	Around Running Track
Deficiency Quantity	600
Quantity Uom	S.F.
Potential Action	REPLACE
Urgency of Action	PRIORITY 3
Purpose of Action	LEVEL 2
Deficiency Photo1	 
Violations	Around Running Track No violations recorded.
Concrete	Inspected
Condition	2 - Between Good and Fair
Deficiency	DAMAGED/DETERIORATED/MISSING SECTIONS
Deficiency Location/Instance	Drinking Fountain Area
Deficiency Quantity	25
Quantity Uom	S.F.
Potential Action	REPLACE
Urgency of Action	PRIORITY 3
Purpose of Action	LEVEL 2

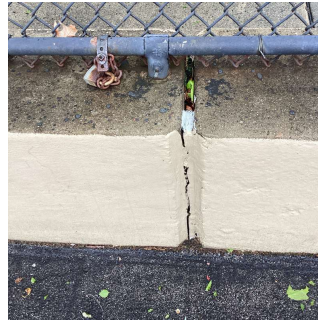
Question	Response
SITE	
PAVING	
DOT Sidewalk	
Concrete	
Purpose of Action	LEVEL 2
Deficiency Photo1	 
	115th Avenue
Violations	No violations recorded.
Deficiency	DAMAGED CURBS
Deficiency Location/Instance	Francis Lewis Boulevard, 115th Avenue, 208 Street
Deficiency Quantity	330
Quantity Uom	L.F.
Potential Action	REPLACE
Urgency of Action	PRIORITY 3
Purpose of Action	LEVEL 2
Deficiency Photo1	 
	Francis Lewis Boulevard
Violations	No violations recorded.
Pavers	Does not Exist
PLAYGROUNDS	Does not Exist
RETAINING WALLS	Inspected
Are there any Retaining Walls 6' OR higher facing public street/sidewalk?	No
Condition	4 - Between Fair and Poor
Deficiency	CAST IN PLACE CONCRETE: DETERIORATED CONTROL/EXPANSION JOINT
Deficiency Location/Instance	115th Avenue, Francis Lewis Boulevard
Deficiency Quantity	60
Quantity Uom	L.F.
Potential Action	REPLACE
Urgency of Action	PRIORITY 3
Purpose of Action	LEVEL 2

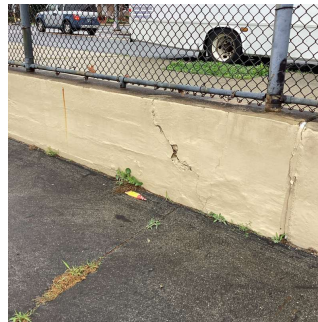
115th Avenue

CAST IN PLACE CONCRETE: CRACKS/SPALLING - MAJOR

115th Avenue, Francis Lewis Boulevard

REPLACE

PRIORITY 3

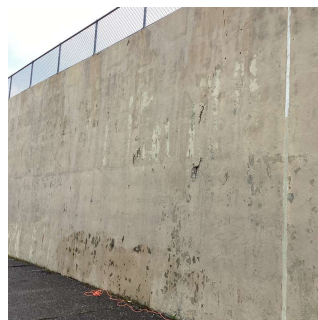
CAST IN PLACE CONCRETE: CRACKS/SPALLING - MAJOR

Near Exit 12

REPLACE

PRIORITY 3
