NYC Department of Education
Building Condition Assessment Survey 2023 - 2024

Architectural Inspection

Q503

Asset: 3K CENTER @ 47-09 36TH STREET - QUEENS, 47-09 36TH STREET, 11101

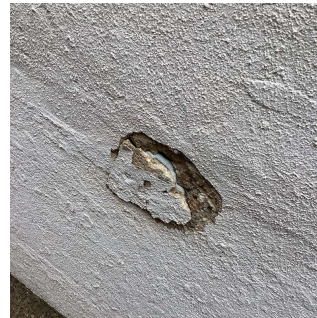
Facade C

Question	Response
EXTERIOR	
EXTERIOR WALLS	
Instance Condition	3 - Fair
Instance Quantity	4,000
Instance Quantity Uom	S.F.
Deficiency	CAST IN PLACE / PRE-CAST CONCRETE: MINOR CRACKS/SPALLING
Roof Plan reference	<p>Q503</p>  
Elevation	 
Deficiency Quantity	10
Quantity Uom	S.F.
Potential Action	REPAIR
Urgency of Action	PRIORITY 3
Purpose of Action	LEVEL 2
Deficiency Photo1	  <p>Facade C</p>
Violations	No violations recorded.
Deficiency	CAST IN PLACE / PRE-CAST CONCRETE: MAJOR CRACKS/SPALLING

REPLACE

PRIORITY 4

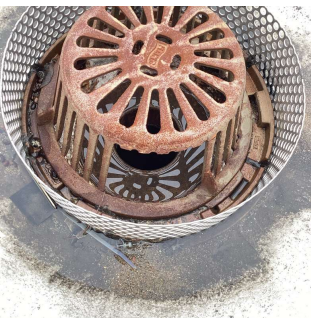
Do solar panels exist on these roofs?	No
Is/Are the roof(s) suitable for Solar Panel installation?	No
Installation Year	2024
Source of Installation	Custodial Staff
Deficiency	No deficiencies recorded
ROOFING DRAINS	Inspected
Condition	3 - Fair
Deficiency	DETERIORATED

Deficiency Quantity	1
Quantity Uom	EACH
Potential Action	REPLACE
Urgency of Action	PRIORITY 4
Purpose of Action	LEVEL 2
Deficiency Photo1

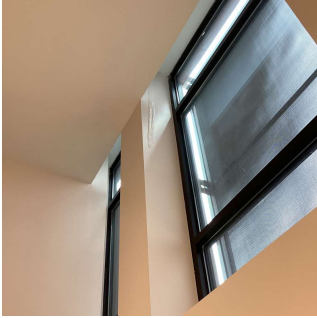
Question	Response
INTERIOR	
STAIRS/RAMPS: INTERIOR	
Ceiling	Inspected
Deficiency	No deficiencies recorded
Door(s)	Inspected
Condition	1 - Good
Deficiency	No deficiencies recorded
Partition	Does not Exist
Railings	Inspected
Condition	1 - Good
Deficiency	No deficiencies recorded
Stairs and Landings	Inspected
Condition	1 - Good
Deficiency	No deficiencies recorded
Walls	Inspected
Condition	2 - Between Good and Fair
Deficiency	GYPSUM BOARD: DETERIORATED
Deficiency Location/Instance	Stair B/1
Deficiency Quantity	10
Quantity Uom	S.F.
Potential Action	REPLACE
Urgency of Action	PRIORITY 3
Purpose of Action	LEVEL 2
Deficiency Photo1

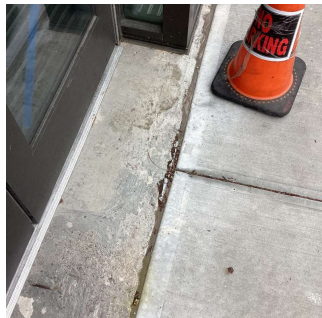
Question	Response
INTERIOR	
TOILET ROOMS - STUDENTS	
Ceiling	Inspected
Condition	1 - Good
Deficiency	No deficiencies recorded
Door(s)	Inspected
Condition	1 - Good
Deficiency	No deficiencies recorded
Floor Finish	Inspected
Condition	1 - Good
Deficiency	No deficiencies recorded
Stalls	Does not Exist
Walls	Inspected
Condition	1 - Good
Deficiency	No deficiencies recorded
LIFE SAFETY	Inspected
F.D. HOLDING AREA	Does not Exist
STEEL STAIRS	Does not Exist
SITE	Inspected
CONTAINERIZATION	Does not Exist
Drainage System for Asphalt	Does not Exist
Drainage System for Concrete	Does not Exist
Drainage System for Soil	Does not Exist
DRINKING FOUNTAINS	Does not Exist
FENCES	Does not Exist
IRRIGATION SYSTEM	Does not Exist
PAVING	Inspected
Student Non-Use	Does not Exist
Student Use	Does not Exist
Site Sidewalks & Walkways	Inspected
Asphalt	Does not Exist
Concrete	Inspected
Condition	2 - Between Good and Fair
Deficiency	CRACKS - MAJOR
Deficiency Location/Instance	Main Entrance

Deficiency Quantity	25
Quantity Uom	S.F.
Potential Action	REPLACE
Urgency of Action	PRIORITY 3
Purpose of Action	LEVEL 2
Deficiency Photo1

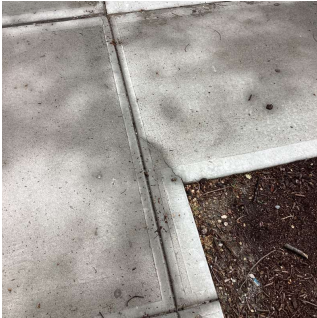
Question	Response
SITE	
PAVING	
Site Sidewalks & Walkways	Inspected
Concrete	Inspected
Violations	Main Entrance No violations recorded.
Pavers	Does not Exist
DOT Sidewalk	Inspected
Asphalt	Does not Exist
Concrete	Inspected
Condition	2 - Between Good and Fair
Deficiency	DAMAGED/DETERIORATED/MISSING SECTIONS
Deficiency Location/Instance	47th Avenue
Deficiency Quantity	25
Quantity Uom	S.F.
Potential Action	REPLACE
Urgency of Action	PRIORITY 3
Purpose of Action	LEVEL 2
Deficiency Photo1
