NYC Department of Education
Building Condition Assessment Survey 2023 - 2024

Architectural Inspection

Q506

Asset: HILLCREST AF - QUEENS, 160-05 HIGHLAND AVENUE, New York, 11437

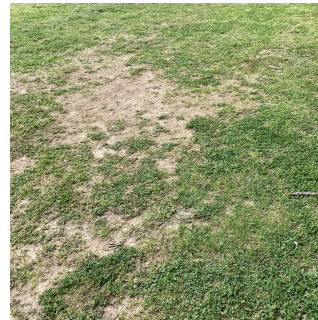
Question	Response
Architectural	
EXTERIOR	Does not Exist
INTERIOR	Does not Exist
ATHLETIC FIELDS	Inspected
PLAYING SURFACE	Inspected
Synthetic Turf Field exists?	No
Replacement Quantity	136,000
Replacement Uom	S.F.
Instance on Baseball/Soccer Field	Inspected
Instance Condition	5 - Poor
Instance Quantity	105,000
Instance Quantity Uom	S.F.
Deficiency	NATURAL TURF: DAMAGED/WORN OUT
Deficiency Location/Instance	Baseball/Soccer Field

REPLACE

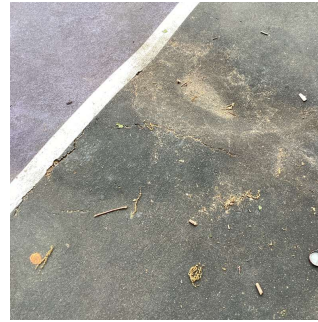
3 - Fair

ASPHALT: DAMAGED/DETERIORATED

Basketball Courts

REPLACE

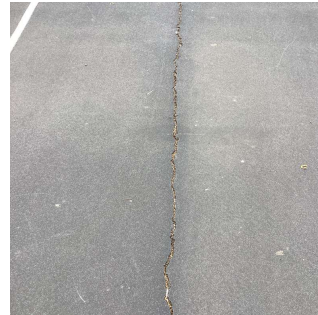
4 - Between Fair and Poor

ASPHALT: DAMAGED/DETERIORATED

Handball Courts

REPLACE

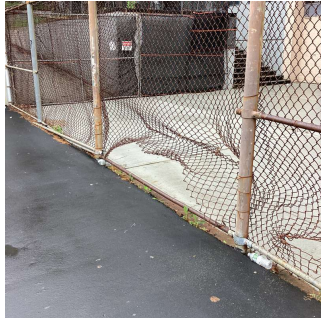
No	Protruding Elements	Severely damaged fence with protruding elements is a potential safety hazard.	SITE FENCES	Handball Court	William Hirt	Fireman

DRINKING FOUNTAINS	Does not Exist
FENCES	Inspected
Condition	5 - Poor
Deficiency	CHAIN LINK: DAMAGED/DETERIORATED
Deficiency Location/Instance	Handball Court
Deficiency Quantity	100
Quantity Uom	S.F.
Potential Action	REPLACE
Urgency of Action	PRIORITY 5
Purpose of Action	LEVEL 6
Deficiency Photo1

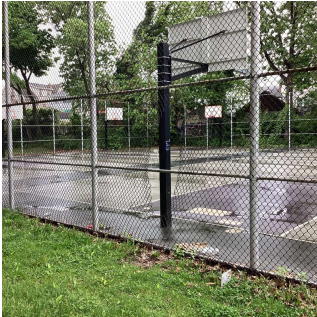
Question	Response
SITE	
FENCES	
Deficiency Location/Instance	Handball Court, Basketball Court, Tennis Court
Deficiency Quantity	1,000
Quantity Uom	S.F.
Potential Action	REPLACE
Urgency of Action	PRIORITY 3
Purpose of Action	LEVEL 2
Deficiency Photo1

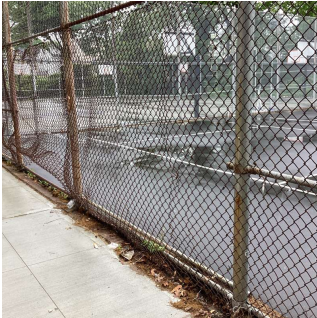
Basketball Court
Violations	No violations recorded.
Deficiency	CHAIN LINK: DAMAGED POST/RAIL
Deficiency Location/Instance	Handball Court, Basketball Court, Tennis Court
Deficiency Quantity	120
Quantity Uom	L.F.
Potential Action	REPLACE
Urgency of Action	PRIORITY 3
Purpose of Action	LEVEL 2
Deficiency Photo1

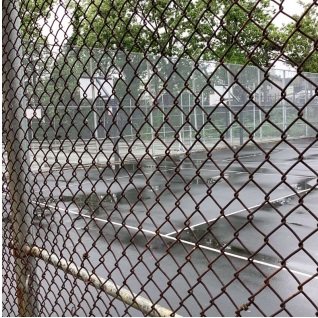
Handball Courts
Violations	No violations recorded.
Deficiency	CHAIN LINK: RUST - MAJOR
Deficiency Location/Instance	Handball Court, Basketball Court, Tennis Court
Deficiency Quantity	3,500
Quantity Uom	S.F.
Potential Action	REPLACE
Urgency of Action	PRIORITY 3
Purpose of Action	LEVEL 2

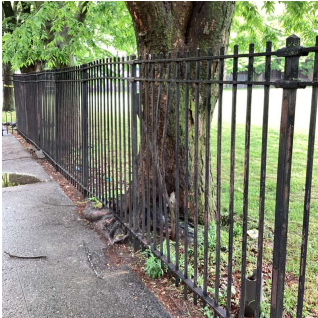
Handball Courts
Violations	No violations recorded.
Deficiency	WROUGHT IRON: DAMAGED/DETERIORATED
Deficiency Location/Instance	Near Soccer Field, 86th Avenue, Parsons Boulevard
Deficiency Quantity	1,200
Quantity Uom	S.F.
Potential Action	REPLACE
Urgency of Action	PRIORITY 3
Purpose of Action	LEVEL 2
Deficiency Photo1

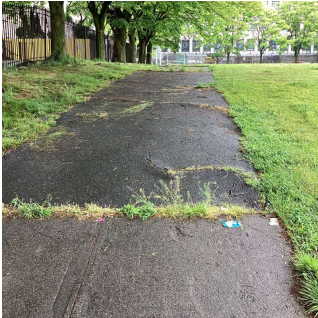
Near Soccer Field
Violations	No violations recorded.
IRRIGATION SYSTEM	Inspected
Condition	5 - Poor
Deficiency	INOPERABLE
Deficiency Location/Instance	Field
Deficiency Quantity	1
Quantity Uom	EACH
Potential Action	MAINTENANCE
Urgency of Action	PRIORITY 3
Purpose of Action	LEVEL 2
Deficiency Photo1	No photo recorded
Violations	No violations recorded.
PAVING	Inspected
Student Non-Use	Does not Exist
Student Use	Does not Exist
Site Sidewalks & Walkways	Inspected
Asphalt	Inspected
Condition	3 - Fair
Deficiency	CRACKS - MAJOR

Question	Response
SITE	
PAVING	
Site Sidewalks & Walkways	
Asphalt	
Deficiency Location/Instance	Parsons Boulevard
Deficiency Quantity	200
Quantity Uom	S.F.
Potential Action	REPLACE
Urgency of Action	PRIORITY 3
Purpose of Action	LEVEL 2
Deficiency Photo1

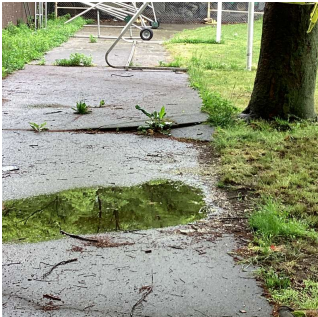
Yes	Tripping Hazard	Severely heaving concrete pavement is a potential tripping hazard.	SITE PAVING Site Sidewalks & Walkways Concrete	Near Soccer Field	William Hirt	Fireman

Violations	Parsons Boulevard No violations recorded.
Concrete	
Condition	Inspected
Deficiency	3 - Fair
Deficiency Location/Instance	HEAVING
Deficiency Quantity	Near Soccer Field
Quantity Uom	25
Potential Action	S.F.
Urgency of Action	REPLACE
Purpose of Action	PRIORITY 5
Deficiency Photo1	LEVEL 6

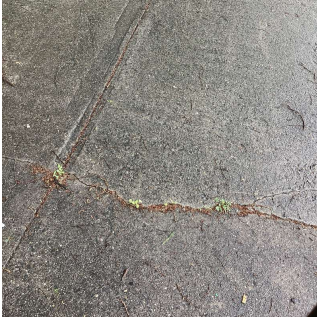
Violations	Near Soccer Field No violations recorded.
Deficiency	CRACKS - MAJOR
Deficiency Location/Instance	Parsons Boulevard
Deficiency Quantity	100
Quantity Uom	S.F.
Potential Action	REPLACE
Urgency of Action	PRIORITY 3
Purpose of Action	LEVEL 2

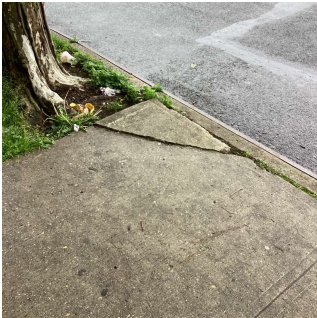
Violations	Parsons Boulevard No violations recorded.
Pavers	Does not Exist
DOT Sidewalk	Inspected
Asphalt	Does not Exist
Concrete	Inspected
Condition	4 - Between Fair and Poor
Deficiency	HEAVING
Deficiency Location/Instance	Parsons Boulevard, 86th Avenue
Deficiency Quantity	75
Quantity Uom	S.F.
Potential Action	REPLACE
Urgency of Action	PRIORITY 3
Purpose of Action	LEVEL 2
Deficiency Photo1

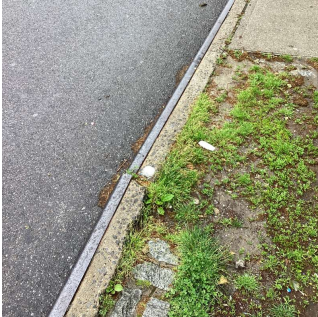
Violations	Parsons Boulevard No violations recorded.
Deficiency	DAMAGED CURBS
Deficiency Location/Instance	Highland Avenue, Parsons Boulevard, 86th Avenue
Deficiency Quantity	180
Quantity Uom	L.F.
Potential Action	REPLACE
Urgency of Action	PRIORITY 3
Purpose of Action	LEVEL 2

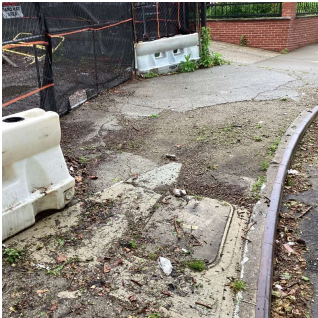
Violations	Highland Avenue No violations recorded.
Deficiency	DAMAGED/DETERIORATED/MISSING SECTIONS
Deficiency Location/Instance	Highland Avenue, Parsons Boulevard, 86th Avenue
Deficiency Quantity	900
Quantity Uom	S.F.
Potential Action	REPLACE
Urgency of Action	PRIORITY 3
Purpose of Action	LEVEL 2
Deficiency Photo1

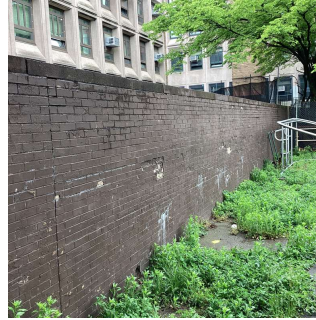
Violations	86th Avenue No violations recorded.
Pavers	Does not Exist
PLAYGROUNDS	Does not Exist
RETAINING WALLS	Inspected
Are there any Retaining Walls 6' OR higher facing public street/sidewalk?	No
Condition	4 - Between Fair and Poor
Deficiency	BRICK: CRACKS/SPALLING - MAJOR
Deficiency Location/Instance	Near Soccer Field
Deficiency Quantity	140
Quantity Uom	S.F.
Potential Action	REPLACE
Urgency of Action	PRIORITY 3
Purpose of Action	LEVEL 2

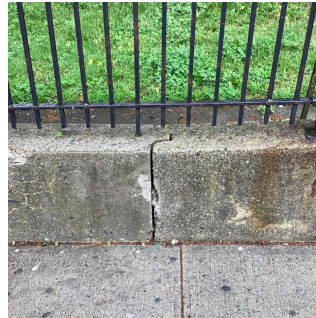
Highland Avenue

CAST IN PLACE CONCRETE: DETERIORATED CONTROL/EXPANSION JOINT

Highland Avenue, Handball Court

REPLACE

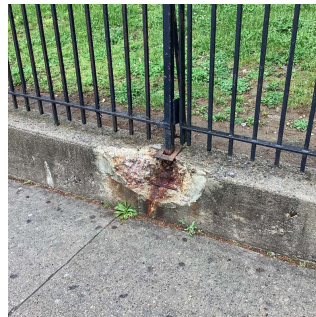
Highland Avenue

CAST IN PLACE CONCRETE: CRACKS/SPALLING - MAJOR

Highland Avenue, Parsons Boulevard, Handball Court

REPLACE

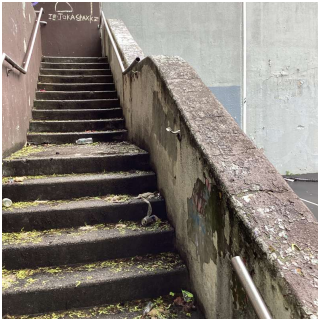
No	Protruding Elements	Severely damaged Stair railing with protruding elements is a potential safety hazard.	SITE STAIRS/RAMP S: EXTERIOR Railings	Handball Court	William Hirt	Fireman

Question	Response
SITE	
SEATING	Does not Exist
SITE WALLS (NOT RETAINING WALLS)	Does not Exist
STAIRS/RAMPS: EXTERIOR	Inspected
Railings	Inspected
Condition	3 - Fair
Deficiency	DAMAGED
Deficiency Location/Instance	Handball Court
Deficiency Quantity	10
Quantity Uom	L.F.
Potential Action	REPLACE
Urgency of Action	PRIORITY 5
Purpose of Action	LEVEL 6
Deficiency Photo1

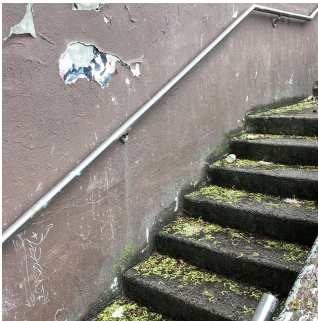
Violations	Handball Court No violations recorded.
Site Cheek/flank Walls	Inspected
Condition	2 - Between Good and Fair
Deficiency	CAST IN PLACE CONCRETE: CRACKS/SPALLING - MAJOR
Deficiency Location/Instance	Handball Court
Deficiency Quantity	40
Quantity Uom	S.F.
Potential Action	REPLACE
Urgency of Action	PRIORITY 3
Purpose of Action	LEVEL 2
Deficiency Photo1

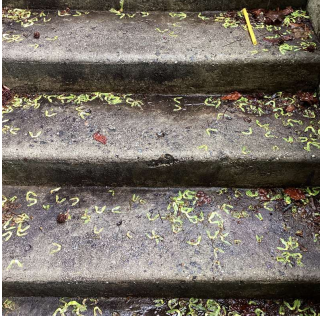
Violations	Handball Court No violations recorded.
Stairs/ramps	Inspected
Condition	3 - Fair
Deficiency	CAST IN PLACE CONCRETE: CRACKS/SPALLING - MAJOR
Deficiency Location/Instance	Handball Court

Deficiency Quantity	60
Quantity Uom	S.F.

Question	Response
SITE	
STAIRS/RAMPS: EXTERIOR	
Stairs/ramps	
Potential Action	REPLACE
Urgency of Action	PRIORITY 3
Purpose of Action	LEVEL 2
Deficiency Photo1
