NYC Department of Education
Building Condition Assessment Survey 2023 - 2024

Architectural Inspection

Asset: MIDDLE COLLEGE CAMPUS - QUEENS, 45-35 VAN DAM STREET, New York, 11101

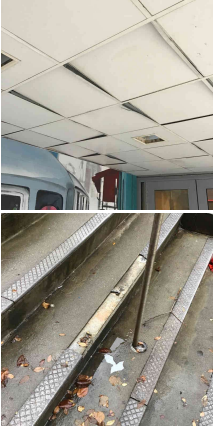
Yes	Potential Falling Debris	Loose canopy ceiling tiles are a potential falling debris hazard.	EXTERIOR AWNINGS AND CANOPIES	Courtyard facing 32nd Place.	Gus Vidhja	Handyman

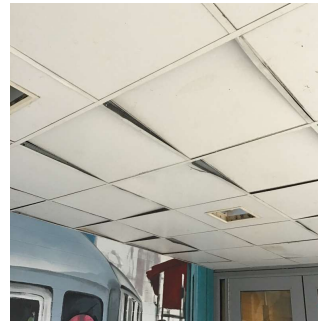
Facade J

Question	Response
Architectural	
EXTERIOR	Inspected
AREAWAY	Does not Exist
AWNINGS AND CANOPIES	Inspected
Condition	4 - Between Fair and Poor
Deficiency	METAL: DETERIORATION/DAMAGED/MISSING PIECES

REPLACE

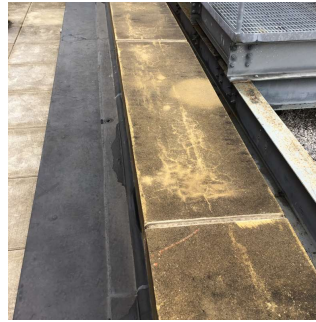
Roof 3

CAST STONE: DISINTEGRATING / FREEZE THAW

REPLACE-IN-KIND

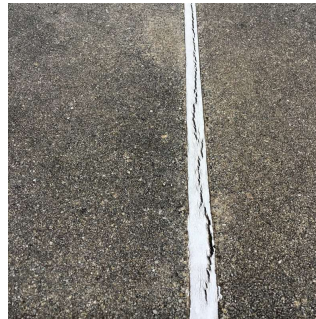
Roof 3

CAST STONE: DETERIORATED TRANSVERSE JOINTS

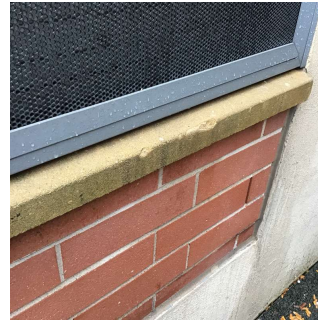
Facade B

BRICK: DETERIORATED MASONRY SILLS - MINOR

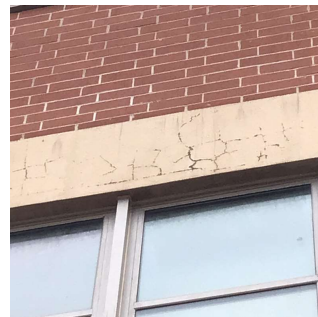
Facade A

STUCCO CEMENT SURFACE: CRACKS, SPALLING

REPLACE

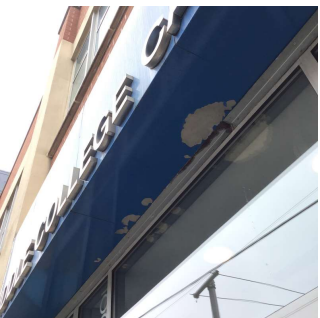
Question	Response
EXTERIOR	
EXTERIOR SOFFITS	
Condition	3 - Fair
Deficiency	METAL: WATER PENETRATION
Roof Plan reference

Deficiency Quantity	10
Quantity Uom	S.F.
Potential Action	REPAIR
Urgency of Action	PRIORITY 5
Purpose of Action	LEVEL 2
Deficiency Photo1

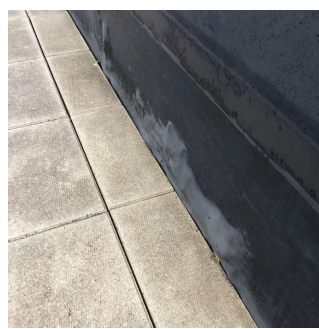
Question	Response
EXTERIOR	
PARAPETS	
Instance Quantity Uom	C.F.
Deficiency	CONCRETE: MINOR CRACKS, SPALLING
Roof Plan reference

Deficiency Quantity	50
Quantity Uom	S.F.
Potential Action	REPAIR
Urgency of Action	PRIORITY 3
Purpose of Action	LEVEL 2
Deficiency Photo1

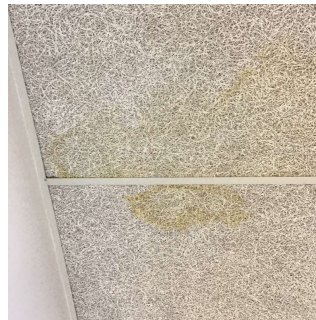
Roof 3 - Corridor near Room 258, also Room 256, Roof 1 - Room 221

Deficiency	IRMA: ROOFING: MAJOR ACTIVE ROOF LEAKS IN INSTRUCTIONAL SPACE
------------	---

REPLACE ROOFING WITH MAJOR EQUIPMENT REMOVAL
PRIORITY 5

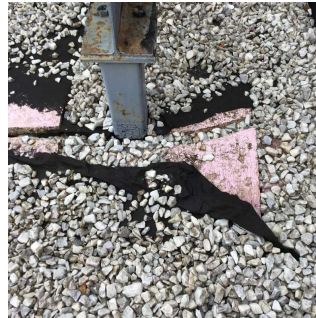
Roof 1

Deficiency	IRMA: ROOFING: DAMAGED INSULATION
------------	-----------------------------------

REPLACE

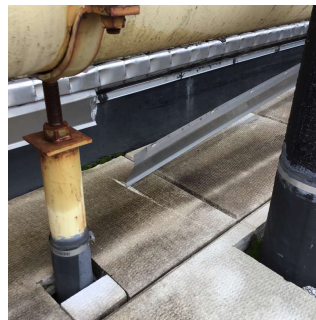
Roof 3

IRMA: FLASHING: CAP FLASHING DAMAGED

REPLACE

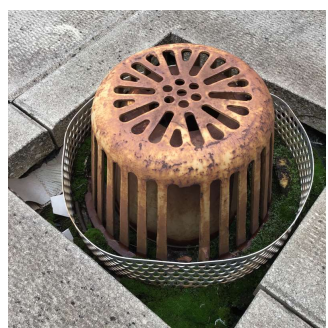
Question	Response
EXTERIOR	
ROOF	
Roofing	
ROOFING	Roof 5
Instance Quantity	300
Instance Quantity Uom	S.F.
Does the roof have major mechanical equipment sitting on Dunnage Steel less than 18" above the Roofing?	No
Does this roof instance have a Sustainable Roof System?	No
Do solar panels exist on these roofs?	No
Is/Are the roof(s) suitable for Solar Panel installation?	No
Installation Year	2012
Source of Installation	Custodial Staff
Deficiency	No deficiencies recorded
ROOFING DRAINS	Inspected
Condition	3 - Fair
Deficiency	DETERIORATED
Roof Plan reference

Deficiency Quantity	1
Quantity Uom	EACH
Potential Action	REPLACE
Urgency of Action	PRIORITY 4
Purpose of Action	LEVEL 2
Deficiency Photo1

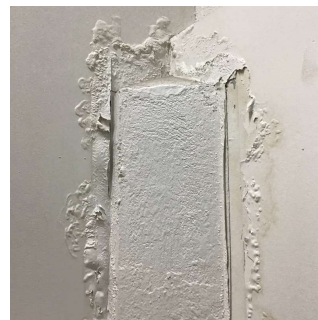
Roof 1 - Bulkhead 1

Violations	Roof 3 No violations recorded.
Specialties	Inspected
BULKHEAD/PENTHOUSE	Inspected
Condition	3 - Fair
Deficiency	BULKHEAD/PENTHOUSE WALLS/INTERIOR: GYPSUM BOARD DAMAGED/DETERIORATED

30
S.F.
REPLACE
PRIORITY 3
LEVEL 2

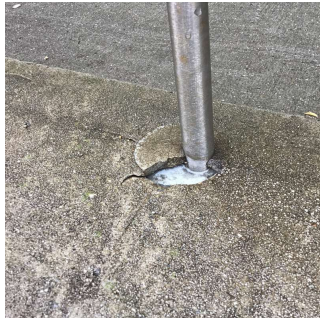
CAST IN PLACE CONCRETE: CRACKS/SPALLING - MINOR

10
S.F.
REPAIR
PRIORITY 3

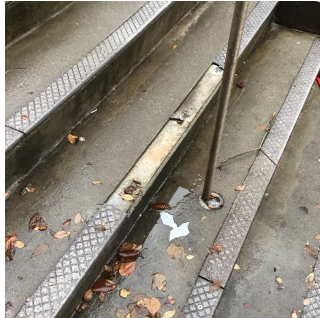
Violations	Facade H No violations recorded.
RAILINGS	
Condition	Inspected 2 - Between Good and Fair
Deficiency	No deficiencies recorded
STAIRS/RAMPS	
Condition	Inspected 5 - Poor
Deficiency	CONCRETE: WORN-OUT TREAD/RISER/NOSING
Roof Plan reference

Deficiency Quantity	20
Quantity Uom	S.F.
Potential Action	REPLACE
Urgency of Action	PRIORITY 5
Purpose of Action	LEVEL 6
Deficiency Photo1

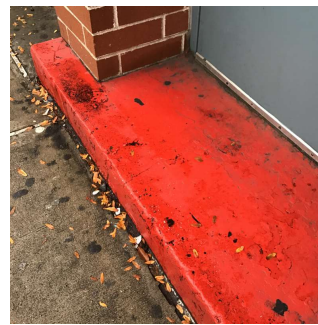
Facade A
No violations recorded.

Violations	Facade G No violations recorded.
Deficiency	STONE: WORN-OUT TREAD/RISER/NOSING

10
S.F.
REPLACE
PRIORITY 4
LEVEL 2

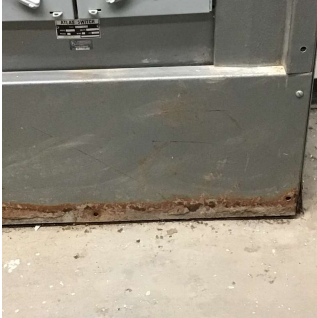
Condition	4 - Between Fair and Poor
Deficiency	CONCRETE: WATER INFILTRATION IN ELECTRICAL PANEL ROOM
Deficiency Location/Instance	1st Floor - Electrical Panel Room 135
Deficiency Quantity	100

Question	Response
INTERIOR	
STRUCTURAL	
FOUNDATION WALLS	
Quantity Uom	S.F.
Potential Action	INSTALL WATERPROOFING
Urgency of Action	PRIORITY 5
Purpose of Action	LEVEL 6
Deficiency Photo1

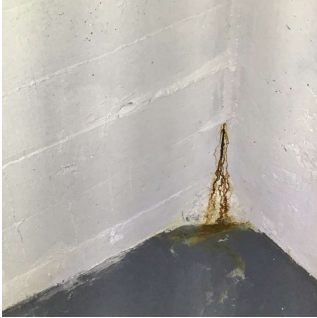
Violations	1st Floor - Electrical Panel Room 135 No violations recorded.
Deficiency	CONCRETE: WATER INFILTRATION IN NON- INSTRUCTIONAL SPACE
Deficiency Location/Instance	Basement - Gas Meter Room
Deficiency Quantity	100
Quantity Uom	S.F.
Potential Action	INSTALL WATERPROOFING
Urgency of Action	PRIORITY 5
Purpose of Action	LEVEL 5
Deficiency Photo1

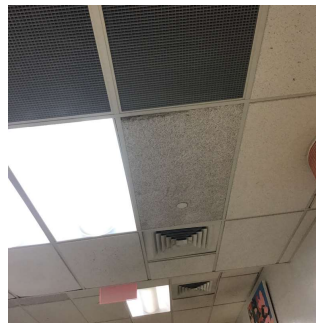
Near Exit

Deficiency	TECTUM: DAMAGED/MISSING
------------	-------------------------

Potential Action	REPLACE
------------------	---------

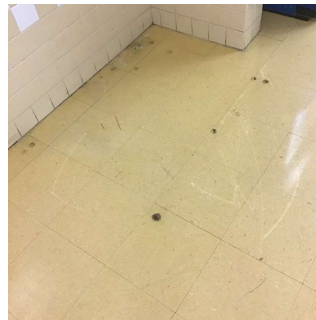
Near Exit

Deficiency	VINYL TILES: BROKEN/DETERIORATED/MISSING TILES
------------	--

Potential Action	REPLACE
------------------	---------

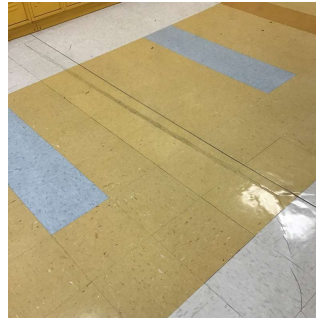
Near Stair F/1

VINYL TILES: DETERIORATED SUBSTRATE

REPLACE

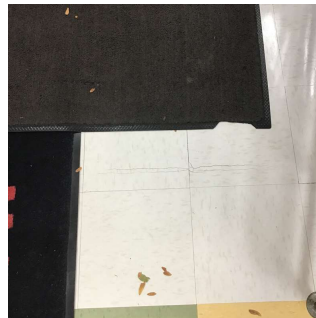
Near Entrance

VINYL TILES: BROKEN/DETERIORATED/MISSING TILES

REPLACE

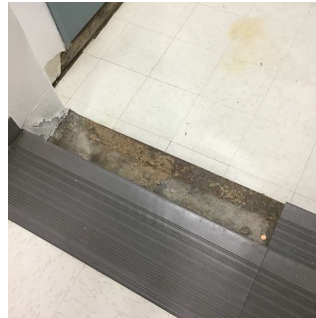
Stair A/1

SHEET VINYL: BROKEN/DETERIORATED

REPLACE

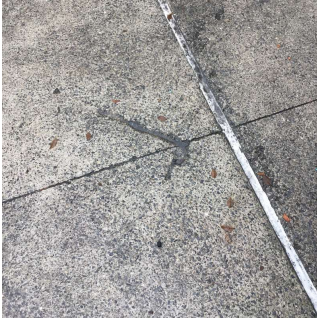
Question	Response
SITE	
PAVING	
Student Use	
Concrete	
Condition	2 - Between Good and Fair
Deficiency	CRACKS - MAJOR
Deficiency Location/Instance	Courtyard
Deficiency Quantity	20
Quantity Uom	S.F.
Potential Action	REPLACE
Urgency of Action	PRIORITY 3
Purpose of Action	LEVEL 2
Deficiency Photo1

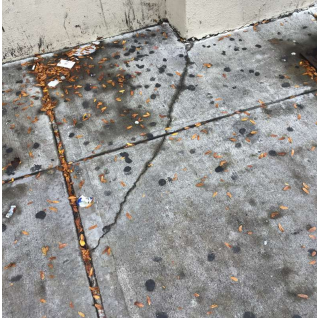
Question	Response
SITE	
PAVING	
DOT Sidewalk	
Concrete	Inspected
Condition	3 - Fair
Deficiency	DAMAGED/DETERIORATED/MISSING SECTIONS
Deficiency Location/Instance	Along Van Dam Street, 32nd Place, 47th Avenue
Deficiency Quantity	400
Quantity Uom	S.F.
Potential Action	REPLACE
Urgency of Action	PRIORITY 3
Purpose of Action	LEVEL 2
Deficiency Photo1

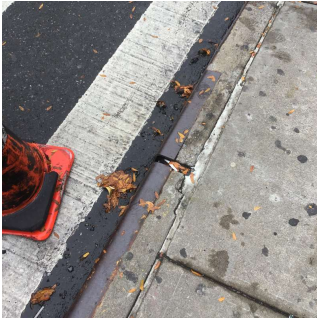
Violations	Along Van Dam Street No violations recorded.
Deficiency	DAMAGED CURBS
Deficiency Location/Instance	Along Van Dam Street, 32nd Place, 47th Avenue
Deficiency Quantity	90
Quantity Uom	L.F.
Potential Action	REPLACE
Urgency of Action	PRIORITY 3
Purpose of Action	LEVEL 2
Deficiency Photo1
