NYC Department of Education
Building Condition Assessment Survey 2023 - 2024

Architectural Inspection

Q593

Asset: P.S. @ 140 BEACH 112 STREET - QUEENS, 140 BEACH 112 STREET, New York, 11694

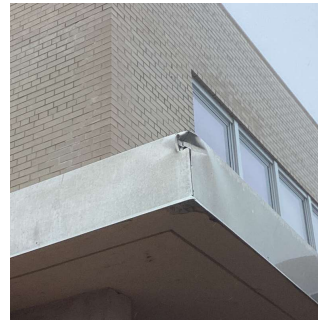
Facade C

Question	Response
Architectural	
EXTERIOR	Inspected
AREAWAY	Does not Exist
AWNINGS AND CANOPIES	Inspected
Condition	3 - Fair
Deficiency	CONCRETE: DETERIORATED

10
S.F.
REPLACE
PRIORITY 4
LEVEL 2

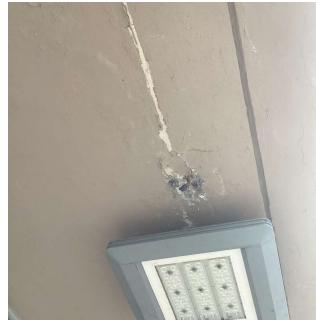
Facade A

CONCRETE: MAJOR CRACKS/SPALLING

10
S.F.
REPAIR
PRIORITY 4
LEVEL 2

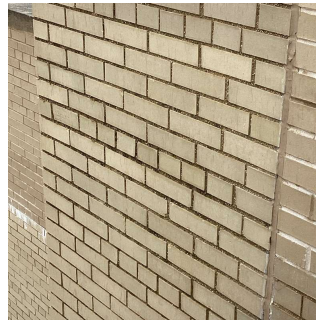
Roof 1 - Chimney 1

BRICK: DETERIORATED JOINTS

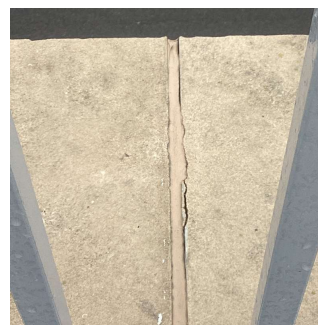
Roof 1
 No violations recorded.

CAST STONE: DETERIORATED TRANSVERSE JOINTS

150
 L.F.
 MAINTENANCE
 PRIORITY 3
 LEVEL 2

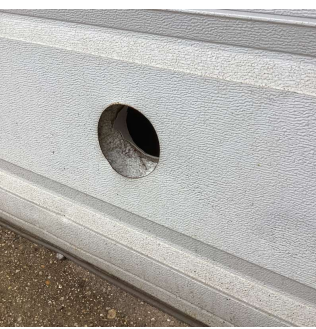
Question	Response
EXTERIOR	
DOORS	
DOORS AND FRAMES	
Deficiency	ROLL-UP DOOR: DETERIORATED DOOR - MAJOR DETERIORATION
Roof Plan reference

<p>Q593 Beach 111th Street</p> <p>Beach 112th Street</p>
Deficiency Quantity	300
Quantity Uom	S.F.
Potential Action	REPLACE
Urgency of Action	PRIORITY 4
Purpose of Action	LEVEL 2
Deficiency Photo1

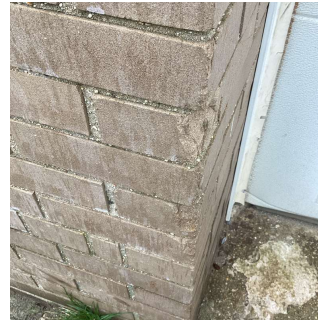
Facade C

BRICK: CRACKS/DISPLACED/SPALLED BRICK AT BUILDING CORNERS

10
S.F.
REMOVE AND REBUILD
PRIORITY 4
LEVEL 2

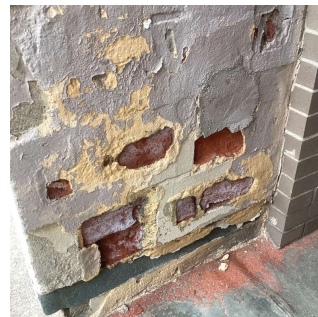
Facade C

BRICK: MAJOR / THRU CRACKS

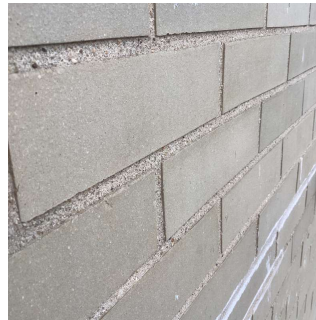
Facade A

BRICK: DETERIORATED JOINTS

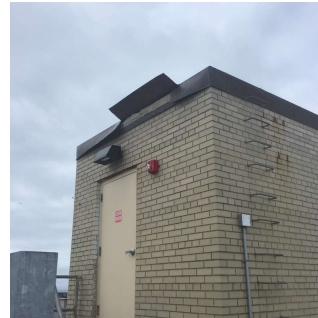
EMR

Deficiency	BULKHEAD/PENTHOUSE ROOF: DETERIORATED
------------	---------------------------------------

REPLACE

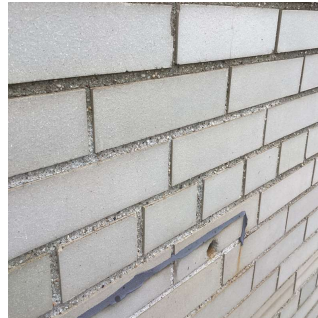
Roof 1 - Bulkhead 1

BULKHEAD/PENTHOUSE WALLS/EXTERIOR: DETERIORATED JOINTS

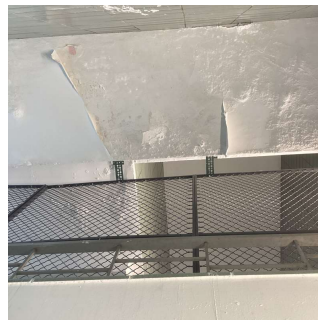
Roof 1 - Bulkhead 2

BULKHEAD/PENTHOUSE CEILING: PLASTER DAMAGED/DETERIORATED

REPLACE

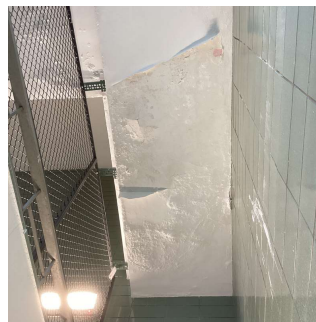
Roof 1 - Bulkhead 2, also Elevator Machine Room

BULKHEAD/PENTHOUSE ROOF: MAJOR LEAKAGE

200
S.F.
REPLACE
PRIORITY 5
LEVEL 2

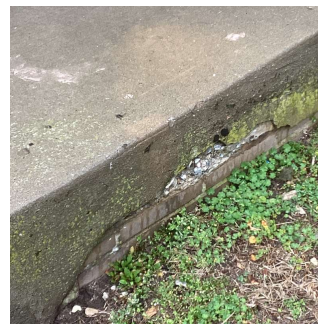
Facade A
 No violations recorded.

CUPOLA/ SPIRES/ TOWERS	Does not Exist
DORMER	Does not Exist
DUNNAGE STEEL	Inspected
Condition	1 - Good
Deficiency	No deficiencies recorded
SKYLIGHT/ROOF VENT	Does not Exist
ROOF/GRAVITY TANK	Does not Exist
STAIRS/RAMPS: EXTERIOR	Inspected
BUILDING CHEEK/FLANK WALLS	Inspected
Condition	3 - Fair
Deficiency	CAST IN PLACE CONCRETE: CRACKS/SPALLING - MAJOR

10
 S.F.
 REPLACE
 PRIORITY 4
 LEVEL 2

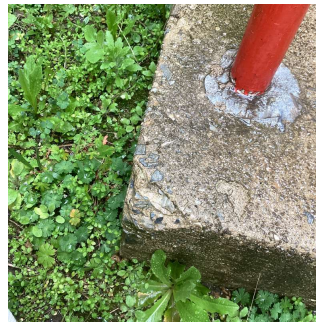
Facade D

Inspected
 4 - Between Fair and Poor
 CONCRETE: CRACKS/SPALLING - MINOR

20
 S.F.
 REPAIR
 PRIORITY 3
 LEVEL 2

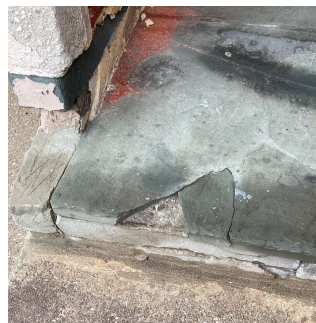
Facade C

STONE: CRACKS/SPALLING - MAJOR

REPLACE

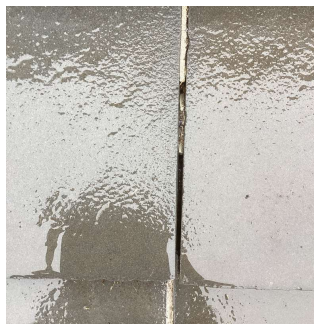
Facade B
No violations recorded.

STONE: DETERIORATED JOINTS

10
L.F.
REPOINT
PRIORITY 4
LEVEL 2

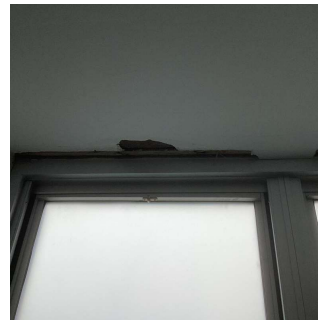
Facade E - Room 102

WINDOWS	Inspected
Replacement Quantity	7,300
Replacement Uom	S.F.
EXTERIOR GUARDS	Does not Exist
LINTELS	Inspected
Condition	2 - Between Good and Fair
Deficiency	No deficiencies recorded
WINDOWS	Inspected
Material Type(s)	Aluminum
Instance on Aluminum - Double Hung: All Facades	Inspected
Instance Condition	3 - Fair
Instance Quantity	7,300
Instance Quantity Uom	S.F.
Are these windows insulated	Yes
Installation Year	2020
Source of Installation	Custodial Staff
Deficiency	ALUMINUM - DOUBLE HUNG: AIR/WATER INFILTRATION

REPLACE TRIM, SILLS OR WEATHERSTRIPPING

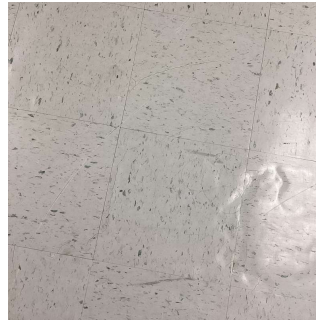
Corridor near Stair D/3
Violations	No violations recorded.
Deficiency	GYPSUM BOARD: DAMAGED/DETERIORATED
Deficiency Location/Instance	Rooms 109, 203, Corridor near Rooms 207, 208
Deficiency Quantity	60
Quantity Uom	S.F.
Potential Action	REPLACE
Urgency of Action	PRIORITY 3
Purpose of Action	LEVEL 2
Deficiency Photo1	 
	Room 109
Violations	No violations recorded.
Door(s)	Inspected
Condition	2 - Between Good and Fair
Deficiency	No deficiencies recorded
Floor Finish	Inspected
Condition	2 - Between Good and Fair
Deficiency	VINYL TILES: BROKEN/DETERIORATED/MISSING TILES
Deficiency Location/Instance	Rooms 111, 222, Corridor near Room 222
Deficiency Quantity	30
Quantity Uom	S.F.
Potential Action	REPLACE
Urgency of Action	PRIORITY 3
Purpose of Action	LEVEL 2

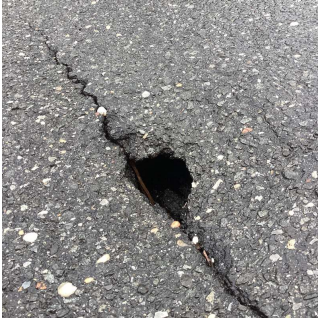
No	Tripping Hazard	Large Asphalt Pothole in Parking Area is a tripping hazard condition	SITE PAVING Student Non-Use Asphalt	Near Center Parking Lot	Carmine Morales	Fireman

Violations	B112nd Street No violations recorded.
IRRIGATION SYSTEM	
	Does not Exist
PAVING	
Student Non-Use	Inspected
Gravel Exists?	No
Asphalt	
Condition	Inspected 4 - Between Fair and Poor
Deficiency	POTHOLES
Deficiency Location/Instance	Near Center Parking Lot, Containerization Area
Deficiency Quantity	40
Quantity Uom	S.F.
Potential Action	REPAIR
Urgency of Action	PRIORITY 5
Purpose of Action	LEVEL 6
Deficiency Photo1
