**NYC Department of Education**  
**Building Condition Assessment Survey 2023 - 2024**

Architectural Inspection

**Q600**

**Asset:** QUEENS VOC HS - Q, 37-02 47 AVENUE, New York, 11101

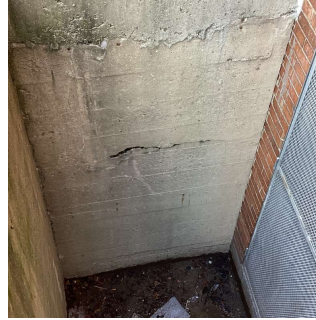
AW5

Question	Response
<b>Architectural</b>	
<b>EXTERIOR</b>	Inspected
<b>AREAWAY</b>	Inspected
Instance on AW1-AW9	Inspected
Instance Condition	4 - Between Fair and Poor
Instance Quantity	9
Instance Quantity Uom	EACH
Deficiency	AREAWAY WALLS: CRACKS AND SPALLING
Roof Plan reference	
Deficiency Quantity	10
Quantity Uom	S.F.
Potential Action	REPAIR
Urgency of Action	PRIORITY 3
Purpose of Action	LEVEL 2

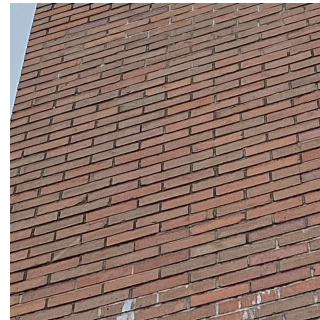
CH

BRICK: DETERIORATED JOINTS

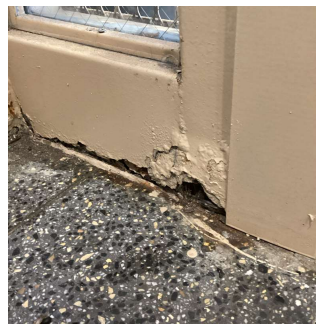
Facade A

Deficiency Quantity	50
Quantity Uom	S.F.
Potential Action	MAINTENANCE
Urgency of Action	PRIORITY 3
Purpose of Action	LEVEL 2
Deficiency Photo1	No photo recorded
Violations	No violations recorded.
Deficiency	METAL: DENTED, MAJOR RUSTING

10  
S.F.  
REPLACE  
PRIORITY 4  
LEVEL 2

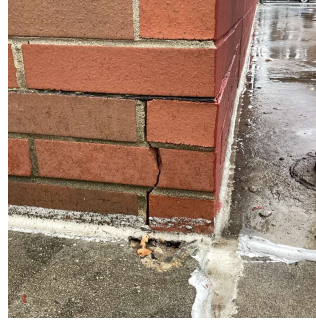
Facade C

BRICK: CRACKS/DISPLACED/SPALLED BRICK AT BUILDING CORNERS

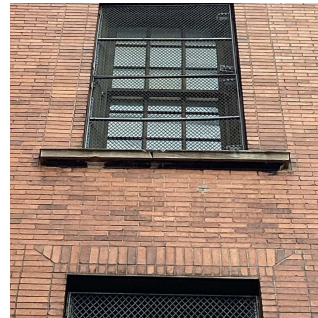
Facade H

BRICK: DETERIORATED MASONRY SILLS - MINOR

REPAIR

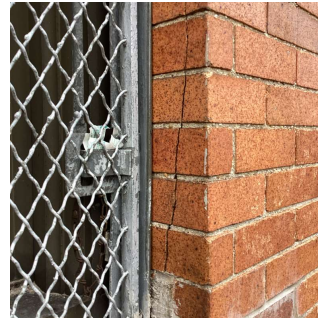
Facade A

BRICK: MAJOR / THRU CRACKS

PRIORITY 4  
LEVEL 2

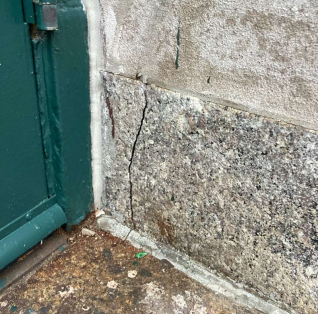
Question	Response
<b>EXTERIOR</b>	
<b>EXTERIOR WALLS</b>	
Violations	No violations recorded.
Deficiency	STONE: CHIPPED/SPALLED/BROKEN PIECES - MINOR
Roof Plan reference

Deficiency Quantity	20
Quantity Uom	S.F.
Potential Action	REPAIR
Urgency of Action	PRIORITY 3
Purpose of Action	LEVEL 2
Deficiency Photo1

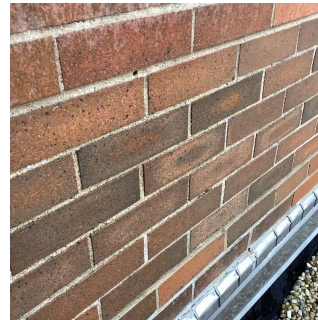
Roof 2

BRICK: DETERIORATED JOINTS

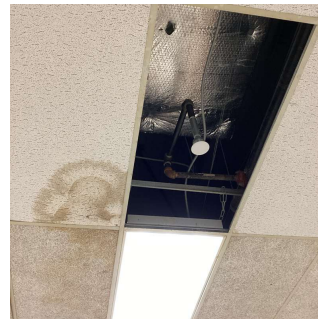
Roof 1 - Corridor near Room 439 (Roof 1 - Corridor near Room 435, Stair B/4, Library similar)

Do solar panels exist on these roofs?	No
Is/Are the roof(s) suitable for Solar Panel installation?	Yes
Installation Year	2005
Source of Installation	Custodial Staff
Deficiency	IRMA: ROOFING: MAJOR ACTIVE ROOF LEAKS IN INSTRUCTIONAL SPACE

400  
S.F.  
REPLACE ROOFING WITHOUT MAJOR EQUIPMENT  
REMOVAL  
PRIORITY 5  
LEVEL 2

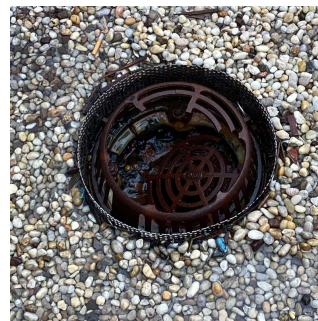
Roof 2

DETERIORATED

REPLACE

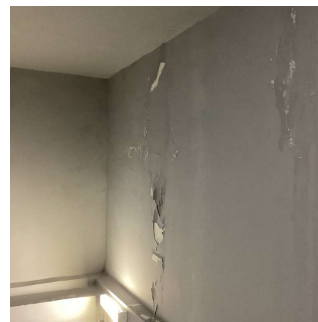
BH1  
 No violations recorded.

BULKHEAD/PENTHOUSE WALLS/EXTERIOR: WATER INFILTRATION

100  
 S.F.  
 REPAIR  
 PRIORITY 5  
 LEVEL 2

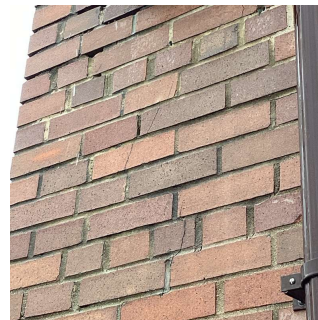
BH1

**BULKHEAD/PENTHOUSE WALLS/EXTERIOR:  
CRACKS/SPALLING - MINOR**

REPAIR

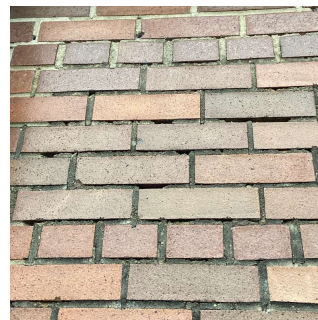
BH1  
No violations recorded.

**BULKHEAD/PENTHOUSE WALLS/EXTERIOR: DETERIORATED  
JOINTS**

20  
S.F.  
REPOINT  
PRIORITY 4  
LEVEL 2

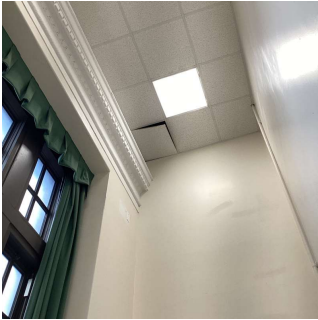
Violations	Back stage Right Side No violations recorded.
Deficiency	ACOUSTIC TILES: DAMAGED/MISSING
Deficiency Location/Instance	Exit 5 Vestibule
Deficiency Quantity	10
Quantity Uom	S.F.
Potential Action	REPLACE
Urgency of Action	PRIORITY 5
Purpose of Action	LEVEL 6
Deficiency Photo1

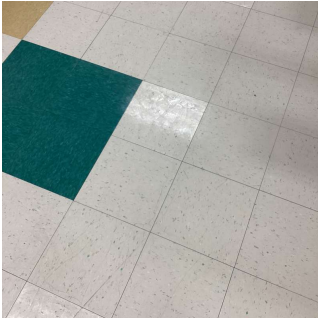
Question	Response
<b>INTERIOR</b>	
<b>CAFETERIA</b>	
<b>Floor Finish</b>	
Deficiency	VINYL TILES: BROKEN/DETERIORATED/MISSING TILES
Deficiency Location/Instance	Near Entrance
Deficiency Quantity	10
Quantity Uom	S.F.
Potential Action	REPLACE
Urgency of Action	PRIORITY 3
Purpose of Action	LEVEL 2
Deficiency Photo1

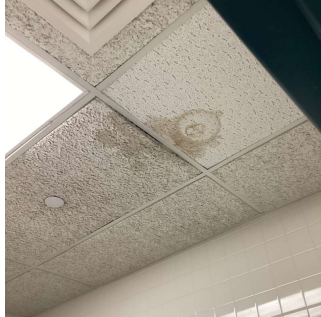
Room 250E

Deficiency	ACOUSTIC TILES: DAMAGED/MISSING
Deficiency Location/Instance	Rooms 250E, 250D
Deficiency Quantity	20
Quantity Uom	S.F.
Potential Action	REPLACE
Urgency of Action	PRIORITY 3
Purpose of Action	LEVEL 2
Deficiency Photo1

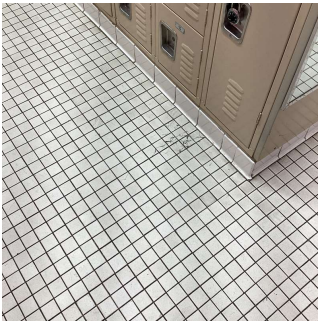
Deficiency Location/Instance	Near Locker 4
Deficiency Quantity	10
Quantity Uom	S.F.
Potential Action	REPLACE
Urgency of Action	PRIORITY 3
Purpose of Action	LEVEL 2
Deficiency Photo1

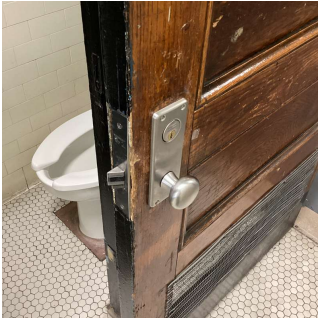
Room 339
Violations	No violations recorded.
Deficiency	WOOD: DETERIORATED DOOR
Deficiency Location/Instance	Rooms 415, 315, 215, 201
Deficiency Quantity	4
Quantity Uom	EACH
Potential Action	MAINTENANCE
Urgency of Action	PRIORITY 3
Purpose of Action	LEVEL 2
Deficiency Photo1

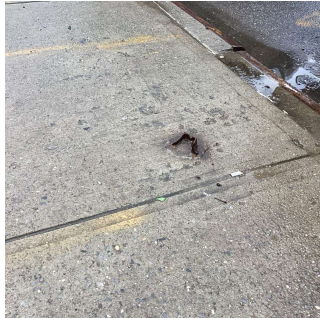
Violations	Exit 1 No violations recorded.
<b>Pavers</b>	Does not Exist
<b>DOT Sidewalk</b>	Inspected
<b>Asphalt</b>	Does not Exist
<b>Concrete</b>	Inspected
Condition	4 - Between Fair and Poor
Deficiency	DAMAGED/DETERIORATED/MISSING SECTIONS
Deficiency Location/Instance	47th Avenue
Deficiency Quantity	25
Quantity Uom	S.F.
Potential Action	REPLACE
Urgency of Action	PRIORITY 5
Purpose of Action	LEVEL 6
Deficiency Photo1
