**NYC Department of Education**  
**Building Condition Assessment Survey 2023 - 2024**

Architectural Inspection

**Asset: PRE-K CENTER @ 83-30 KEW GARDENS ROAD - QUEENS, 83-30 KEW GARDENS ROAD, New York, 11415**

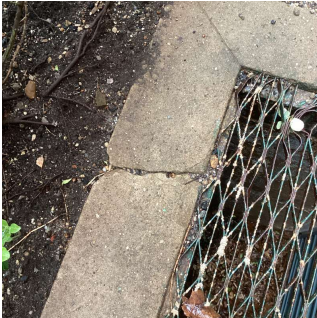
Question	Response
<b>Architectural</b>	
<b>EXTERIOR</b>	Inspected
<b>AREAWAY</b>	Inspected
Instance on AW1-AW6	Inspected
Instance Condition	3 - Fair
Instance Quantity	6
Instance Quantity Uom	EACH
Deficiency	AREAWAY WALLS: CRACKS AND SPALLING
Roof Plan reference	Q608
	<p>The diagram is identical to the one above, but with a red rectangular box highlighting the area between AW4 and AW6 along the eastern boundary of the building.</p>
Deficiency Quantity	40
Quantity Uom	S.F.
Potential Action	REPLACE
Urgency of Action	PRIORITY 4
Purpose of Action	LEVEL 2

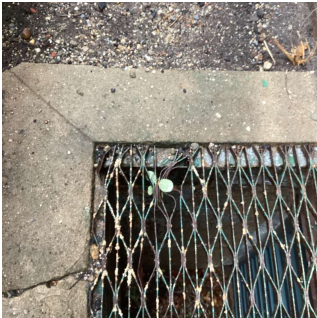
Violations	Facade C - AW4 No violations recorded.
Deficiency	AREAWAY GRATINGS: MAJOR RUSTING / OR BROKEN
Roof Plan reference	Q608

Deficiency Quantity	10
Quantity Uom	S.F.
Potential Action	REPLACE
Urgency of Action	PRIORITY 4
Purpose of Action	LEVEL 2
Deficiency Photo1

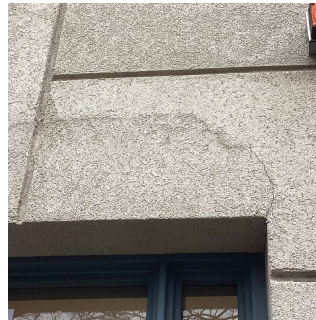
Facade A

STUCCO CEMENT SURFACE: CRACKS, SPALLING

Deficiency Quantity

20

REPLACE

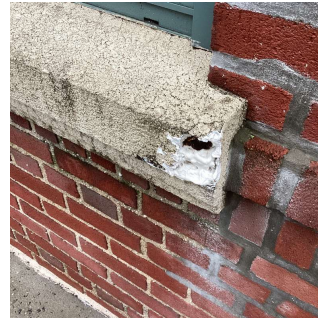
Facade A

BRICK: DETERIORATED MASONRY SILLS - MINOR

REPAIR

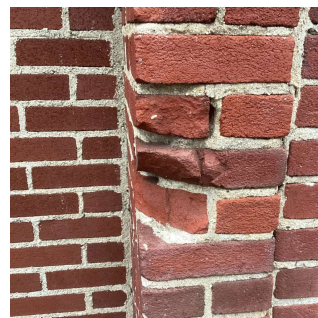
Facade A

BRICK: CRACKS/DISPLACED/SPALLED BRICK AT BUILDING CORNERS

20  
S.F.  
REMOVE AND REBUILD  
PRIORITY 4  
LEVEL 2

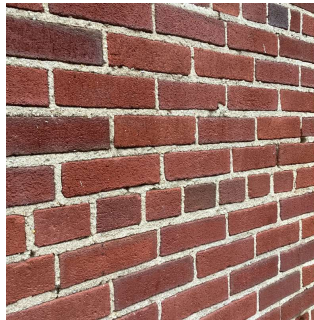
Facade A

BRICK: DETERIORATED JOINTS

500

REPOINT

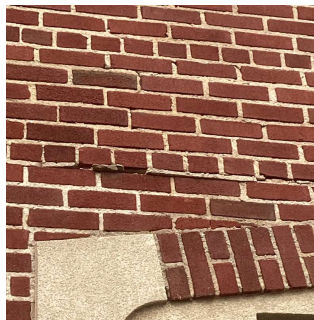
Facade A

BRICK: DETERIORATED JOINTS

10

REPOINT

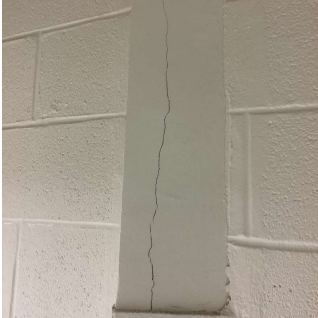
Basement - Corridor
Violations	No violations recorded.
<b>FLOOR STRUCTURE</b>	Inspected
Condition	2 - Between Good and Fair
Deficiency	No deficiencies recorded
<b>FOUNDATION WALLS</b>	Inspected
Material Type(s)	Concrete
Condition	2 - Between Good and Fair
Deficiency	No deficiencies recorded

Question	Response
<b>EXTERIOR</b>	
<b>WINDOWS</b>	
Replacement Uom	S.F.
<b>EXTERIOR GUARDS</b>	Inspected
Condition	2 - Between Good and Fair
Deficiency	No deficiencies recorded
<b>LINTELS</b>	Inspected
Condition	2 - Between Good and Fair
Deficiency	No deficiencies recorded
<b>WINDOWS</b>	Inspected
Material Type(s)	Aluminum
Instance on Aluminum - Other: All Facades	Inspected
Instance Condition	2 - Between Good and Fair
Instance Quantity	300
Instance Quantity Uom	S.F.
Are these windows insulated	Yes
Installation Year	2015
Source of Installation	Custodial Staff
Deficiency	No deficiencies recorded
<b>INTERIOR</b>	Inspected
<b>POOLS</b>	Does not Exist
<b>STRUCTURAL</b>	Inspected
<b>COLUMNS/BEAMS/BEARING WALLS</b>	Inspected
Condition	2 - Between Good and Fair
Deficiency	STEEL COLUMNS/BEAMS: DETERIORATED CONCRETE FIREPROOFING
Deficiency Location/Instance	Basement - Corridor
Deficiency Quantity	10
Quantity Uom	S.F.
Potential Action	REPLACE
