**NYC Department of Education**  
**Building Condition Assessment Survey 2023 - 2024**

Architectural Inspection

Q633

**Asset:** EAGLE ACADEMY - QUEENS, 171-10 LINDEN BOULEVARD, New York, 11434

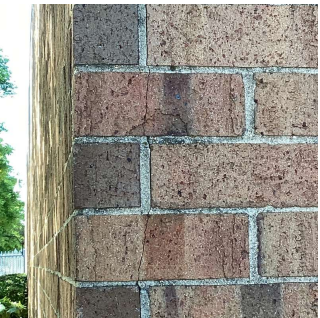
Question	Response
<b>EXTERIOR</b>	
<b>EXTERIOR WALLS</b>	
Instance Condition	3 - Fair
Instance Quantity	30,000
Instance Quantity Uom	S.F.
Deficiency	BRICK: CRACKS/DISPLACED/SPALLED BRICK AT BUILDING CORNERS
Roof Plan reference	<p>Q633</p>

Deficiency Quantity	30
Quantity Uom	S.F.
Potential Action	REMOVE AND REBUILD
Urgency of Action	PRIORITY 4
Purpose of Action	LEVEL 2
Deficiency Photo1

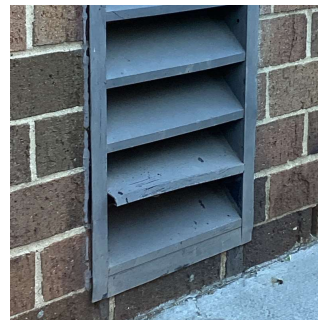
Facade F

Violations	No violations recorded.
<b>EXTERIOR SOFFITS</b>	Does not Exist
<b>LOADING DOCK</b>	Does not Exist
<b>LOUVER</b>	Inspected
Condition	3 - Fair
Deficiency	BROKEN/ DENTED BLADES

REPLACE

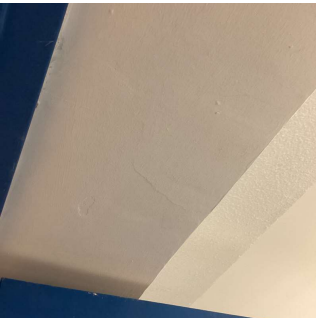
Question	Response
<b>EXTERIOR</b>	
<b>PLAZA DECK</b>	
Instance Quantity Uom	S.F.
Installation Year	2002
Source of Installation	Custodial Staff
Deficiency	ASPHALT: MAJOR ACTIVE PLAZA DECK LEAKS IN INSTRUCTIONAL SPACE
Roof Plan reference	<p>Q633</p>

Deficiency Quantity	100
Quantity Uom	S.F.
Potential Action	REPLACE
Urgency of Action	PRIORITY 5
Purpose of Action	LEVEL 4
Deficiency Photo1

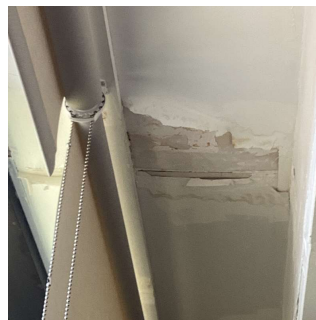
Roof 1 - Room 318

Deficiency	MODIFIED BITUMEN: ROOFING: MAJOR ACTIVE ROOF LEAKS IN INSTRUCTIONAL SPACE
------------	---

Deficiency Quantity	100
Quantity Uom	S.F.
Potential Action	REPLACE ROOFING WITH MAJOR EQUIPMENT REMOVAL
Urgency of Action	PRIORITY 5
Purpose of Action	LEVEL 4
Deficiency Photo1

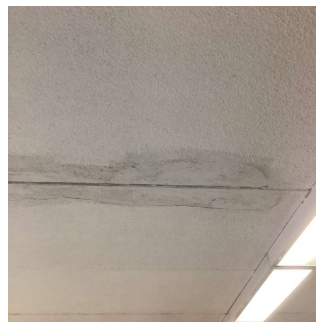
Roof 1 - Room 306, also Corridor near Room 303

200  
 S.F.  
 REPLACE ROOFING WITH MAJOR EQUIPMENT REMOVAL  
 PRIORITY 5  
 LEVEL 2

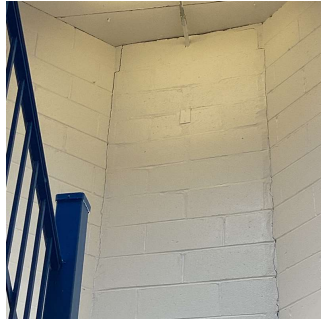
BULKHEAD/PENTHOUSE WALLS/INTERIOR: CMU  
 CRACKS/SPALLING

10  
 S.F.  
 REPLACE

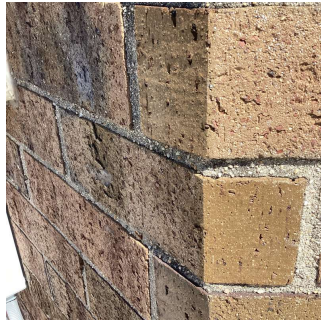
Violations	Roof 1 - Bulkhead 1 No violations recorded.
Deficiency	BULKHEAD/PENTHOUSE WALLS/EXTERIOR: DETERIORATED JOINTS
Roof Plan reference	Q633

Deficiency Quantity	100
Quantity Uom	S.F.
Potential Action	REPOINT
Urgency of Action	PRIORITY 3
Purpose of Action	LEVEL 2
Deficiency Photo1

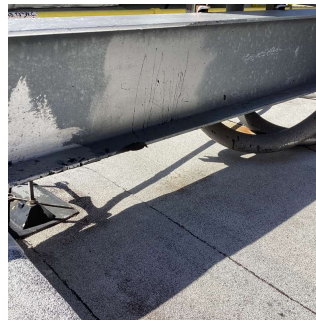
Roof 1  
No violations recorded.

Violations	Roof 1 - Bulkhead 1 No violations recorded.
<b>CUPOLA/ SPIRES/ TOWERS</b>	Does not Exist
<b>DORMER</b>	Does not Exist
<b>DUNNAGE STEEL</b>	Inspected
Condition	3 - Fair
Deficiency	HEIGHT LESS THAN 18"

60  
L.F.  
REPLACE  
PRIORITY 3  
LEVEL 2

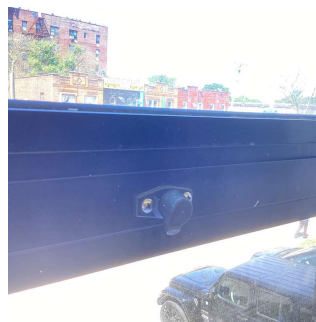
Facade F - Room 210  
No violations recorded.

Deficiency	ALUMINUM - OTHER: HARDWARE POOR CONDITION/MISSING
------------	---

30  
EACH  
MAINTENANCE  
PRIORITY 3  
LEVEL 2

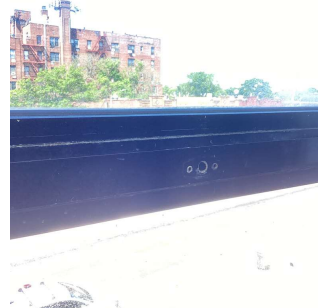
Facade F - Room 314

ALUMINUM - OTHER: HARDWARE POOR  
CONDITION/MISSING

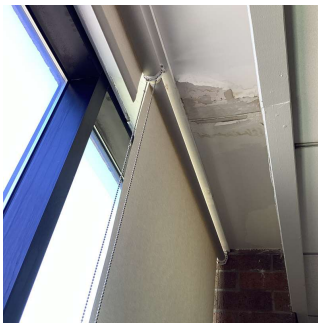
Violations	Near Serving Area No violations recorded.
<b>Window Curtains/Shades/Blinds</b>	
Instance on Basement	Does not Exist
<b>CLASSROOMS/CORRIDORS/ADMIN SPACES</b>	
<b>Ceiling</b>	
Condition	Inspected
Condition	2 - Between Good and Fair
Deficiency	GYP SUM BOARD: DAMAGED/DETERIORATED - ACTIVE LEAK
Deficiency Location/Instance	Room 318
Deficiency Quantity	20

Quantity Uom	S.F.
Potential Action	REPLACE
Urgency of Action	PRIORITY 5
Purpose of Action	LEVEL 4

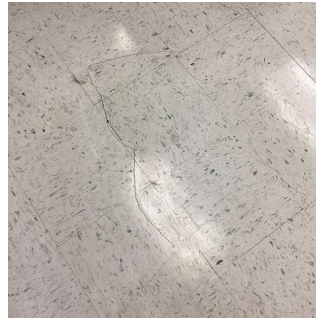
Room 100

VINYL TILES: DETERIORATED SUBSTRATE

REPLACE

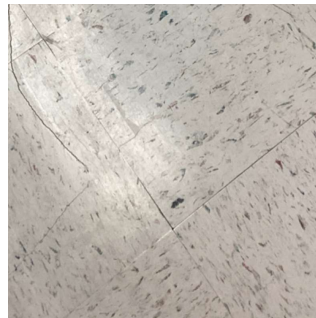
Room 112

VINYL TILES: BROKEN/DETERIORATED/MISSING TILES

REPLACE

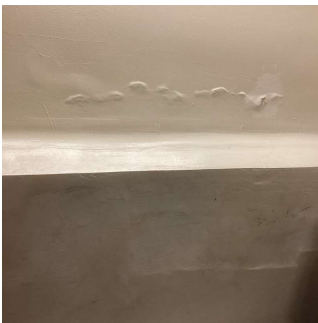
Violations	Stair A/1 No violations recorded.
Deficiency	PLASTER: CRACKS/SPALLING - ACTIVE LEAK
Deficiency Location/Instance	Stair B/Basement
Deficiency Quantity	30
Quantity Uom	S.F.
Potential Action	REPLACE
Urgency of Action	PRIORITY 5
Purpose of Action	LEVEL 2

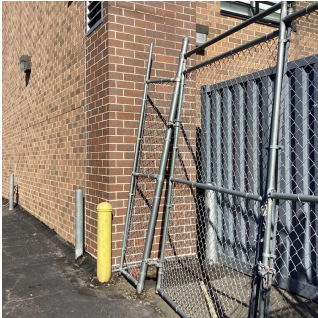
Violations	Room 321A No violations recorded.
<b>LIFE SAFETY</b>	Inspected
<b>F.D. HOLDING AREA</b>	Does not Exist
<b>STEEL STAIRS</b>	Does not Exist
<b>SITE</b>	Inspected
<b>CONTAINERIZATION</b>	Does not Exist
<b>Drainage System for Asphalt</b>	Inspected
<b>Catch Basins/Manhole - Surrounded by asphalt</b>	Inspected
Condition	2 - Between Good and Fair
Deficiency	No deficiencies recorded
<b>Culverts - Asphalt Covering</b>	Does not Exist
<b>Drainage System for Concrete</b>	Inspected
<b>Catch Basins/Manhole - Surrounded by concrete</b>	Inspected
Condition	2 - Between Good and Fair
Deficiency	No deficiencies recorded
<b>Culverts - Concrete Covering</b>	Does not Exist
<b>Drainage System for Soil</b>	Does not Exist
<b>DRINKING FOUNTAINS</b>	Does not Exist
<b>FENCES</b>	Inspected
Condition	3 - Fair
Deficiency	CHAIN LINK: DAMAGED/DETERIORATED

Deficiency Location/Instance	Parking Lot Area
Deficiency Quantity	100
Quantity Uom	S.F.
Potential Action	REPLACE
Urgency of Action	PRIORITY 3
Purpose of Action	LEVEL 2
Deficiency Photo1
