NYC Department of Education
Building Condition Assessment Survey 2023 - 2024

Architectural Inspection

Asset: **RICHMOND HILL HS ANNEX - QUEENS, 94-25 117TH STREET, New York, 11419**

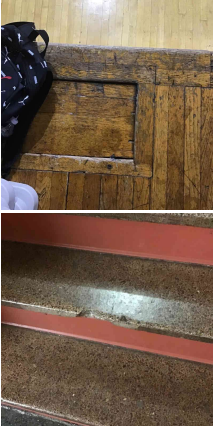
| Yes | Tripping Hazard | Broken Flooring resulting in potential hazardous condition | INTERIOR GYMNASIUM Stage Stage | Front | Charles Jones | Fireman | |

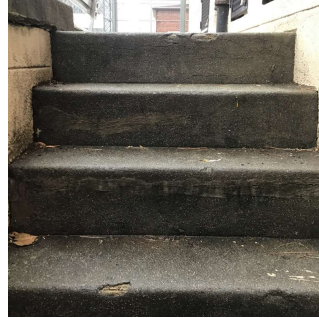
| Question | Response |
|---|--|
| Deficiency | AREAWAY STAIRS: DETERIORATED TREADS/RISERS/NOSINGS |

| Question | Response |
|---|--|
| Potential Action | REPAIR |

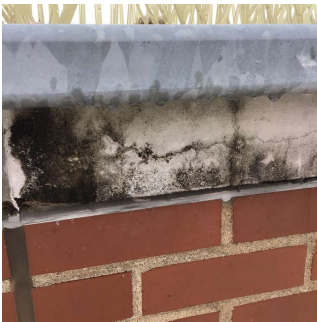
| Question | Response |
|---|--|
| Deficiency | CAST STONE: DISINTEGRATING / FREEZE THAW |

| Question | Response |
|---|--|
| Potential Action | REPLACE-IN-KIND |

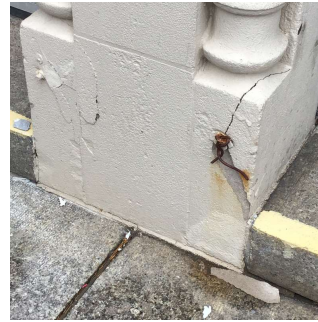
Facade A

| Question | Response |
|---|--|
| Deficiency | STONE: CHIPPED/SPALLED/BROKEN PIECES - MINOR |

| Question | Response |
|---|--|
| Potential Action | REPAIR |

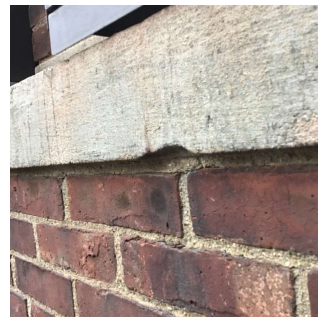
Facade C

BRICK: DETERIORATED MASONRY SILLS - MINOR

REPAIR

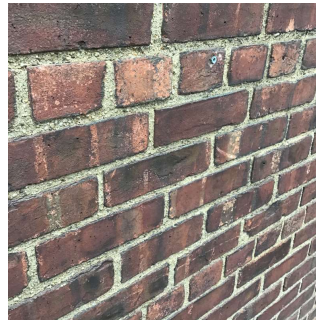
Facade C

BRICK: DETERIORATED JOINTS

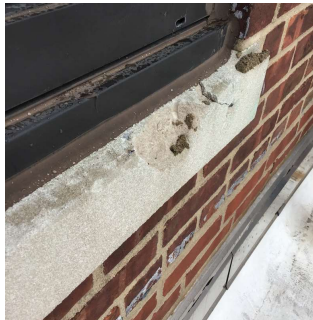
Roof 1 - Bulkhead

BRICK: DETERIORATED MASONRY SILLS - MAJOR

REMOVE AND REPLACE

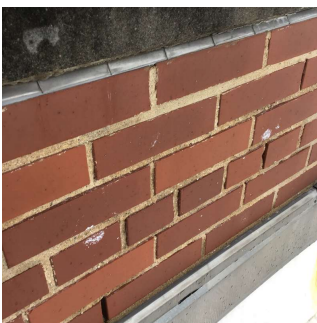
| Question | Response |
|---|--|
| Deficiency | BRICK: DETERIORATED JOINTS |

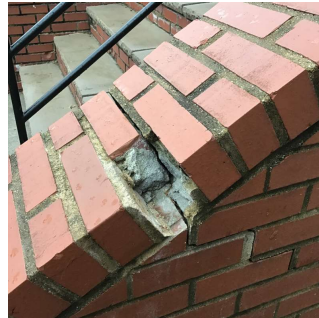
| Question | Response |
|---|--|
| Deficiency | BRICK: CRACKS/SPALLING - MAJOR |

| Question | Response |
|---|--|
| Potential Action | REPLACE |

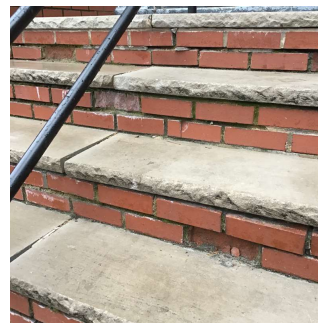
Facade A

| Question | Response |
|---|--|
| Deficiency | BRICK: WORN-OUT TREAD/RISER/NOSING |

REPLACE

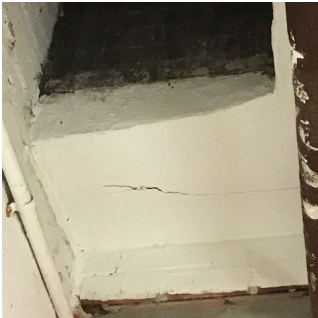
| Question | Response |
|---|--|
| Deficiency | STEEL COLUMNS/BEAMS: DETERIORATED CONCRETE FIREPROOFING |
| Deficiency Location/Instance | Basement - Room C08 |

| Question | Response |
|---|--|
| Potential Action | REPLACE |

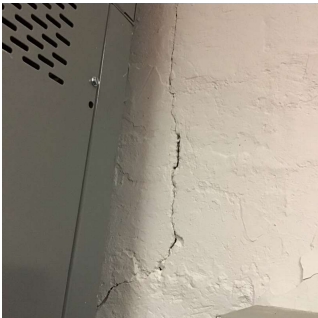
| Question | Response |
|---|--|
| Deficiency | CONCRETE: CRACKED/SPALLED/REINFORCEMENT EXPOSED |
| Deficiency Location/Instance | Basement - Electrical Panel Room |

| Question | Response |
|---|--|
| Potential Action | REPAIR |

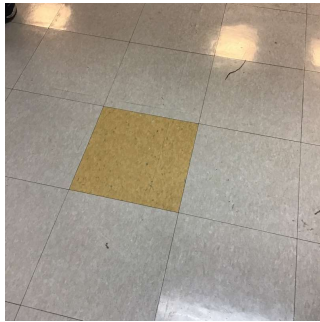
| Question | Response |
|--|--|
| Deficiency | VINYL TILES: BROKEN/DETERIORATED/MISSING TILES |
| Deficiency Location/Instance | Near Stair E, Near Servery |

| Question | Response |
|--|--|
| Potential Action | REPLACE |

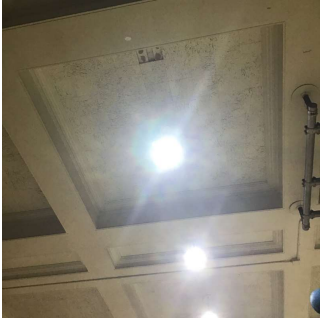
| Question | Response |
|--|---|
| Deficiency | ACOUSTIC TILES ON PLASTER: DAMAGED/MISSING |
| Deficiency Location/Instance | Near Stage |

| Question | Response |
|--|---|
| Potential Action | REPLACE |

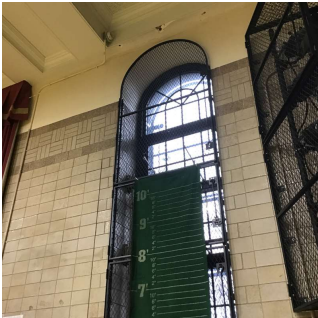
| Question | Response |
|---|--|
| Deficiency | WORN/DAMAGED CURTAINS |
| Deficiency Location/Instance | Right Side |

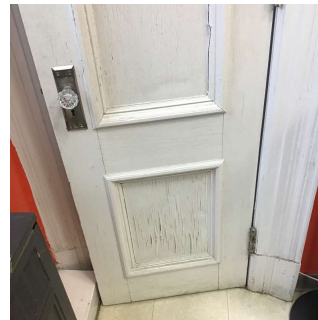
Principals Restroom

WOOD: DETERIORATED DOOR

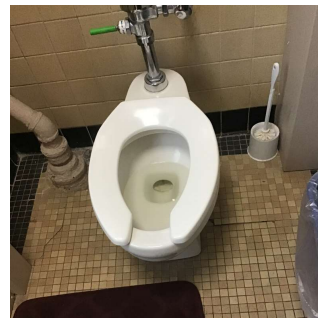
CERAMIC TILE: DETERIORATED SUBSTRATE

REPLACE

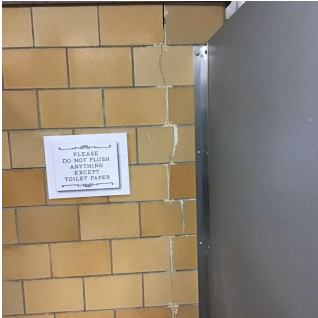
| Question | Response |
|---|--|
| Deficiency | GLAZED BLOCK: CRACKS/SPALLING |
| Deficiency Location/Instance | Room C05 |

| Question | Response |
|---|--|
| Potential Action | REPLACE |
