NYC Department of Education
Building Condition Assessment Survey 2023 - 2024

Architectural Inspection

Asset: HS FOR CONST.TRADES,ENGG.,& ARCH-Q, 94-06 104TH STREET, New York, 11416

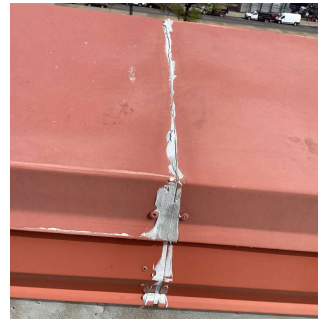
Roof 1 - Facade D

METAL: DETERIORATED JOINTS

REPAIR

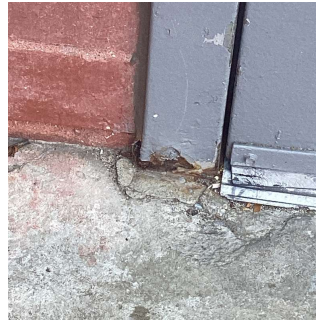
Facade D - Exit 5

METAL: DETERIORATED DOOR - MINOR DETERIORATION

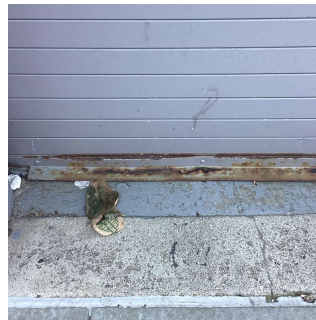
Facade D

ROLL-UP DOOR: DETERIORATED DOOR - MAJOR DETERIORATION

REPLACE

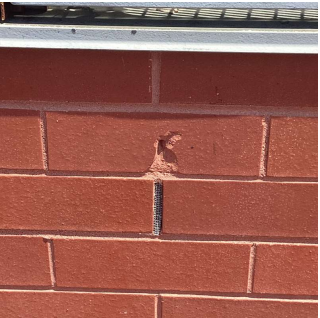
Deficiency Quantity	20
Quantity Uom	S.F.
Potential Action	RESTITCH
Urgency of Action	PRIORITY 3
Purpose of Action	LEVEL 2
Deficiency Photo1

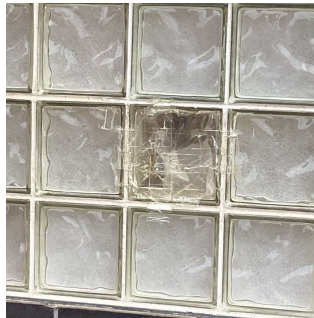
Facade B

GLASS BLOCK: CHIPPED/ BROKEN PIECES

REPLACE-IN-KIND

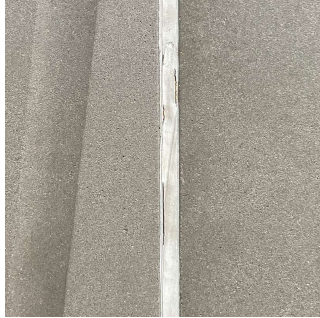
CAST IN PLACE / PRE-CAST CONCRETE: DETERIORATED CONTROL/EXPANSION JOINTS

Question	Response
EXTERIOR	
EXTERIOR WALLS	
Potential Action	MAINTENANCE
Urgency of Action	PRIORITY 3
Purpose of Action	LEVEL 2
Deficiency Photo1

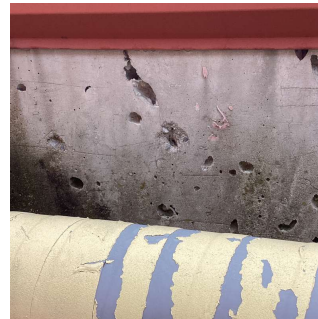
Roof 1 - Facade J

CONCRETE: MINOR CRACKS, SPALLING

REPAIR

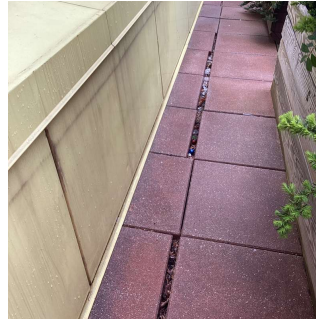
Roof 5 - Facade G side
No violations recorded.

PAVERS: DETERIORATED JOINTS

20
L.F.
REPOINT
PRIORITY 4
LEVEL 2

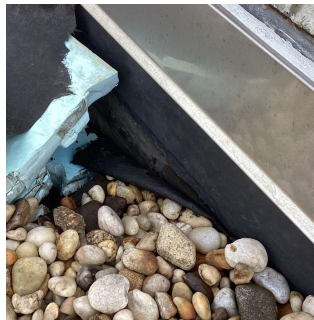
Roof 1 - Facade E

10
S.F.
REPLACE
PRIORITY 4
LEVEL 2

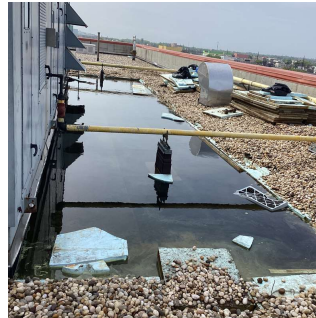
Roof 1

IRMA: ROOFING: DAMAGED INSULATION

300
S.F.
REPLACE
PRIORITY 4
LEVEL 2

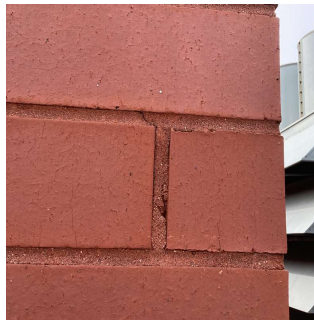
BH
 No violations recorded.

BULKHEAD/PENTHOUSE WALLS/EXTERIOR: DETERIORATED JOINTS

10
 S.F.
 REPOINT
 PRIORITY 3
 LEVEL 2

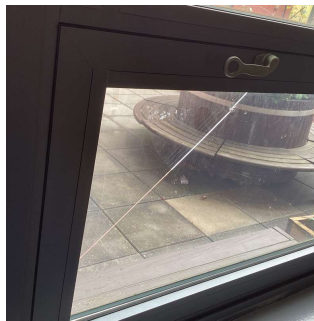
Facade H - Corridor near Room 352

Instance Condition	3 - Fair
Instance Quantity	6,000
Instance Quantity Uom	S.F.
Are these windows insulated	Yes
Installation Year	2006
Source of Installation	Custodial Staff
Deficiency	ALUMINUM - OTHER: BROKEN PANE
Roof Plan reference	Q650

Deficiency Quantity	30
Quantity Uom	S.F.
Potential Action	MAINTENANCE
Urgency of Action	PRIORITY 3
Purpose of Action	LEVEL 2
Deficiency Photo1

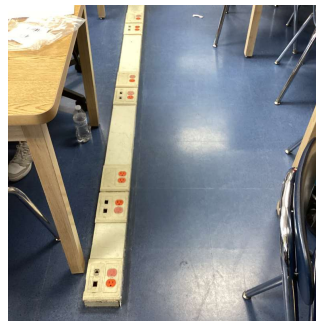
Room 208

VINYL TILES: TRIPPING HAZARD - ELECTRICAL OUTLET

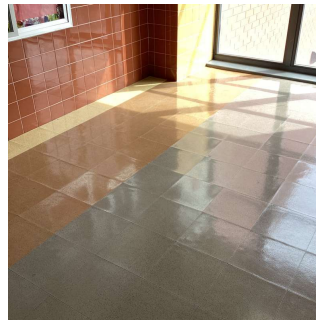
Corridor near Stair B/4

VINYL TILES: BROKEN/DETERIORATED/MISSING TILES

REPLACE

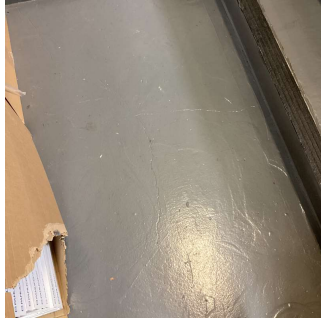
Deficiency	CONCRETE: CRACKS/SPALLING - MAJOR
Deficiency Location/Instance	Stair B/Bulkhead
Deficiency Quantity	50
Quantity Uom	S.F.
Potential Action	REPLACE
Urgency of Action	PRIORITY 3
Purpose of Action	LEVEL 2
Deficiency Photo1

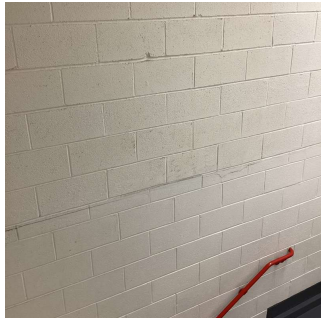
Stair B/Basement

Deficiency	MASONRY: CRACKS/SPALLING
Deficiency Location/Instance	Stairs A/1, B/Basement
Deficiency Quantity	80
Quantity Uom	S.F.
Potential Action	REPLACE
Urgency of Action	PRIORITY 3
Purpose of Action	LEVEL 2
Deficiency Photo1

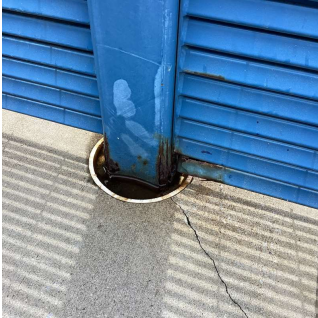
Question	Response
SITE	
FENCES	
Deficiency	WROUGHT IRON: RUST - MAJOR
Deficiency Location/Instance	94th Street
Deficiency Quantity	120
Quantity Uom	S.F.
Potential Action	REPLACE
Urgency of Action	PRIORITY 3
Purpose of Action	LEVEL 2
Deficiency Photo1
