NYC Department of Education
Building Condition Assessment Survey 2023 - 2024

Architectural Inspection

Asset: SKILLMAN HIGH SCHOOL - QUEENS, 24-30 SKILLMAN AVENUE, New York, 11101

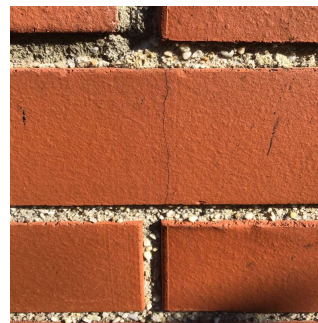
Question	Response
EXTERIOR	
EXTERIOR WALLS	
Instance on All Facades	Inspected
Instance Condition	3 - Fair
Instance Quantity	22,000
Instance Quantity Uom	S.F.
Deficiency	METAL/GLASS CURT WALL: WATER INFILTRATION IN INSTRUCTIONAL SPACE
Roof Plan reference	<p>Q667</p>  
Elevation	 
Deficiency Quantity	100
Quantity Uom	S.F.
Potential Action	REPAIR
Urgency of Action	PRIORITY 5
Purpose of Action	LEVEL 4
Deficiency Photo1	 
Violations	Facade A - Stair A/2 35582124M
Deficiency	BRICK: MINOR CRACKS AND SPALLING

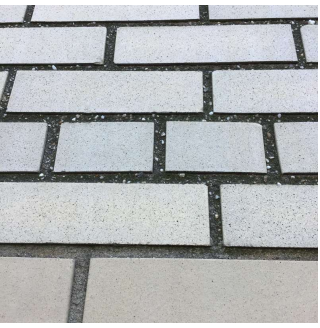
Question	Response
EXTERIOR	
EXTERIOR WALLS	
Urgency of Action	PRIORITY 3
Purpose of Action	LEVEL 2
Deficiency Photo1	No photo recorded
Violations	No violations recorded.
Deficiency	BRICK: DETERIORATED JOINTS
Roof Plan reference	<p>Q667</p>

Deficiency Quantity	5,000
Quantity Uom	S.F.
Potential Action	REPOINT
Urgency of Action	PRIORITY 3
Purpose of Action	LEVEL 2
Deficiency Photo1

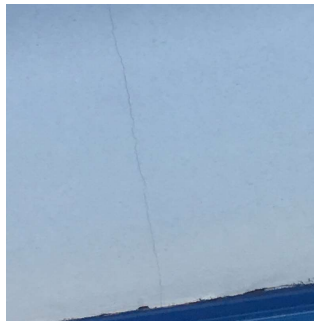
Facade B

Violations	<p>Facade B</p> <p>No violations recorded.</p>
EXTERIOR SOFFITS	
Condition	Inspected
Deficiency	2 - Between Good and Fair
	CONCRETE: MINOR CRACKS/SPALLING

REPAIR

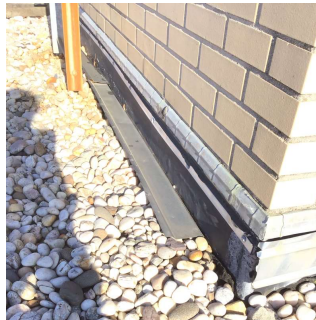
Roof 1
 No violations recorded.

Installation Year	2005
Source of Installation	Custodial Staff
Deficiency	IRMA: FLASHING: CAP FLASHING MISSING
Roof Plan reference	Q667

30
 L.F.
 INSTALL NEW
 PRIORITY 4
 LEVEL 2

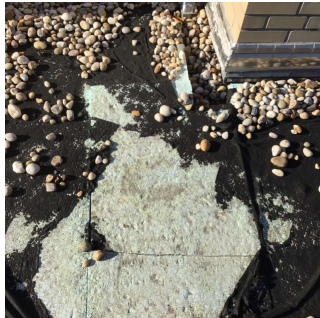
Deficiency	IRMA: ROOFING: DAMAGED INSULATION
Roof Plan reference	Q667

30
 S.F.
 REPLACE
 PRIORITY 4
 LEVEL 2

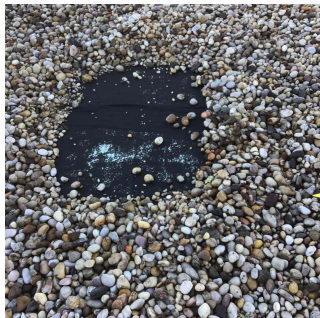
Violations	Roof 1 No violations recorded.
Deficiency	IRMA: ROOFING: LOSS OF GRAVEL
Roof Plan reference	Q667

Deficiency Quantity	200
Quantity Uom	S.F.
Potential Action	MAINTENANCE
Urgency of Action	PRIORITY 3
Purpose of Action	LEVEL 2
Deficiency Photo1

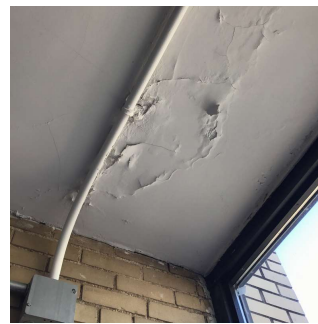
BH1
35674887Z

Violations	Roof 1 No violations recorded.
ROOFING DRAINS	Inspected
Condition	2 - Between Good and Fair
Deficiency	No deficiencies recorded
Specialties	Inspected
BULKHEAD/PENTHOUSE	Inspected
Condition	4 - Between Fair and Poor
Deficiency	BULKHEAD/PENTHOUSE CEILING: PLASTER DAMAGED/DETERIORATED

Q667
30
S.F.
REPLACE
PRIORITY 4
LEVEL 4

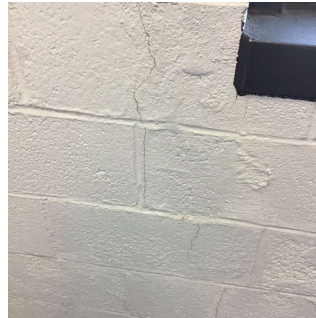
BH3

BULKHEAD/PENTHOUSE WALLS/INTERIOR: CMU
CRACKS/SPALLING

Q667
10
S.F.
REPLACE
PRIORITY 3
LEVEL 2

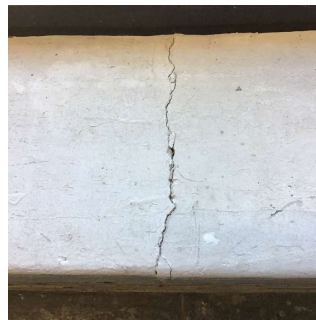
BH1

BULKHEAD/PENTHOUSE WINDOWS: AIR/WATER INFILTRATION WITH DAMAGED TRIM OR SILLS

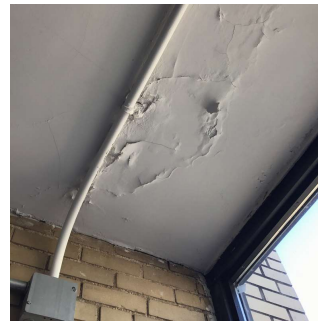
BH1
35674887Z

BULKHEAD/PENTHOUSE ROOF: MAJOR LEAKAGE

200
S.F.
REPLACE
PRIORITY 5
LEVEL 4

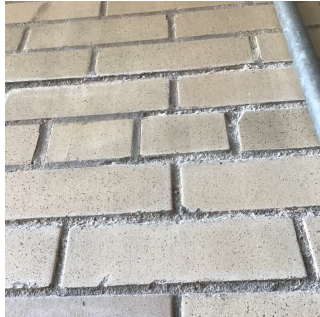
BULKHEAD/PENTHOUSE WALLS/INTERIOR: BRICK DETERIORATED JOINTS

40
S.F.
REPOINT
PRIORITY 3
LEVEL 2

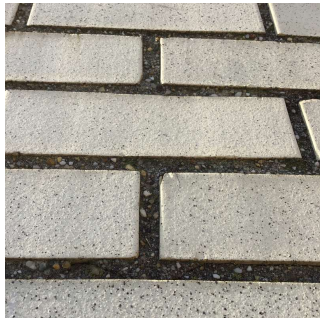
Violations	BH1 No violations recorded.
Deficiency	BULKHEAD/PENTHOUSE WALLS/EXTERIOR: DETERIORATED JOINTS
Roof Plan reference	Q667

Deficiency Quantity	40
Quantity Uom	S.F.
Potential Action	REPOINT
Urgency of Action	PRIORITY 3
Purpose of Action	LEVEL 2
Deficiency Photo1

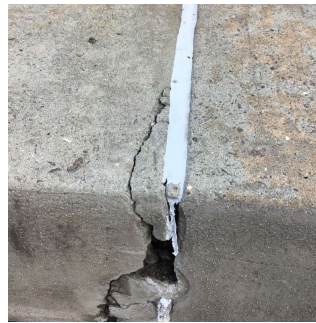
Facade A

CAST IN PLACE CONCRETE: CRACKS/SPALLING - MAJOR

50
S.F.
REPLACE
PRIORITY 4
LEVEL 2

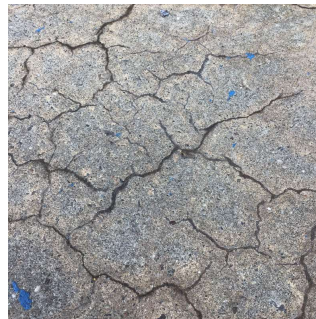
Facade A

CONCRETE: CRACKS/SPALLING - MINOR

30

REPAIR

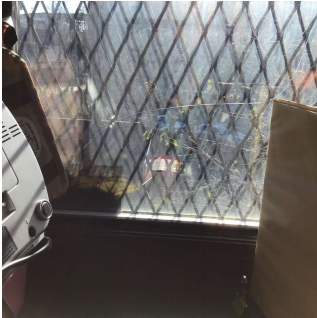
Question	Response
EXTERIOR	
STAIRS/RAMPS: EXTERIOR	
STAIRS/RAMPS	
RooF Plan reference	
Deficiency Quantity	40
Quantity Uom	S.F.
Potential Action	REPLACE
Urgency of Action	PRIORITY 4
Purpose of Action	LEVEL 2
Deficiency Photo1	
Violations	Facade C No violations recorded.
WINDOWS	Inspected
Replacement Quantity	3,000
Replacement Uom	S.F.
EXTERIOR GUARDS	Inspected
Condition	2 - Between Good and Fair
Deficiency	No deficiencies recorded
LINTELS	Inspected
Condition	2 - Between Good and Fair
Deficiency	No deficiencies recorded
WINDOWS	Inspected
Material Type(s)	Aluminum
Instance on Aluminum - Other: All Facades	Inspected
Instance Condition	3 - Fair
Instance Quantity	3,000
Instance Quantity Uom	S.F.
Are these windows insulated	Yes
Installation Year	2005
Source of Installation	Custodial Staff
Deficiency	ALUMINUM - OTHER: BROKEN PANE

Deficiency Quantity	30
Quantity Uom	S.F.
Potential Action	MAINTENANCE
Urgency of Action	PRIORITY 3
Purpose of Action	LEVEL 2
Deficiency Photo1

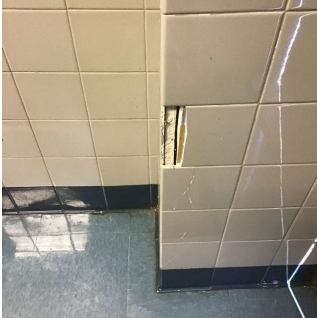
Question	Response
INTERIOR	
CLASSROOMS/CORRIDORS/ADMIN SPACES	
Walls	Inspected
Condition	2 - Between Good and Fair
Deficiency	CERAMIC TILE: BROKEN/ MISSING
Deficiency Location/Instance	Near Exit 7
Deficiency Quantity	10
Quantity Uom	S.F.
Potential Action	REPLACE
Urgency of Action	PRIORITY 3
Purpose of Action	LEVEL 2
Deficiency Photo1

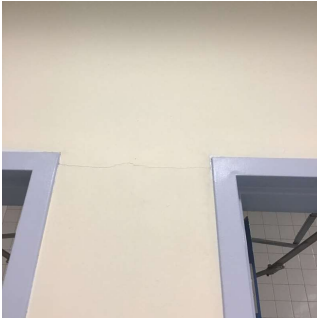
Violations	Near Exit 7 No violations recorded.
Deficiency	GYPSUM BOARD: DETERIORATED
Deficiency Location/Instance	Rooms 114, 204, Corridor near Rooms 103, 114, 226, and others.
Deficiency Quantity	200
Quantity Uom	S.F.
Potential Action	REPLACE
Urgency of Action	PRIORITY 3
Purpose of Action	LEVEL 2
Deficiency Photo1

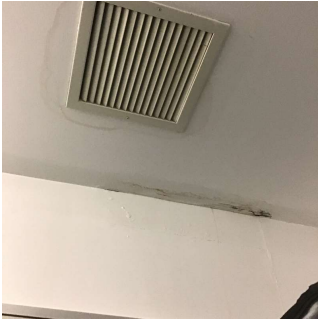
Instance on 1st Floor	Inspected
Condition	2 - Between Good and Fair
Deficiency	GYPSUM BOARD: DAMAGED/DETERIORATED
Deficiency Location/Instance	Room 127
Deficiency Quantity	10
Quantity Uom	S.F.
Potential Action	REPLACE
Urgency of Action	PRIORITY 3
Purpose of Action	LEVEL 2
Deficiency Photo1

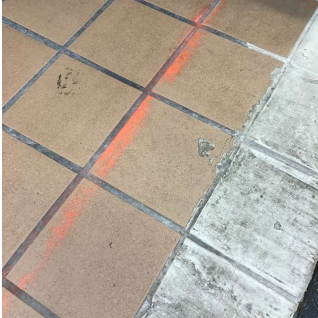
Instance on 1st Floor	Inspected
Condition	2 - Between Good and Fair
Deficiency	QUARRY TILE: BROKEN/MISSING TILES
Deficiency Location/Instance	Near Entrance, Office
Deficiency Quantity	10
Quantity Uom	S.F.
Potential Action	REPLACE
Urgency of Action	PRIORITY 3
Purpose of Action	LEVEL 2
Deficiency Photo1

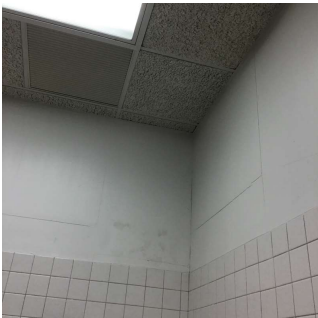
Question	Response
INTERIOR	
KITCHEN	Inspected
Floor Finish	
	Near Office
Violations	No violations recorded.
Walls	
Instance on 1st Floor	Inspected
Condition	3 - Fair
Deficiency	GYP SUM BOARD: DETERIORATED
Deficiency Location/Instance	Storage Room, Office, Room 127
Deficiency Quantity	60
Quantity Uom	S.F.
Potential Action	REPLACE
Urgency of Action	PRIORITY 3
Purpose of Action	LEVEL 2
Deficiency Photo1

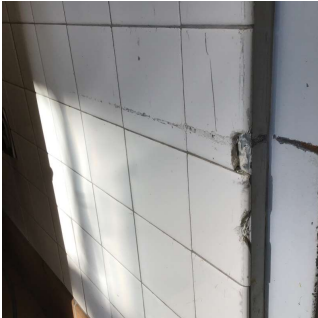
Storage Room
Violations	No violations recorded.
Deficiency	CERAMIC TILE: BROKEN/ MISSING
Deficiency Location/Instance	Near Entrance, Exit
Deficiency Quantity	10
Quantity Uom	S.F.
Potential Action	REPLACE
Urgency of Action	PRIORITY 3
Purpose of Action	LEVEL 2
Deficiency Photo1

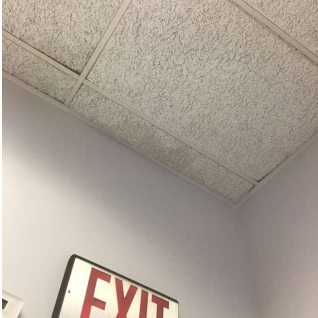
Question	Response
INTERIOR	
LIBRARY	
Ceiling	
Instance on Room 110 (600 SF)	Inspected
Condition	2 - Between Good and Fair
Deficiency	ACOUSTIC TILES: DAMAGED/MISSING
Deficiency Location/Instance	Near Entrance
Deficiency Quantity	10
Quantity Uom	S.F.
Potential Action	REPLACE
Urgency of Action	PRIORITY 3
Purpose of Action	LEVEL 2
Deficiency Photo1

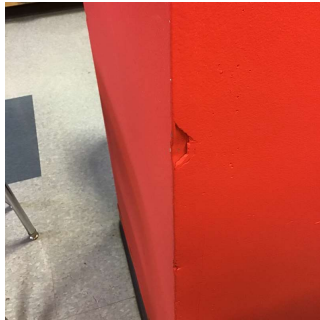
Question	Response
INTERIOR	
LIBRARY	
Walls	
Condition	2 - Between Good and Fair
Deficiency	GYPSUM BOARD: DETERIORATED
Deficiency Location/Instance	Column
Deficiency Quantity	10
Quantity Uom	S.F.
Potential Action	REPLACE
Urgency of Action	PRIORITY 3
Purpose of Action	LEVEL 2
Deficiency Photo1

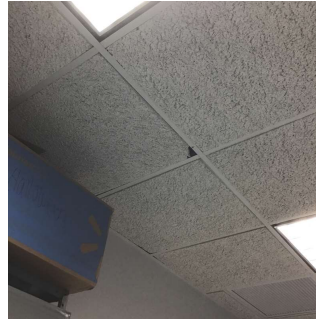
Violations	Near Room 122A No violations recorded.
Instance on 2nd Floor	Inspected
Condition	2 - Between Good and Fair
Deficiency	ACOUSTIC TILES: DAMAGED/MISSING

Deficiency Location/Instance	Room 222A
Deficiency Quantity	10
Quantity Uom	S.F.
Potential Action	REPLACE
Urgency of Action	PRIORITY 3
Purpose of Action	LEVEL 2
Deficiency Photo1

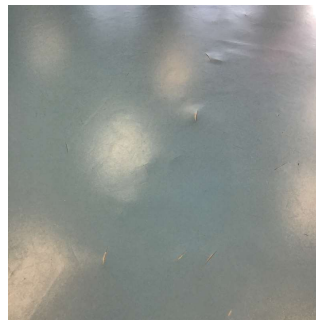
Near Room 122A

Instance on 1st Floor	Inspected
Condition	2 - Between Good and Fair
Deficiency	RUBBER MATTING: WORN/DETERIORATED
Deficiency Location/Instance	Near Room 122A, Center, Windows
Deficiency Quantity	100
Quantity Uom	S.F.
Potential Action	REPLACE
Urgency of Action	PRIORITY 3
Purpose of Action	LEVEL 2
Deficiency Photo1

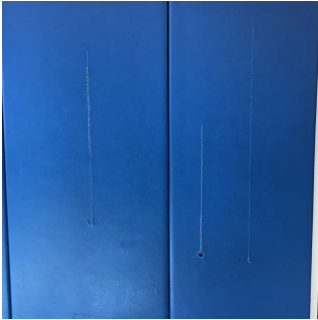
Question	Response
INTERIOR	
MULTI-PURPOSE ROOM	
Walls	
Violations	No violations recorded.
Instance on 1st Floor	Inspected
Condition	3 - Fair
Deficiency	WALL PADDING: DETERIORATED
Deficiency Location/Instance	Near Room 122A, Columns, Entrance
Deficiency Quantity	240
Quantity Uom	S.F.
Potential Action	REPLACE
Urgency of Action	PRIORITY 3
Purpose of Action	LEVEL 2
Deficiency Photo1

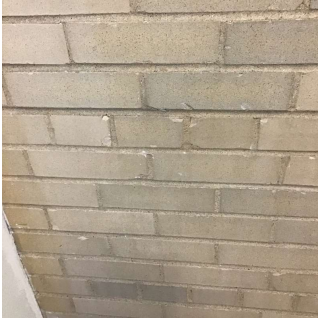
Question	Response
INTERIOR	
STAIRS/RAMPS: INTERIOR	
Walls	Inspected
Condition	2 - Between Good and Fair
Deficiency	BRICK: CRACKS/SPALLING
Deficiency Location/Instance	Stair A/1
Deficiency Quantity	10
Quantity Uom	S.F.
Potential Action	REPLACE
Urgency of Action	PRIORITY 3
Purpose of Action	LEVEL 2
Deficiency Photo1

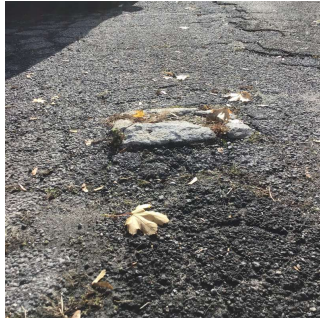
No	Tripping Hazard	damaged pavement is a potential tripping hazard.	SITE PAVING Student Non-Use Concrete	Near Entrance 25th Street	Vinny Casella	Handyman

Near 49th Avenue
Violations	No violations recorded.
Concrete	Inspected
Condition	3 - Fair
Deficiency	HEAVING
Deficiency Location/Instance	Near Entrance 25th Street
Deficiency Quantity	10
Quantity Uom	S.F.
Potential Action	REPLACE
Urgency of Action	PRIORITY 5
Purpose of Action	LEVEL 6
Deficiency Photo1

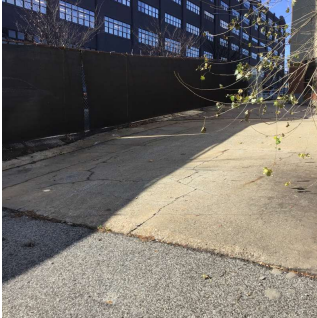
Near Entrance 25th Street
Violations	No violations recorded.
Deficiency	DAMAGED/DETERIORATED/MISSING SECTIONS
Deficiency Location/Instance	Ramp Near Front Parking Lot
Deficiency Quantity	200
Quantity Uom	S.F.
Potential Action	REPLACE
Urgency of Action	PRIORITY 3
Purpose of Action	LEVEL 2

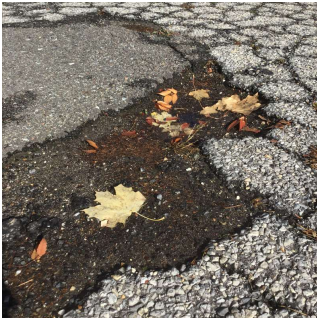
No	Tripping Hazard	Severely damaged asphalt is a potential tripping hazard	SITE PAVING Student Use Asphalt	Near Playground	Vinny Casella	Handyman

Violations	Ramp Near Front Parking Lot No violations recorded.
Pavers	Does not Exist
Student Use	Inspected
Gravel Exists?	No
Asphalt	Inspected
Condition	5 - Poor
Deficiency	POTHOLES
Deficiency Location/Instance	Near Playground
Deficiency Quantity	20
Quantity Uom	S.F.
Potential Action	REPAIR
Urgency of Action	PRIORITY 5
Purpose of Action	LEVEL 6
Deficiency Photo1

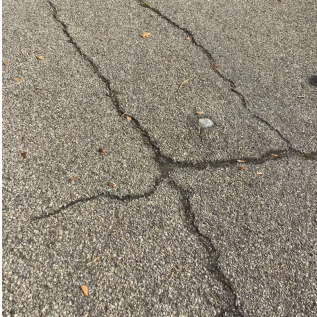
Violations	Near Playground No violations recorded.
Deficiency	CRACKS - MAJOR
Deficiency Location/Instance	Near Exits 3, 4, 5, Playground
Deficiency Quantity	10,000
Quantity Uom	S.F.
Potential Action	REPLACE
Urgency of Action	PRIORITY 3
Purpose of Action	LEVEL 2

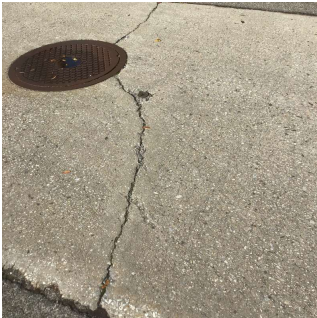
Violations	Near Exits 4 No violations recorded.
Concrete	Inspected
Condition	3 - Fair
Deficiency	DAMAGED/DETERIORATED/MISSING SECTIONS
Deficiency Location/Instance	Near Exit 3
Deficiency Quantity	50
Quantity Uom	S.F.
Potential Action	REPLACE
Urgency of Action	PRIORITY 3
Purpose of Action	LEVEL 2
Deficiency Photo1

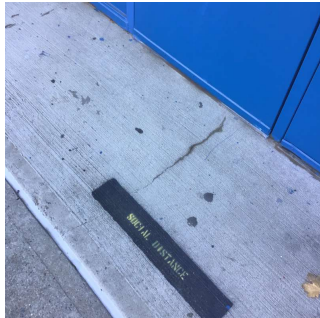
Violations	Near Exit 8 No violations recorded.
Concrete	Inspected
Condition	3 - Fair
Deficiency	DAMAGED/DETERIORATED/MISSING SECTIONS
Deficiency Location/Instance	Near Exit 1
Deficiency Quantity	50
Quantity Uom	S.F.
Potential Action	REPLACE
Urgency of Action	PRIORITY 3
Purpose of Action	LEVEL 2
Deficiency Photo1

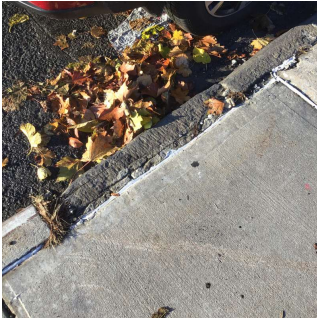
Violations	49th Avenue No violations recorded.
Concrete	Inspected
Condition	4 - Between Fair and Poor
Deficiency	DAMAGED CURBS
Deficiency Location/Instance	49th Avenue, Skillman Avenue
Deficiency Quantity	550
Quantity Uom	L.F.
Potential Action	REPLACE
Urgency of Action	PRIORITY 3
Purpose of Action	LEVEL 2
Deficiency Photo1
