**NYC Department of Education
Building Condition Assessment Survey 2023 - 2024**

Architectural Inspection

Q680

Asset: YOUNG WOMENS' LEADERSHIP SCHOOL - QUEENS, 150-91 87 ROAD, New York, 11432

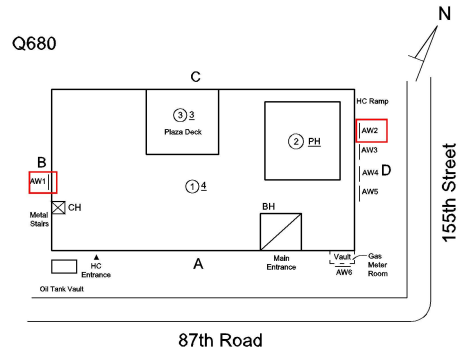
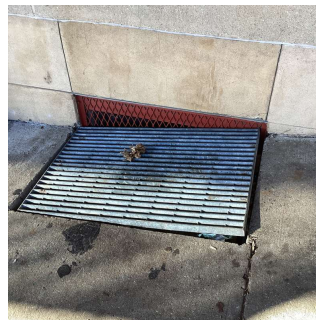
Facade D - AW2

AREAWAY GRATINGS: MAJOR RUSTING / OR BROKEN

20
S.F.
REPLACE
PRIORITY 4
LEVEL 2

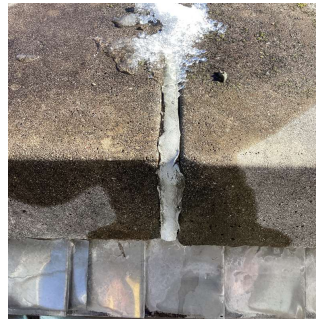
Roof 1
No violations recorded.

CAST STONE: DETERIORATED TRANSVERSE JOINTS

20
L.F.
MAINTENANCE
PRIORITY 3
LEVEL 2

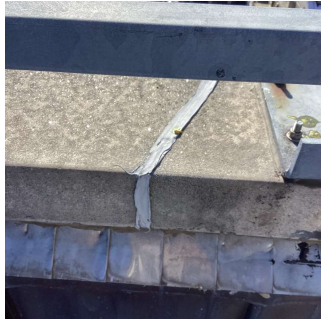
CAST STONE: CRACKED/BROKEN PIECES

10
L.F.
REPLACE-IN-KIND
PRIORITY 4
LEVEL 2

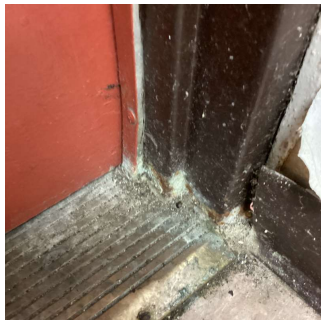
Violations	Roof 1 No violations recorded.
CORNICE	Does not Exist
DOORS	Inspected
DOORS AND FRAMES	Inspected
Condition	3 - Fair
Deficiency	METAL: DETERIORATED DOOR AND FRAME - MINOR DETERIORATION
Roof Plan reference

<p>Q680</p> <p>87th Road</p> <p>155th Street</p>
Deficiency Quantity	3
Quantity Uom	EACH
Potential Action	MAINTENANCE
Urgency of Action	PRIORITY 3
Purpose of Action	LEVEL 2
Deficiency Photo1

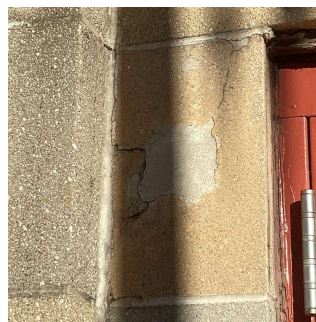
Facade A

Deficiency
 Roof Plan reference

200
S.F.
RESTITCH
PRIORITY 3
LEVEL 2

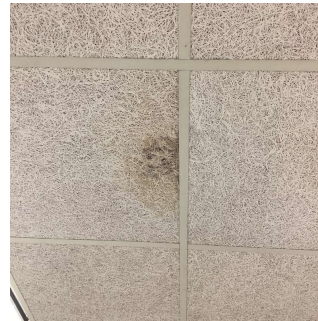
Roof 1 - Room 418, also Room 421A

Source of Installation	Custodial Staff
Deficiency	BUILT-UP: ROOFING: MAJOR ACTIVE ROOF LEAKS IN INSTRUCTIONAL SPACE
Roof Plan reference

Deficiency Quantity	200
Quantity Uom	S.F.
Potential Action	REPLACE ROOFING WITHOUT MAJOR EQUIPMENT REMOVAL

PRIORITY 5
 LEVEL 2

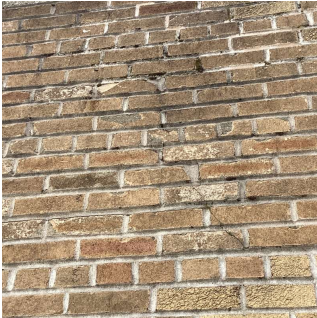
Violations	Roof 1 No violations recorded.
Specialties	Inspected
BULKHEAD/PENTHOUSE	Inspected
Condition	3 - Fair
Deficiency	BULKHEAD/PENTHOUSE WALLS/EXTERIOR: CRACKS/SPALLING - MINOR
Roof Plan reference

Deficiency Quantity	10
Quantity Uom	S.F.
Potential Action	REPAIR
Urgency of Action	PRIORITY 3
Purpose of Action	LEVEL 2
Deficiency Photo1

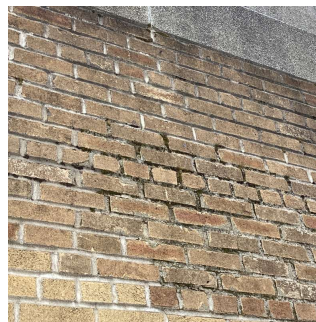
Violations	Roof 1 - Bulkhead No violations recorded.
Deficiency	BULKHEAD/PENTHOUSE WALLS/EXTERIOR: DETERIORATED JOINTS

30
S.F.
REPOINT
PRIORITY 3
LEVEL 2

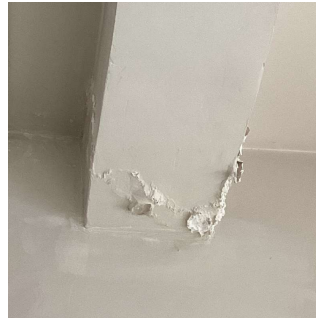
Roof 1 - Bulkhead

Deficiency	BULKHEAD/PENTHOUSE CEILING: PLASTER DAMAGED/DETERIORATED
------------	---

30
S.F.
REPLACE
PRIORITY 3
LEVEL 2

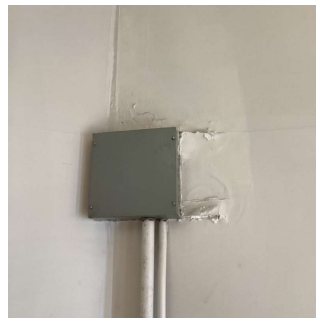
Roof 1 - Bulkhead

BULKHEAD/PENTHOUSE WALLS/INTERIOR: GYPSUM BOARD DAMAGED/DETERIORATED

REPLACE

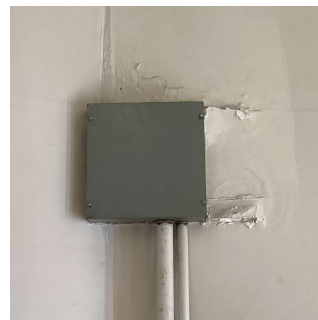
Roof 1 - Bulkhead

BULKHEAD/PENTHOUSE WALLS/EXTERIOR: WATER INFILTRATION

50
S.F.
REPAIR
PRIORITY 5
LEVEL 2

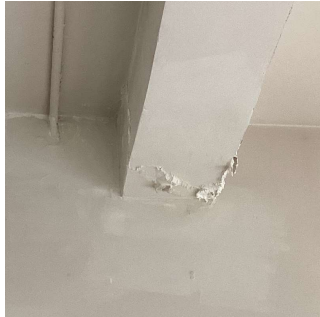
BULKHEAD/PENTHOUSE ROOF: MAJOR LEAKAGE

100
S.F.
REPLACE
PRIORITY 5
LEVEL 2

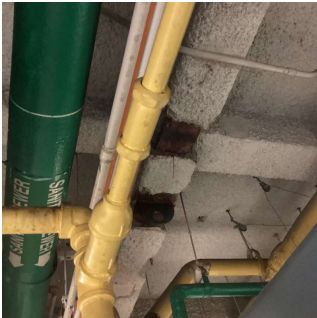
INTERIOR	Inspected
POOLS	Does not Exist
STRUCTURAL	Inspected
COLUMNS/BEAMS/BEARING WALLS	Inspected
Condition	3 - Fair
Deficiency	STEEL COLUMNS/BEAMS: DETERIORATED CONCRETE FIREPROOFING
Deficiency Location/Instance	Basement - Boiler Room

Question	Response
INTERIOR	
STRUCTURAL	
COLUMNS/BEAMS/BEARING WALLS	
Deficiency Quantity	10
Quantity Uom	S.F.
Potential Action	REPLACE
Urgency of Action	PRIORITY 3
Purpose of Action	LEVEL 5
Deficiency Photo1

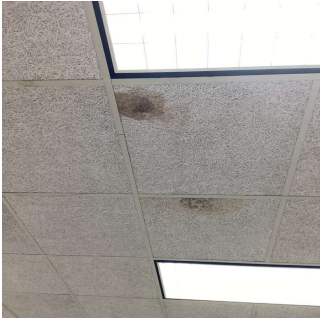
Violations	Room 418 No violations recorded.
Deficiency	TECTUM: DAMAGED/MISSING - ACTIVE LEAK

Deficiency Location/Instance	Rooms 316, 418, 421A

Question	Response
INTERIOR	
CLASSROOMS/CORRIDORS/ADMIN SPACES	
Ceiling	
Deficiency Quantity	60
Quantity Uom	S.F.
Potential Action	REPLACE
Urgency of Action	PRIORITY 5
Purpose of Action	LEVEL 2
Deficiency Photo1

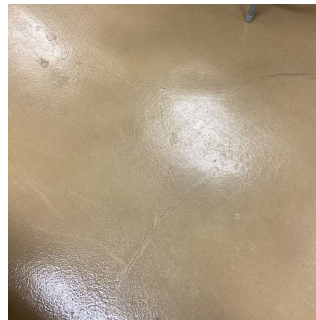
Room 322

EPOXY FLOORING: CRACKS/SPALLING

REPLACE

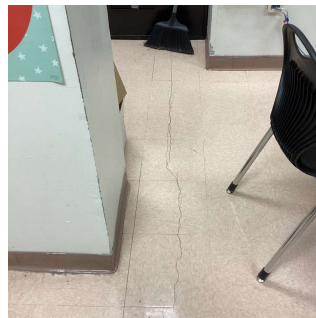
VINYL TILES: DETERIORATED SUBSTRATE

REPLACE

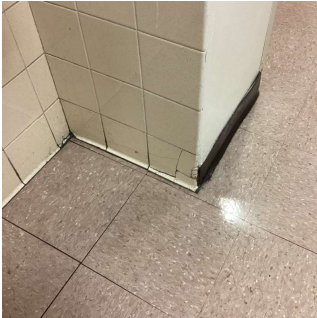
Violations	Room 211 No violations recorded.
Walls	Inspected
Condition	2 - Between Good and Fair
Deficiency	CERAMIC TILE: BROKEN/ MISSING
Deficiency Location/Instance	Corridor near Room 217
Deficiency Quantity	10
Quantity Uom	S.F.
Potential Action	REPLACE
Urgency of Action	PRIORITY 3
Purpose of Action	LEVEL 2
Deficiency Photo1

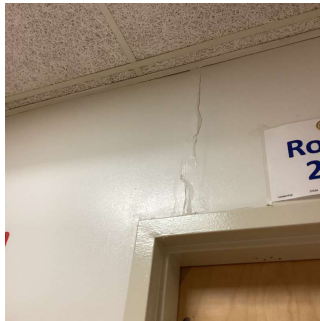
Violations	Corridor near Room 217 No violations recorded.
Deficiency	GYPSON BOARD: DETERIORATED
Deficiency Location/Instance	Rooms 110, 114, 211, 411, Corridor near Room 213, and others.
Deficiency Quantity	200

Quantity Uom	S.F.
Potential Action	REPLACE
Urgency of Action	PRIORITY 3
Purpose of Action	LEVEL 2

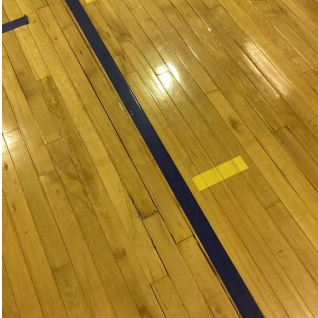
Question	Response
INTERIOR	
GYMNASIUM	
Floor Finish	
Instance on Basement	Inspected
Condition	2 - Between Good and Fair
Deficiency	WOOD: DAMAGED/DETERIORATED
Deficiency Location/Instance	Near Bleachers
Deficiency Quantity	20
Quantity Uom	S.F.
Potential Action	REPLACE
Urgency of Action	PRIORITY 3
Purpose of Action	LEVEL 2
Deficiency Photo1

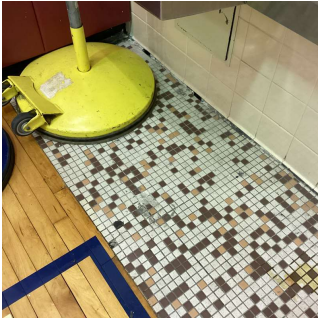
Violations	Near Bleachers No violations recorded.
Deficiency	CERAMIC TILE: BROKEN/MISSING TILES
Deficiency Location/Instance	Drinking Fountain Area
Deficiency Quantity	10
Quantity Uom	S.F.
Potential Action	REPLACE
Urgency of Action	PRIORITY 3
Purpose of Action	LEVEL 2
Deficiency Photo1

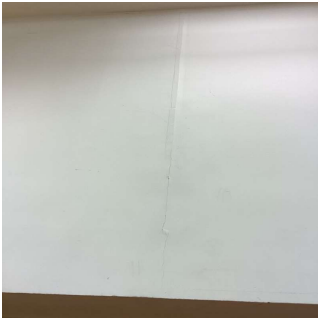
Question	Response
INTERIOR	
GYMNASIUM	
Walls	
Instance on Basement	Inspected
Condition	2 - Between Good and Fair
Deficiency	GYPSUM BOARD: DETERIORATED
Deficiency Location/Instance	Near Entrance, Bleachers Area, Exit, Windows, B10
Deficiency Quantity	100
Quantity Uom	S.F.
Potential Action	REPLACE
Urgency of Action	PRIORITY 3
Purpose of Action	LEVEL 2
Deficiency Photo1

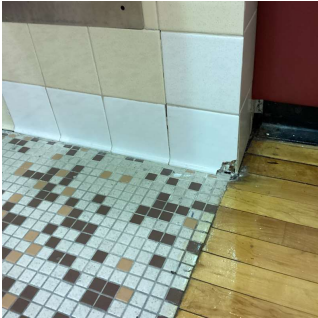
Violations	Near Entrance No violations recorded.
Deficiency	CERAMIC TILE: BROKEN/ MISSING
Deficiency Location/Instance	Drinking Fountain Area
Deficiency Quantity	10
Quantity Uom	S.F.
Potential Action	REPLACE
Urgency of Action	PRIORITY 3
Purpose of Action	LEVEL 2
Deficiency Photo1
