NYC Department of Education
Building Condition Assessment Survey 2023 - 2024

Architectural Inspection

Q686

Asset: METROPOLITAN AVENUE CAMPUS - QUEENS, 91-30 METROPOLITAN AVENUE, New York, 11375

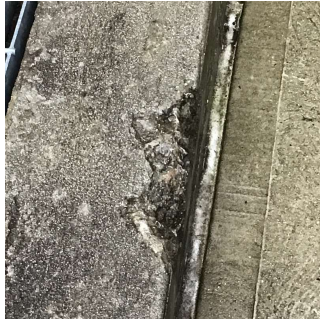
Question	Response
Architectural	
EXTERIOR	Inspected
AREAWAY	Inspected
Instance on AW1-AW2	Inspected
Instance Condition	2 - Between Good and Fair
Instance Quantity	2
Instance Quantity Uom	EACH
Deficiency	AREAWAY WALLS: CRACKS AND SPALLING
Roof Plan reference	
Deficiency Quantity	20
Quantity Uom	S.F.
Potential Action	REPAIR
Urgency of Action	PRIORITY 3
Purpose of Action	LEVEL 2

Violations	Facade A -AW2 No violations recorded.
AWNINGS AND CANOPIES	
Condition	Inspected 3 - Fair
Deficiency	CONCRETE: WATER PENETRATION
Roof Plan reference

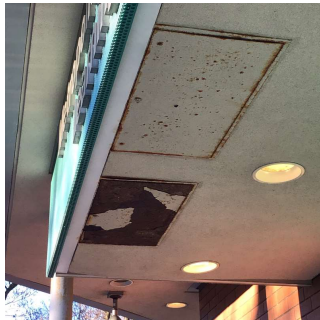
Deficiency Quantity	30
Quantity Uom	S.F.
Potential Action	REPAIR
Urgency of Action	PRIORITY 5
Purpose of Action	LEVEL 2
Deficiency Photo1

Violations	Facade C No violations recorded.
CHIMNEY	
Material Type(s)	Inspected Metal
Condition	2 - Between Good and Fair
Deficiency	No deficiencies recorded
COPING	
Condition	Inspected 3 - Fair
Deficiency	CAST STONE: CRACKED/BROKEN PIECES

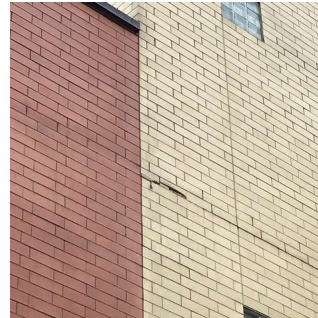
Facade D

BRICK: MAJOR / THRU CRACKS

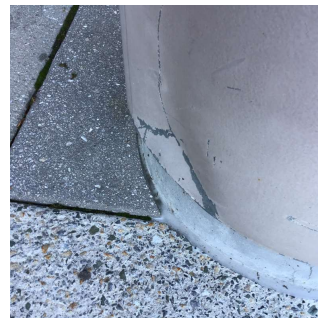
Facade B

REPLACE

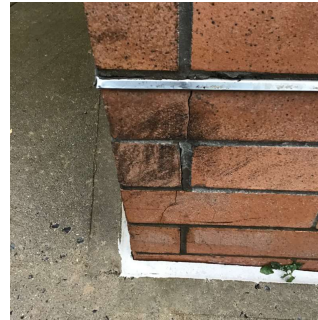
Facade D

BRICK: CRACKS/DISPLACED/SPALLED BRICK AT BUILDING CORNERS

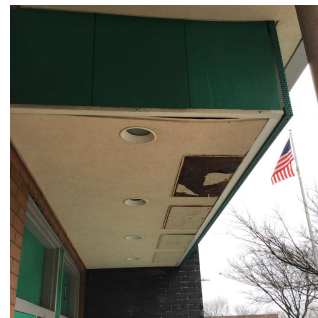
Facade C

STUCCO/PLASTER: MAJOR CRACKS/SPALLING

REPLACE

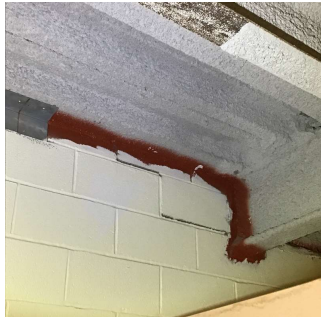
Condition	2 - Between Good and Fair
Deficiency	BULKHEAD/PENTHOUSE WALLS/INTERIOR: CMU DETERIORATED JOINTS

Deficiency Quantity	20
Quantity Uom	S.F.
Potential Action	REPOINT
Urgency of Action	PRIORITY 3
Purpose of Action	LEVEL 2

Violations	BH1 No violations recorded.
CUPOLA/ SPIRES/ TOWERS	Does not Exist
DORMER	Does not Exist
DUNNAGE STEEL	Inspected
Condition	2 - Between Good and Fair
Deficiency	No deficiencies recorded
SKYLIGHT/ROOF VENT	Inspected
Material Type(s)	Glass
Condition	2 - Between Good and Fair
Deficiency	No deficiencies recorded
ROOF/GRAVITY TANK	Does not Exist
STAIRS/RAMPS: EXTERIOR	Does not Exist
WINDOWS	Inspected
Replacement Quantity	12,000
Replacement Uom	S.F.
EXTERIOR GUARDS	Inspected
Condition	2 - Between Good and Fair
Deficiency	No deficiencies recorded
LINTELS	Inspected
Condition	2 - Between Good and Fair
Deficiency	No deficiencies recorded
WINDOWS	Inspected
Material Type(s)	Aluminum
Instance on Aluminum - Other: All Facades	Inspected
Instance Condition	3 - Fair
Instance Quantity	12,000
Instance Quantity Uom	S.F.
Are these windows insulated	Yes

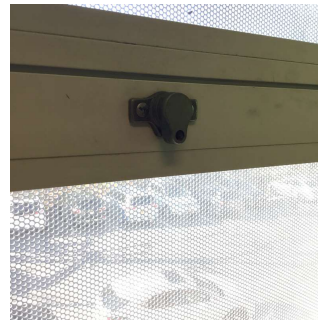
Facade D - 2nd Floor Corridor

Installation Year	2010
Source of Installation	Custodial Staff
Deficiency	ALUMINUM - OTHER: HARDWARE POOR CONDITION/MISSING

1
EACH
MAINTENANCE
PRIORITY 3
LEVEL 2

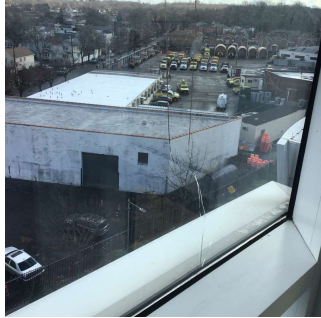
Question	Response
EXTERIOR	
WINDOWS	
WINDOWS	
Potential Action	MAINTENANCE
Urgency of Action	PRIORITY 3
Purpose of Action	LEVEL 2
Deficiency Photo1

Violations	Facade B - 5th Floor Corridor, also 3rd Floor Corridor No violations recorded.
INTERIOR	Inspected
POOLS	Does not Exist
STRUCTURAL	Inspected
COLUMNS/BEAMS/BEARING WALLS	
Condition	3 - Fair
Deficiency	STEEL COLUMNS/BEAMS: DETERIORATED/MISSING SPRAY-ON FIREPROOFING
Deficiency Location/Instance	Roof 1 - Penthouse, Stair 5/D
Deficiency Quantity	20
Quantity Uom	S.F.
Potential Action	REPLACE
Urgency of Action	PRIORITY 3
Purpose of Action	LEVEL 5
Deficiency Photo1

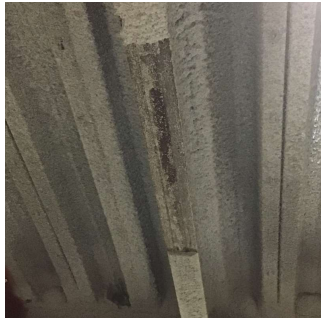
Violations	Roof 1 - Penthouse No violations recorded.
Deficiency	STEEL COLUMNS/BEAMS: MAJOR RUSTING
Deficiency Location/Instance	Facades A and C
Deficiency Quantity	20
Quantity Uom	S.F.
Potential Action	REPLACE
Urgency of Action	PRIORITY 4
Purpose of Action	LEVEL 5

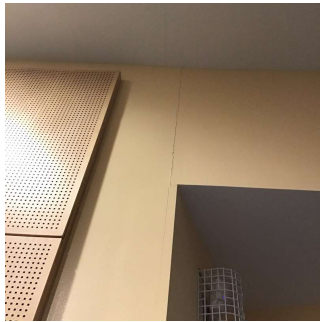
Question	Response
INTERIOR	
AUDITORIUM	
Stage	
Stage Curtains	Inspected
Instance on 1st Floor (762 Seats)	Inspected
Condition	2 - Between Good and Fair
Deficiency	No deficiencies recorded
Walls	
Instance on 1st Floor (762 Seats)	Inspected
Condition	2 - Between Good and Fair
Deficiency	GYPSUM BOARD: DETERIORATED
Deficiency Location/Instance	Near Entrance, Stage
Deficiency Quantity	20
Quantity Uom	S.F.
Potential Action	REPLACE
Urgency of Action	PRIORITY 3
Purpose of Action	LEVEL 2
Deficiency Photo1

Violations	Near Entrance No violations recorded.
Window Curtains/Shades/Blinds	
Instance on 1st Floor (762 Seats)	Does not Exist
CAFETERIA	
Instance on Basement - Staff - Room 0072	Inspected
Instance on Basement - Students - Room 0012	Inspected
Instance on Basement - Students - Room 0014	Inspected
Instance on Basement - Students - Room 0060	Inspected
Instance on Basement - Students - Room 0062	Inspected
Ceiling	
Instance on Basement - Students - Room 0012	Inspected

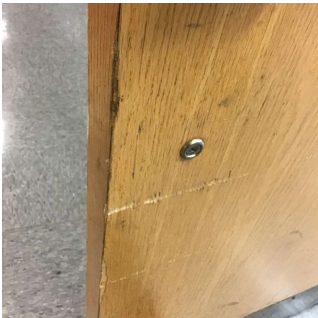
Question	Response
INTERIOR	
CAFETERIA	
Ceiling	
Violations	Near Serving Area No violations recorded.
Door(s)	
Instance on Basement - Students - Room 0012	Inspected
Condition	3 - Fair
Deficiency	WOOD: DETERIORATED DOOR
Deficiency Location/Instance	Entrance
Deficiency Quantity	1
Quantity Uom	EACH
Potential Action	MAINTENANCE
Urgency of Action	PRIORITY 3
Purpose of Action	LEVEL 2
Deficiency Photo1

Violations	Entrance No violations recorded.
Instance on Basement - Students - Room 0062	Inspected
Condition	4 - Between Fair and Poor
Deficiency	WOOD: DETERIORATED DOOR
Deficiency Location/Instance	Entrance, Connecting Cafeteria 0060
Deficiency Quantity	2
Quantity Uom	EACH
Potential Action	MAINTENANCE
Urgency of Action	PRIORITY 3
Purpose of Action	LEVEL 2
Deficiency Photo1

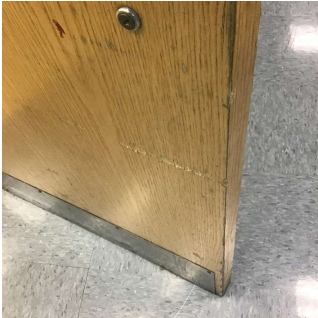
Violations	Entrance No violations recorded.
Fixed Equipment	
Instance on Basement - Students - Room 0014	Does not Exist
Instance on Basement - Staff - Room 0072	Does not Exist

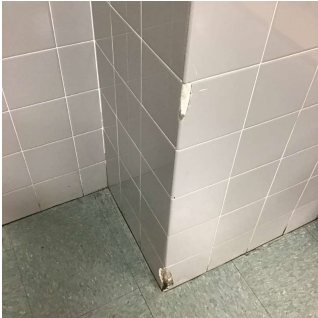
Question	Response
INTERIOR	
CAFETERIA	
Walls	
Violations	Near Entrance No violations recorded.
Instance on Basement - Students - Room 0060	Inspected
Condition	2 - Between Good and Fair
Deficiency	CERAMIC TILE: BROKEN/ MISSING
Deficiency Location/Instance	Columns
Deficiency Quantity	10
Quantity Uom	S.F.
Potential Action	REPLACE
Urgency of Action	PRIORITY 3
Purpose of Action	LEVEL 2
Deficiency Photo1

Violations	Columns No violations recorded.
Deficiency	GYPSUM BOARD: DETERIORATED
Deficiency Location/Instance	Near Serving Area
Deficiency Quantity	10
Quantity Uom	S.F.
Potential Action	REPLACE
Urgency of Action	PRIORITY 3
Purpose of Action	LEVEL 2
Deficiency Photo1

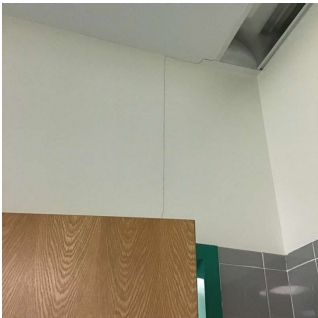
Violations	Near Serving Area No violations recorded.
Instance on Basement - Students - Room 0062	Inspected
Condition	2 - Between Good and Fair
Deficiency	CERAMIC TILE: BROKEN/ MISSING
Deficiency Location/Instance	Near Serving Area, Room 0062D, Columns, Entrance.

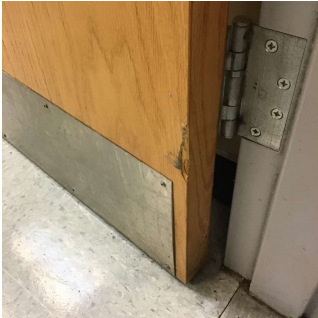
Question	Response
INTERIOR	
CLASSROOMS/CORRIDORS/ADMIN SPACES	
Ceiling	Inspected
	Room 5009
Violations	No violations recorded.
Door(s)	Inspected
Condition	3 - Fair
Deficiency	WOOD: DETERIORATED DOOR
Deficiency Location/Instance	Rooms 3110, 3077, 3009, 4011, 4068
Deficiency Quantity	5
Quantity Uom	EACH
Potential Action	MAINTENANCE
Urgency of Action	PRIORITY 3
Purpose of Action	LEVEL 2
Deficiency Photo1

Room 4011
Violations	No violations recorded.
Floor Finish	Inspected
Condition	2 - Between Good and Fair
Deficiency	RUBBER NOSING: DETERIORATED
Deficiency Location/Instance	Room 0093
Deficiency Quantity	10
Quantity Uom	L.F.
Potential Action	MAINTENANCE
Urgency of Action	PRIORITY 3
Purpose of Action	LEVEL 2
Deficiency Photo1

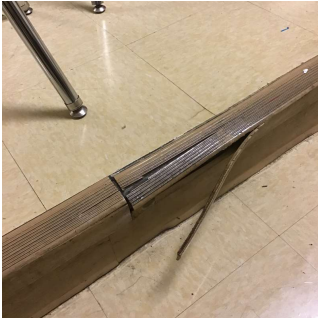
Room 0093
Violations	No violations recorded.
Deficiency	RUBBER MATTING: WORN/DETERIORATED
Deficiency Location/Instance	Room 1066
Deficiency Quantity	40
Quantity Uom	S.F.
Potential Action	REPLACE

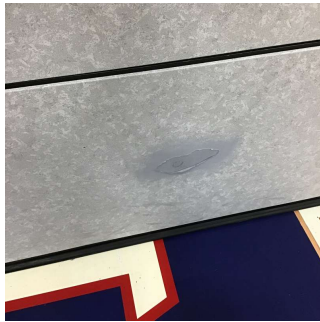
Question	Response
INTERIOR	
GYMNASIUM	
Floor Finish	
Violations	Near Sliding Folding Partition No violations recorded.
Seating	
Instance on 1st Floor	Inspected
Condition	1 - Good
Deficiency	No deficiencies recorded
Instance on 3rd Floor	Does not Exist
Sliding-folding Partition	
Instance on 1st Floor	Inspected
Condition	3 - Fair
Deficiency	MOVABLE PANELS: DAMAGED
Deficiency Location/Instance	Near Bleachers
Deficiency Quantity	80
Quantity Uom	S.F.
Potential Action	REPLACE
Urgency of Action	PRIORITY 3
Purpose of Action	LEVEL 2
Deficiency Photo1

Violations	Near Bleachers No violations recorded.
Stage	
Instance on 1st Floor	Does not Exist
Instance on 3rd Floor	Does not Exist
Walls	
Instance on 1st Floor	Inspected
Condition	2 - Between Good and Fair
Deficiency	GYPSUM BOARD: DETERIORATED
Deficiency Location/Instance	Room 1025A
Deficiency Quantity	10
Quantity Uom	S.F.
Potential Action	REPLACE
Urgency of Action	PRIORITY 3
Purpose of Action	LEVEL 2

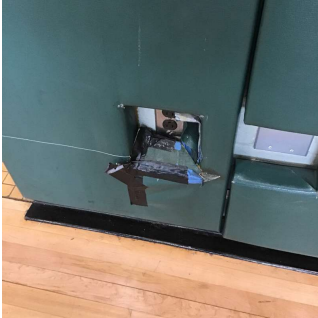
Question	Response
INTERIOR	
GYMNASIUM	
Walls	
Instance on 3rd Floor	Inspected
Condition	2 - Between Good and Fair
Deficiency	WALL PADDING: DETERIORATED
Deficiency Location/Instance	Near Entrances
Deficiency Quantity	60
Quantity Uom	S.F.
Potential Action	REPLACE
Urgency of Action	PRIORITY 3
Purpose of Action	LEVEL 2
Deficiency Photo1

Violations	Near Entrance No violations recorded.
Window Curtains/Shades/Blinds	
Instance on 3rd Floor	Does not Exist
Instance on 1st Floor	Does not Exist
INTERIOR DOOR HARDWARE	
Condition	Inspected
Deficiency	3 - Fair
INTERIOR GUARDS	
Condition	Inspected
Deficiency	2 - Between Good and Fair
KITCHEN	
Instance on Basement	Inspected
Ceiling	
Instance on Basement	Inspected
Condition	2 - Between Good and Fair
Deficiency	ACOUSTIC TILES: DAMAGED/MISSING
Deficiency Location/Instance	Room 0018E
Deficiency Quantity	10
Quantity Uom	S.F.
Potential Action	REPLACE
Urgency of Action	PRIORITY 3
Purpose of Action	LEVEL 2

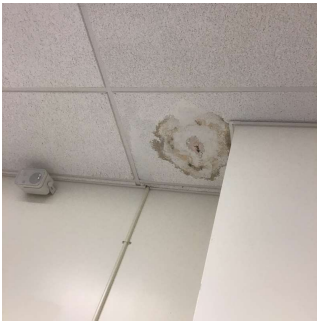
Question	Response
INTERIOR	
KITCHEN	
Ceiling	
Deficiency Photo1

Violations	Room 0018E No violations recorded.
Door(s)	
Instance on Basement	Inspected
Condition	3 - Fair
Deficiency	WOOD: DETERIORATED DOOR
Deficiency Location/Instance	Serving Area 0062B
Deficiency Quantity	1
Quantity Uom	EACH
Potential Action	MAINTENANCE
Urgency of Action	PRIORITY 3
Purpose of Action	LEVEL 2
Deficiency Photo1

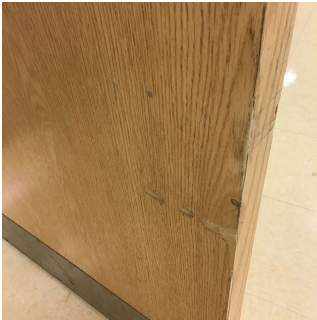
Violations	Serving Area 0062B No violations recorded.
Floor Finish	
Instance on Basement	Inspected
Condition	2 - Between Good and Fair
Deficiency	No deficiencies recorded
Walls	
Instance on Basement	Inspected
Condition	2 - Between Good and Fair
Deficiency	GYPSON BOARD: DETERIORATED
Deficiency Location/Instance	Room 00181
Deficiency Quantity	10
Quantity Uom	S.F.
Potential Action	REPLACE
Urgency of Action	PRIORITY 3
Purpose of Action	LEVEL 2

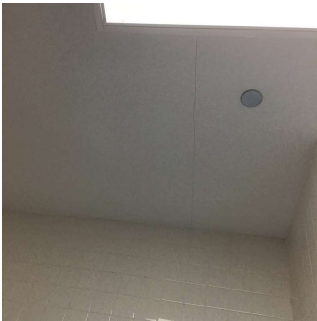
Question	Response
INTERIOR	
LOCKER ROOM	
Ceiling	
Violations	No violations recorded.
Instance on Room 1022 (440 Lockers)	Inspected
Condition	2 - Between Good and Fair
Deficiency	GYPSUM BOARD: DAMAGED/DETERIORATED
Deficiency Location/Instance	Near Entrance
Deficiency Quantity	10
Quantity Uom	S.F.
Potential Action	REPLACE
Urgency of Action	PRIORITY 3
Purpose of Action	LEVEL 2
Deficiency Photo1

Violations	No violations recorded.
Instance on Room 3078H (465 Lockers)	Inspected
Condition	2 - Between Good and Fair
Deficiency	GYPSUM BOARD: DAMAGED/DETERIORATED
Deficiency Location/Instance	Near center, Entrance.
Deficiency Quantity	10
Quantity Uom	S.F.
Potential Action	REPLACE
Urgency of Action	PRIORITY 3
Purpose of Action	LEVEL 2
Deficiency Photo1

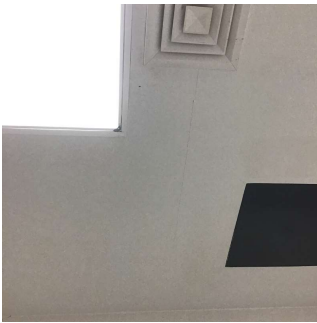
Violations	No violations recorded.
Instance on Room 3078 G (485 Lockers)	Inspected
Condition	2 - Between Good and Fair
Deficiency	GYPSUM BOARD: DAMAGED/DETERIORATED
Deficiency Location/Instance	Near center, Entrance

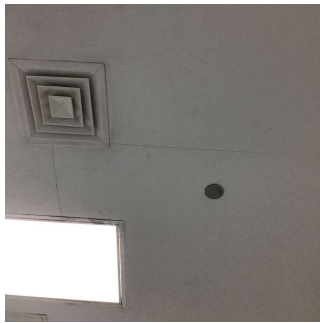
Question	Response
INTERIOR	
SHOWER ROOM	
Ceiling	
Deficiency Photo1

Violations	Near center No violations recorded.
Door(s)	
Instance on Room 3078G	Does not Exist
Instance on Room 3078H	Does not Exist
Floor Finish	
Instance on Room 3078H	Inspected
Condition	2 - Between Good and Fair
Deficiency	No deficiencies recorded
Instance on Room 3078G	Inspected
Condition	2 - Between Good and Fair
Deficiency	No deficiencies recorded
Walls	
Instance on Room 3078G	Inspected
Condition	2 - Between Good and Fair
Deficiency	No deficiencies recorded
Instance on Room 3078H	Inspected
Condition	2 - Between Good and Fair
Deficiency	No deficiencies recorded
STAIRS/RAMPS: INTERIOR	
Do Letter Stair Signs Exist?	Inspected Yes
Ceiling	
Condition	Inspected 2 - Between Good and Fair
Deficiency	GYPSUM BOARD: DAMAGED/DETERIORATED
Deficiency Location/Instance	FG/Basement, 4, N/2
Deficiency Quantity	40
Quantity Uom	S.F.
Potential Action	REPLACE
Urgency of Action	PRIORITY 3

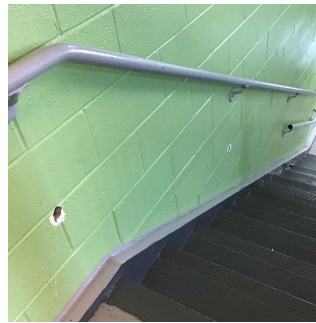
Yes	Protruding Elements	Missing Bottom Rail with a protruding Metal is a potential hazard Condition.	INTERIOR STAIRS/RAMP S: INTERIOR Railings	Stair H/4	Eric Jackson	Fireman

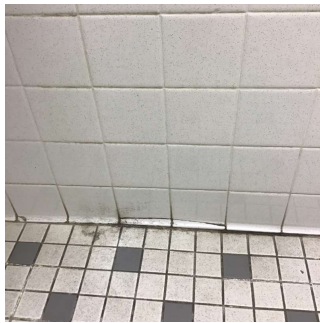
Question	Response
INTERIOR	
TOILET ROOMS - STAFF	
Walls	
Deficiency Photo1

Violations	Room 0018B - Kitchen No violations recorded.
TOILET ROOMS - STUDENTS	
Ceiling	Inspected
Condition	2 - Between Good and Fair
Deficiency	GYPSUM BOARD: DAMAGED/DETERIORATED
Deficiency Location/Instance	Rooms 4070, 4074, 5014, 5048
Deficiency Quantity	20
Quantity Uom	S.F.
Potential Action	REPLACE
Urgency of Action	PRIORITY 3
Purpose of Action	LEVEL 2
Deficiency Photo1

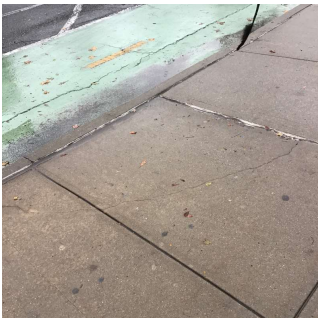
Violations	Near Exit 11 No violations recorded.
Deficiency	DAMAGED/DETERIORATED/MISSING SECTIONS
Deficiency Location/Instance	Near Metropolitan Avenue, Exit 1, Playground, mechanical Area.
Deficiency Quantity	150
Quantity Uom	S.F.
Potential Action	REPLACE
Urgency of Action	PRIORITY 3
Purpose of Action	LEVEL 2
Deficiency Photo1

Violations	Near Metropolitan Avenue No violations recorded.
Pavers	Inspected
Condition	3 - Fair
Deficiency	DAMAGED/MISSING
Deficiency Location/Instance	Near Exit 4
Deficiency Quantity	20
Quantity Uom	S.F.

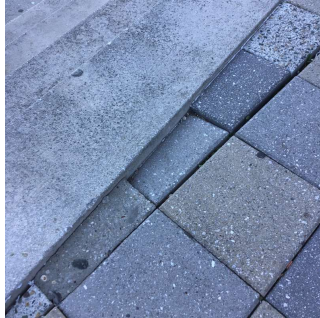
Yes	Tripping Hazard	Sinking Paver at the transition to stair is a potential tripping hazard condition.	SITE PAVING Site Sidewalks & Walkways Pavers	Near Exit 4	Eric Jackson	Fireman

Near Exit 4
Violations	No violations recorded.
Deficiency	DAMAGED/MISSING
Deficiency Location/Instance	Near Exits 4, 8, 12, Playground.
Deficiency Quantity	30
Quantity Uom	S.F.
Potential Action	REPLACE
Urgency of Action	PRIORITY 3
Purpose of Action	LEVEL 2
Deficiency Photo1

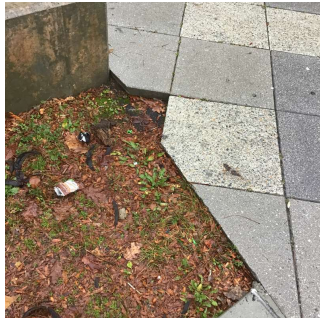
Near Exit 8
Violations	No violations recorded.
DOT Sidewalk	Inspected
Asphalt	Does not Exist
Concrete	Inspected
Condition	3 - Fair
Deficiency	DAMAGED/DETERIORATED/MISSING SECTIONS
Deficiency Location/Instance	Metropolitan Avenue
Deficiency Quantity	225
Quantity Uom	S.F.
Potential Action	REPLACE
Urgency of Action	PRIORITY 3
Purpose of Action	LEVEL 2
