NYC Department of Education
Building Condition Assessment Survey 2023 - 2024

Architectural Inspection

Asset: QUEENS GATEWAY TO HEALTH SCIENCES SECONDARY SCHOOL - QUEENS, 160-20 GOETHALS AVENUE, New York, 11432

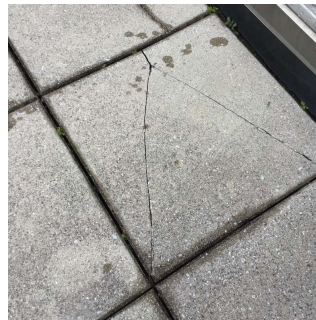
Roof 1

Deficiency	IRMA: ROOFING: DETERIORATED PAVERS WITH INTEGRAL INSULATION
------------	---

Deficiency	IRMA: ROOFING: DAMAGED INSULATION
------------	-----------------------------------

Potential Action	REPLACE
------------------	---------

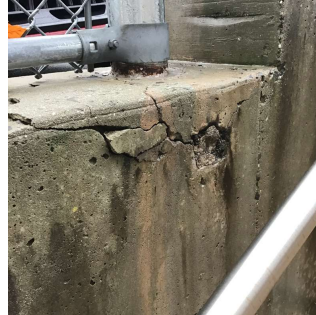
Facade B

Violations	Roof 3 No violations recorded.
ROOFING DRAINS	Inspected
Condition	2 - Between Good and Fair
Deficiency	No deficiencies recorded
Specialties	Inspected
BULKHEAD/PENTHOUSE	Inspected
Condition	2 - Between Good and Fair
Deficiency	No deficiencies recorded
CUPOLA/ SPIRES/ TOWERS	Does not Exist
DORMER	Does not Exist
DUNNAGE STEEL	Does not Exist
SKYLIGHT/ROOF VENT	Inspected
Material Type(s)	Glass
Condition	2 - Between Good and Fair
Deficiency	No deficiencies recorded
ROOF/GRAVITY TANK	Does not Exist
STAIRS/RAMPS: EXTERIOR	Inspected
BUILDING CHEEK/FLANK WALLS	Inspected
Condition	3 - Fair
Deficiency	CAST IN PLACE CONCRETE: CRACKS/SPALLING - MAJOR
Roof Plan reference

Deficiency Quantity	10
Quantity Uom	S.F.
Potential Action	REPLACE

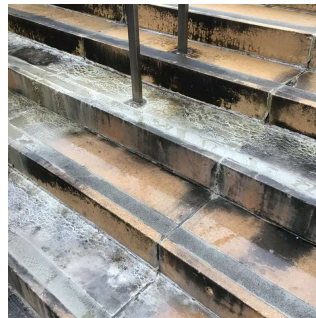
Facade B

STONE: CRACKS/SPALLING - MAJOR

50
S.F.
REPLACE
PRIORITY 4
LEVEL 2

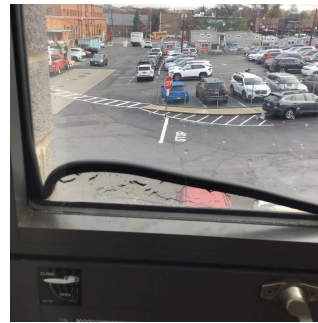
Facade C - Room 251

Deficiency	ALUMINUM - OTHER: DETERIORATED
------------	--------------------------------

Deficiency Quantity	1,800
Quantity Uom	S.F.
Potential Action	REPLACE WINDOW
Urgency of Action	PRIORITY 4
Purpose of Action	LEVEL 2

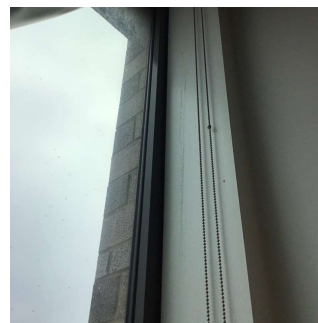
Facade C - Room 251, also Room 321

ALUMINUM - OTHER: AIR/WATER INFILTRATION, DETERIORATED JOINTS WITH DAMAGED CAULKING

60
L.F.
MAINTENANCE
PRIORITY 3
LEVEL 2

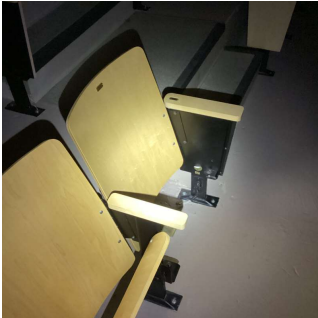
Question	Response
INTERIOR	
AUDITORIUM	
Fixed Seating	
Deficiency	DAMAGED/BROKEN/INOPERABLE
Deficiency Location/Instance	Seat AA/111
Deficiency Quantity	1
Quantity Uom	EACH
Potential Action	REPLACE
Urgency of Action	PRIORITY 3
Purpose of Action	LEVEL 2
Deficiency Photo1

Seat AA/111 (Balcony)
Violations	No violations recorded.
Floor Finish	
Instance on 1st Floor (371 Seats)	Inspected
Condition	2 - Between Good and Fair
Deficiency	VINYL TILES: BROKEN/DETERIORATED/MISSING TILES
Deficiency Location/Instance	Near Seat J/111
Deficiency Quantity	10
Quantity Uom	S.F.
Potential Action	REPLACE
Urgency of Action	PRIORITY 3
Purpose of Action	LEVEL 2
Deficiency Photo1

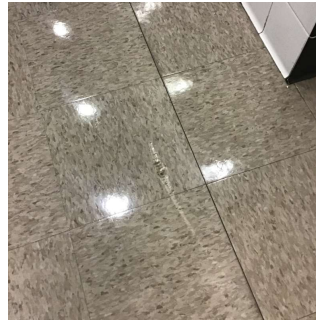
Corridor near room 121A

Corridor near room B61
Violations	No violations recorded.
Deficiency	VINYL TILES: BROKEN/DETERIORATED/MISSING TILES
Deficiency Location/Instance	Corridor near room 121A, near Cafeteria
Deficiency Quantity	20
Quantity Uom	S.F.
Potential Action	REPLACE
Urgency of Action	PRIORITY 3
Purpose of Action	LEVEL 2

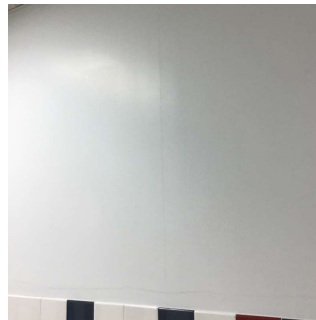
Corridor near Room B51

GYP SUM BOARD: DETERIORATED

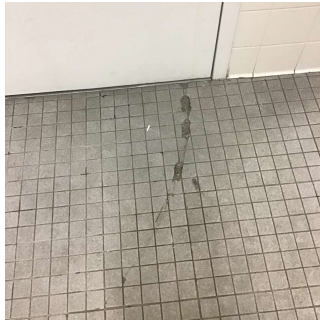
Question	Response
INTERIOR	
LOCKER ROOM	
Alternative use	No
Instance on Basement- Girls (497 Lockers)	Inspected
Alternative use	No
Instance on Basement- Visitors (136 Lockers)	Inspected
Alternative use	No
Ceiling	
Instance on Basement- Boys (507 Lockers)	Does not Exist
Instance on Basement- Girls (497 Lockers)	Does not Exist
Instance on Basement- Visitors (136 Lockers)	Does not Exist
Door(s)	
Instance on Basement- Girls (497 Lockers)	Inspected
Condition	2 - Between Good and Fair
Deficiency	No deficiencies recorded
Instance on Basement- Visitors (136 Lockers)	Inspected
Condition	2 - Between Good and Fair
Deficiency	No deficiencies recorded
Instance on Basement- Boys (507 Lockers)	Inspected
Condition	2 - Between Good and Fair
Deficiency	No deficiencies recorded
Floor Finish	
Instance on Basement- Boys (507 Lockers)	Inspected
Condition	2 - Between Good and Fair
Deficiency	CERAMIC TILE: BROKEN/MISSING TILES
Deficiency Location/Instance	Entrance

Deficiency Quantity	10
Quantity Uom	S.F.
Potential Action	REPLACE
Urgency of Action	PRIORITY 3
Purpose of Action	LEVEL 2
Deficiency Photo1

Violations	Entrance No violations recorded.
Instance on Basement- Girls (497 Lockers)	Inspected
Condition	2 - Between Good and Fair
Deficiency	CERAMIC TILE: DETERIORATED SUBSTRATE
Deficiency Location/Instance	Entrance
Deficiency Quantity	10
Quantity Uom	S.F.
Potential Action	REPLACE
Urgency of Action	PRIORITY 3

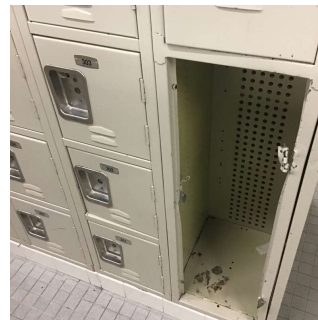
Locker next to 303

Instance on Basement- Boys (507 Lockers)	Inspected
Condition	2 - Between Good and Fair
Deficiency	DAMAGED UNITS
Deficiency Location/Instance	Locker next to 303, Lockers 471, 309, 181, 13 and others
Deficiency Quantity	10
Quantity Uom	EACH
Potential Action	REPLACE
Urgency of Action	PRIORITY 3
Purpose of Action	LEVEL 2
Deficiency Photo1

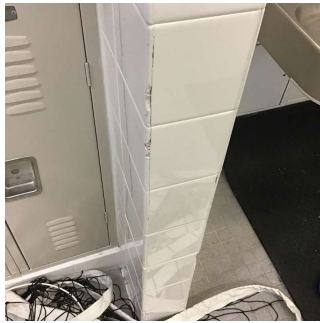
Instance on Basement- Visitors (136 Lockers)	Inspected
Condition	2 - Between Good and Fair
Deficiency	CERAMIC TILE: BROKEN/ MISSING
Deficiency Location/Instance	Near Entrance
Deficiency Quantity	10
Quantity Uom	S.F.
Potential Action	REPLACE
Urgency of Action	PRIORITY 3
Purpose of Action	LEVEL 2

Near Entrance
Violations	No violations recorded.
Instance on Basement- Boys (507 Lockers)	Inspected
Condition	2 - Between Good and Fair
Deficiency	CERAMIC TILE: BROKEN/ MISSING
Deficiency Location/Instance	Center
Deficiency Quantity	10
Quantity Uom	S.F.
Potential Action	REPLACE
Urgency of Action	PRIORITY 3
Purpose of Action	LEVEL 2
Deficiency Photo1

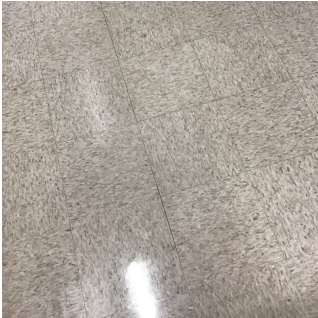
Question	Response
INTERIOR	
SHOWER ROOM	
Alternative use	No
Instance on Basement- Visitors	Inaccessible
Ceiling	
Instance on Basement- Girls	Does not Exist
Door(s)	
Instance on Basement- Girls	Does not Exist
Floor Finish	
Instance on Basement- Girls	Inspected
Condition	2 - Between Good and Fair
Deficiency	No deficiencies recorded
Walls	
Instance on Basement- Girls	Inspected
Condition	2 - Between Good and Fair
Deficiency	No deficiencies recorded
STAIRS/RAMPS: INTERIOR	
Do Letter Stair Signs Exist?	Inspected Yes
Ceiling	
Condition	Inspected 2 - Between Good and Fair
Deficiency	No deficiencies recorded
Door(s)	
Condition	Inspected 2 - Between Good and Fair
Deficiency	No deficiencies recorded
Partition	
	Does not Exist
Railings	
Condition	Inspected 2 - Between Good and Fair
Deficiency	No deficiencies recorded
Stairs and Landings	
Condition	Inspected 2 - Between Good and Fair
Deficiency	VINYL TILES: DETERIORATED SUBSTRATE
Deficiency Location/Instance	Stairs B1/Basement, B2/ Basement

Deficiency Quantity	30
Quantity Uom	S.F.
Potential Action	REPLACE
Urgency of Action	PRIORITY 3
Purpose of Action	LEVEL 2
Deficiency Photo1

Stair B1/Basement
Violations	No violations recorded.
Walls	
Condition	Inspected 2 - Between Good and Fair

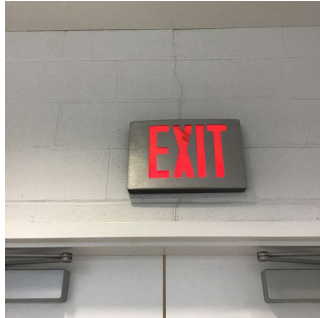
Question	Response
INTERIOR	
STAIRS/RAMPS: INTERIOR	
Walls	
Deficiency	MASONRY: CRACKS/SPALLING
Deficiency Location/Instance	Stair B/1
Deficiency Quantity	10
Quantity Uom	S.F.
Potential Action	REPLACE
Urgency of Action	PRIORITY 3
Purpose of Action	LEVEL 2
Deficiency Photo1

Stair B/1
Violations	No violations recorded.
TOILET ROOMS - STAFF	
	Inspected
Ceiling	
	Inspected
Condition	2 - Between Good and Fair
Deficiency	GYPSUM BOARD: DAMAGED/DETERIORATED
Deficiency Location/Instance	Room 141R
Deficiency Quantity	10
Quantity Uom	S.F.
Potential Action	REPLACE
Urgency of Action	PRIORITY 3
Purpose of Action	LEVEL 2
Deficiency Photo1

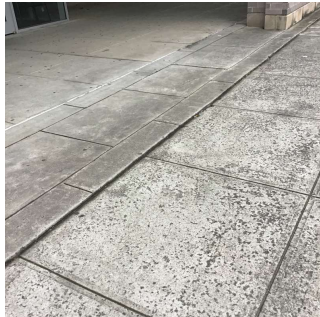
Left Side of Building
Violations	No violations recorded.
Deficiency	HEAVING
Deficiency Location/Instance	Main Entrance
Deficiency Quantity	150
Quantity Uom	S.F.
Potential Action	REPLACE
Urgency of Action	PRIORITY 3
Purpose of Action	LEVEL 2

Violations	Main Entrance No violations recorded.
Deficiency	DAMAGED CURBS
Deficiency Location/Instance	Parking Lot
Deficiency Quantity	50
Quantity Uom	L.F.
Potential Action	REPLACE
Urgency of Action	PRIORITY 3
Purpose of Action	LEVEL 2
Deficiency Photo1

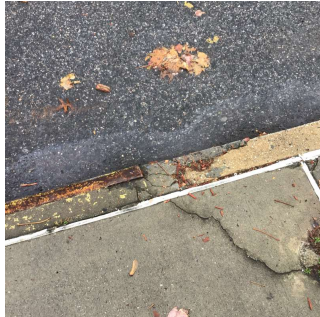
Violations	Parking Lot No violations recorded.
Pavers	Does not Exist
DOT Sidewalk	Inspected
Asphalt	Does not Exist
Concrete	Inspected
Condition	4 - Between Fair and Poor
Deficiency	DAMAGED CURBS
Deficiency Location/Instance	Goethals Avenue
Deficiency Quantity	50
Quantity Uom	L.F.
Potential Action	REPLACE
Urgency of Action	PRIORITY 3
Purpose of Action	LEVEL 2

Violations	Goethals Avenue No violations recorded.
Deficiency	DAMAGED/DETERIORATED/MISSING SECTIONS
Deficiency Location/Instance	Goethals Avenue
Deficiency Quantity	600
Quantity Uom	S.F.
Potential Action	REPLACE
Urgency of Action	PRIORITY 3
Purpose of Action	LEVEL 2
Deficiency Photo1

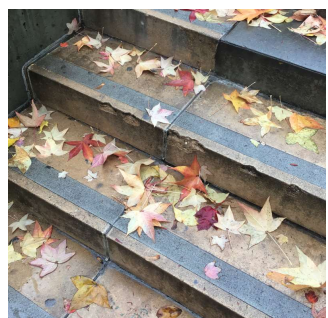
Question	Response
SITE	
STAIRS/RAMPS: EXTERIOR	
Stairs/ramps	
Deficiency Quantity	45
Quantity Uom	S.F.
Potential Action	REPLACE
Urgency of Action	PRIORITY 3
Purpose of Action	LEVEL 2
Deficiency Photo1

Goethals Avenue
Violations	No violations recorded.
ARTWORK	
Instance	Inspected
Instance Photo	Exterior - Front Entrance - 21684
