NYC Department of Education
Building Condition Assessment Survey 2023 - 2024

Architectural Inspection

Q725

Asset: HS FOR INFORMATION TECH - QUEENS, 21-16 44TH ROAD, New York, 11101

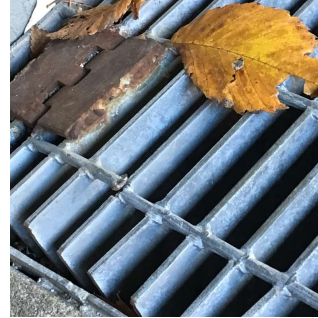
Question	Response
Architectural	
EXTERIOR	Inspected
AREAWAY	Inspected
Instance on AW1 - AW2	Inspected
Instance Condition	3 - Fair
Instance Quantity	2
Instance Quantity Uom	EACH
Deficiency	AREAWAY GRATINGS: MAJOR RUSTING / OR BROKEN
Roof Plan reference	
Deficiency Quantity	25
Quantity Uom	S.F.

REPLACE
 PRIORITY 4
 LEVEL 2

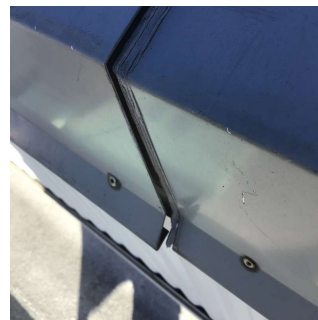
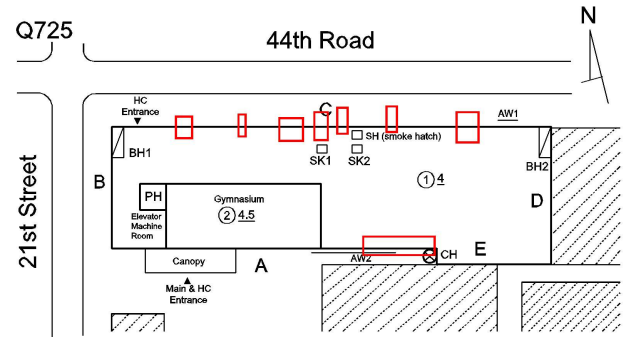
Roof 1

METAL: DETERIORATED TRANSVERSE JOINTS

80
 L.F.
 MAINTENANCE
 PRIORITY 3
 LEVEL 2

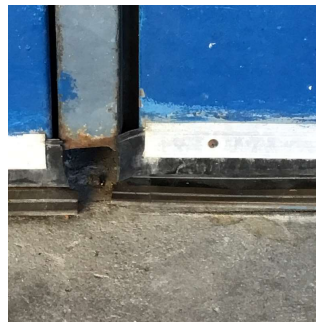
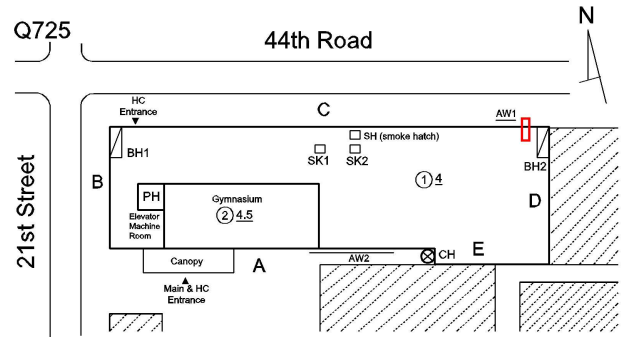
Facade C

Inspected
3 - Fair
METAL: DETERIORATED DOOR AND FRAME - MAJOR DETERIORATION

2
EACH
REPLACE
PRIORITY 4
LEVEL 2

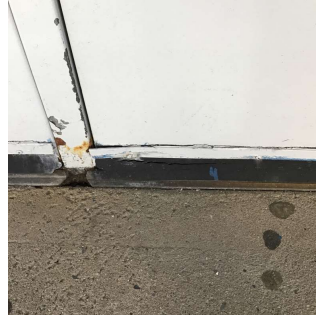
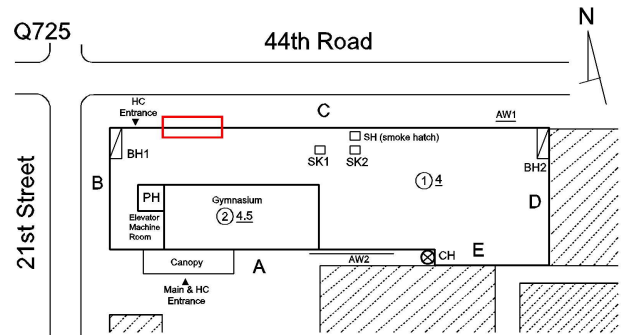
Facade C

METAL: DETERIORATED DOOR - MINOR DETERIORATION

1
EACH
MAINTENANCE

PRIORITY 3
 LEVEL 2

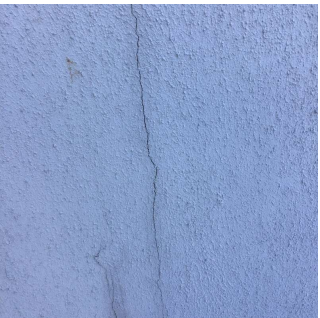
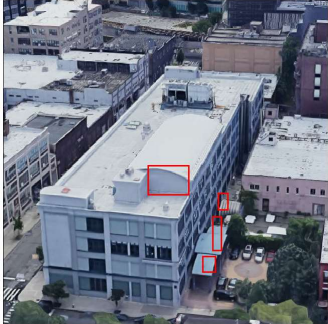
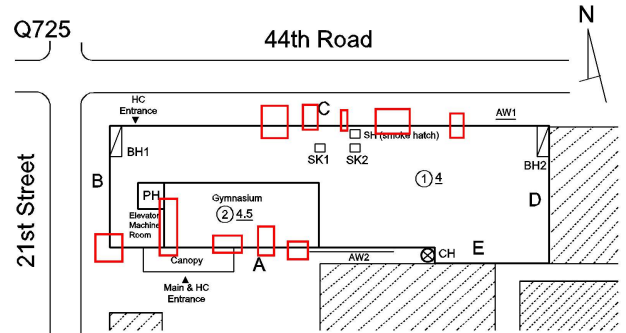
STUCCO CEMENT SURFACE: CRACKS, SPALLING

Deficiency Quantity	90
Quantity Uom	S.F.
Potential Action	REPLACE
Urgency of Action	PRIORITY 4
Purpose of Action	LEVEL 2
Deficiency Photo1

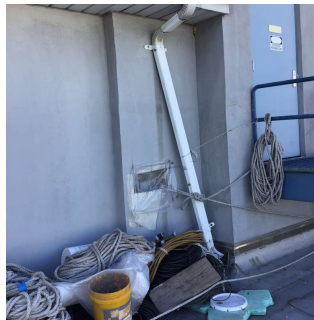
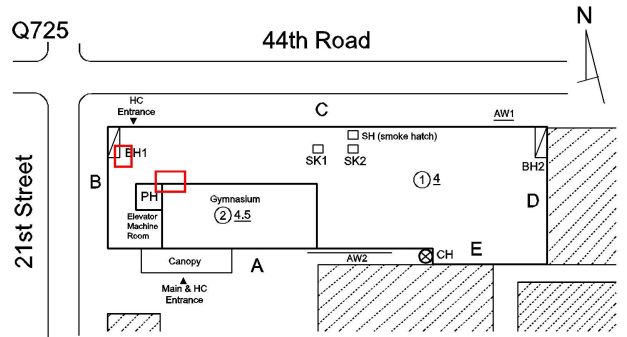
Roof 2

Condition	3 - Fair
Deficiency	DAMAGED/MISSING

24
L.F.
REPLACE
PRIORITY 4
LEVEL 2

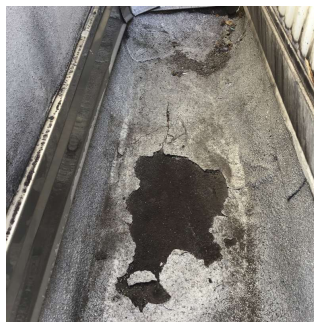
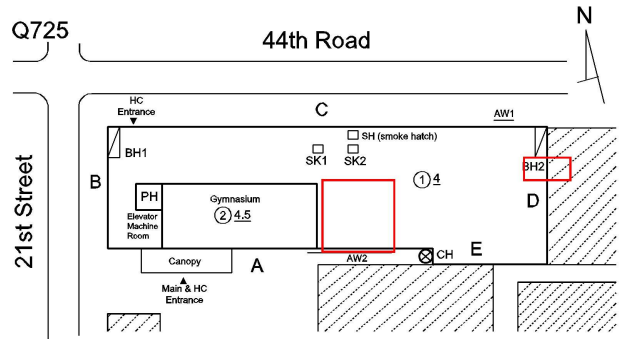
Roof 1
No violations recorded.

Deficiency MODIFIED BITUMEN: ROOFING: DELAMINATION

Deficiency Quantity	60
Quantity Uom	S.F.
Potential Action	REPLACE ROOFING WITHOUT MAJOR EQUIPMENT REMOVAL
Urgency of Action	PRIORITY 4
Purpose of Action	LEVEL 2

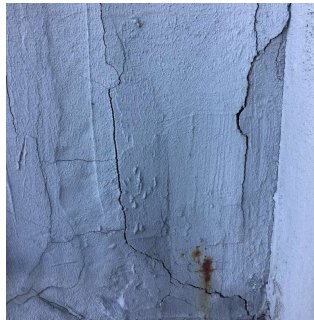
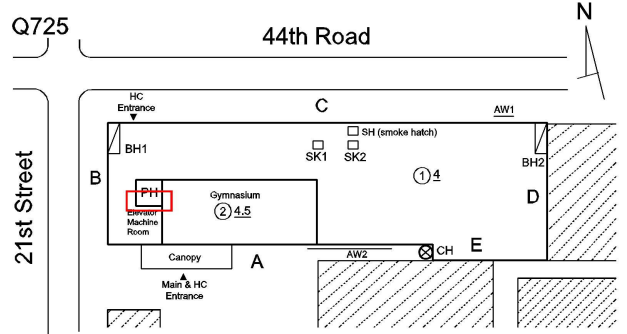
PH
No violations recorded.

Deficiency	BULKHEAD/PENTHOUSE WALLS/EXTERIOR: CRACKS/SPALLING - MAJOR

30
S.F.
REPLACE
PRIORITY 4
LEVEL 2

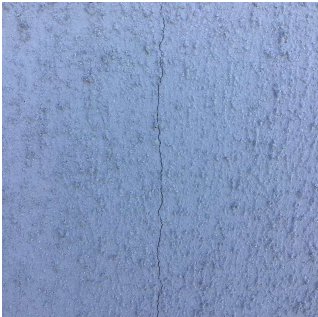
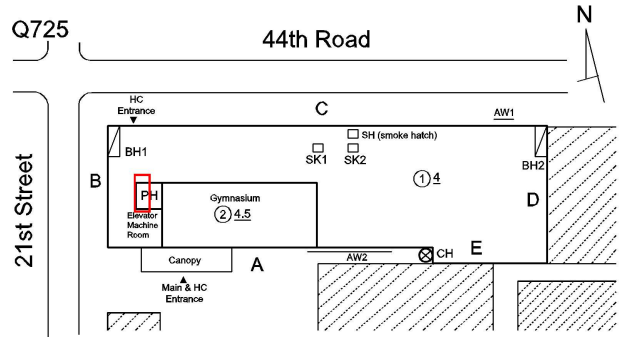
**BULKHEAD/PENTHOUSE WALLS/EXTERIOR:
CRACKS/SPALLING - MINOR**

30
S.F.
REPAIR
PRIORITY 3
LEVEL 2

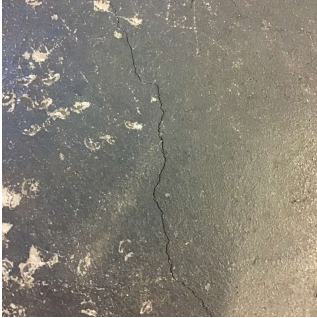
Question	Response
INTERIOR	
STRUCTURAL	
FLOOR STRUCTURE	Inspected
Condition	3 - Fair
Deficiency	CONCRETE: CRACKS/SPALLED/REINFORCEMENT EXPOSED
Deficiency Location/Instance	Room 1 - Elevator Machine Room
Deficiency Quantity	25
Quantity Uom	S.F.
Potential Action	REPAIR
Urgency of Action	PRIORITY 3
Purpose of Action	LEVEL 5
Deficiency Photo1

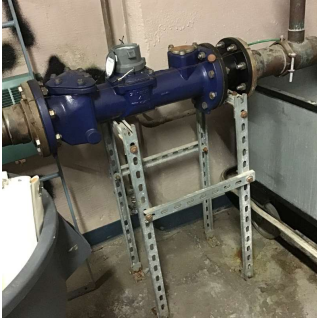
Violations	Room 1 - Elevator Machine Room No violations recorded.
FOUNDATION WALLS	
Material Type(s)	Inspected Concrete
Condition	4 - Between Fair and Poor
Deficiency	CONCRETE: WATER INFILTRATION IN NON- INSTRUCTIONAL SPACE
Deficiency Location/Instance	Basement - Water Meter Sprinkler Control Room 12
Deficiency Quantity	100
Quantity Uom	S.F.
Potential Action	INSTALL WATERPROOFING
Urgency of Action	PRIORITY 5
Purpose of Action	LEVEL 5
Deficiency Photo1

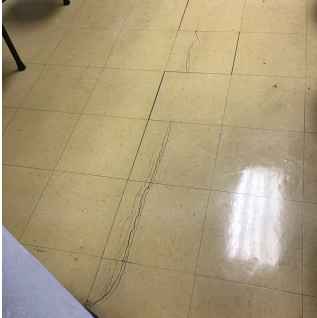
Question	Response
INTERIOR	
CAFETERIA	
Fixed Equipment	
Instance on 1st Floor	Does not Exist
Floor Finish	
Instance on 1st Floor	Inspected
Condition	4 - Between Fair and Poor
Deficiency	VINYL TILES: DETERIORATED SUBSTRATE
Deficiency Location/Instance	Near entrance, Columns.
Deficiency Quantity	60
Quantity Uom	S.F.
Potential Action	REPLACE
Urgency of Action	PRIORITY 3
Purpose of Action	LEVEL 2
Deficiency Photo1

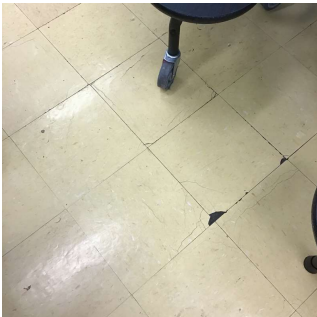
Violations	Near Columns No violations recorded.
Deficiency	VINYL TILES: BROKEN/DETERIORATED/MISSING TILES
Deficiency Location/Instance	Near Entrance, Center, Windows
Deficiency Quantity	300
Quantity Uom	S.F.
Potential Action	REPLACE
Urgency of Action	PRIORITY 3
Purpose of Action	LEVEL 2
Deficiency Photo1

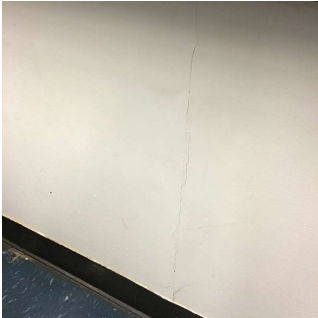
Question	Response
INTERIOR	
CAFETERIA	
Walls	
Deficiency	GYPSUM BOARD: DETERIORATED
Deficiency Location/Instance	Near Windows, Center, Serving Area.
Deficiency Quantity	40
Quantity Uom	S.F.
Potential Action	REPLACE
Urgency of Action	PRIORITY 3
Purpose of Action	LEVEL 2
Deficiency Photo1

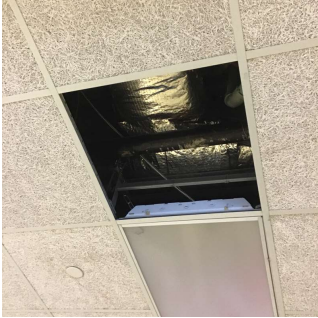
Violations	Near Windows No violations recorded.
Window Curtains/Shades/Blinds	
Instance on 1st Floor	Does not Exist
CLASSROOMS/CORRIDORS/ADMIN SPACES	
Ceiling	Inspected
Condition	2 - Between Good and Fair
Deficiency	TECTUM: DAMAGED/MISSING
Deficiency Location/Instance	Rooms 146, 209
Deficiency Quantity	20
Quantity Uom	S.F.
Potential Action	REPLACE
Urgency of Action	PRIORITY 3
Purpose of Action	LEVEL 2
Deficiency Photo1

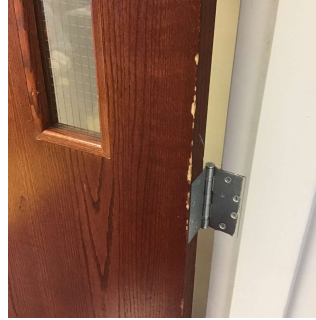
Room 406

Violations	Room 209 No violations recorded.
Door(s)	
Condition	Inspected
Condition	5 - Poor
Deficiency	WOOD: DETERIORATED DOOR
Deficiency Location/Instance	Rooms 201, 209, 334, 406, 433F, and others.
Deficiency Quantity	10

Potential Action	MAINTENANCE
Urgency of Action	PRIORITY 3
Purpose of Action	LEVEL 2
Deficiency Photo1

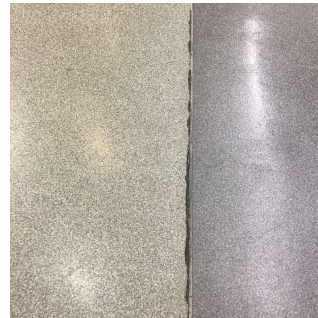
Deficiency	TERRAZZO: CRACKS
Deficiency Location/Instance	Main Entrance Area
Deficiency Quantity	40
Quantity Uom	S.F.
Potential Action	REPLACE
Urgency of Action	PRIORITY 3
Purpose of Action	LEVEL 2
Deficiency Photo1

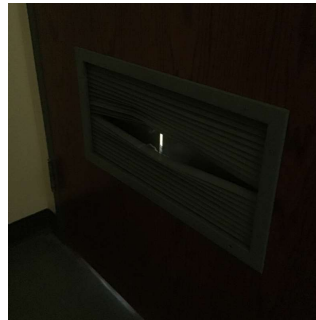
Gymnasium Entrance
 No violations recorded.

Instance on 4th Floor - Girls (760 Lockers)	Inspected
Condition	4 - Between Fair and Poor
Deficiency	METAL: DAMAGED LOUVER
Deficiency Location/Instance	Gymnasium Entrance, hallway Entrance
Deficiency Quantity	2
Quantity Uom	EACH
Potential Action	MAINTENANCE
Urgency of Action	PRIORITY 3
Purpose of Action	LEVEL 2
Deficiency Photo1

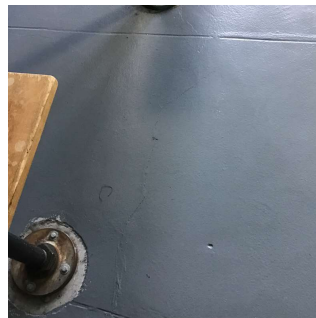
Near center
 No violations recorded.

Instance on 4th Floor - Boys (680 Lockers)	Inspected
Condition	2 - Between Good and Fair
Deficiency	CONCRETE: CRACKS
Deficiency Location/Instance	Near center
Deficiency Quantity	20
Quantity Uom	S.F.
Potential Action	REPLACE
Urgency of Action	PRIORITY 3
Purpose of Action	LEVEL 2
Deficiency Photo1

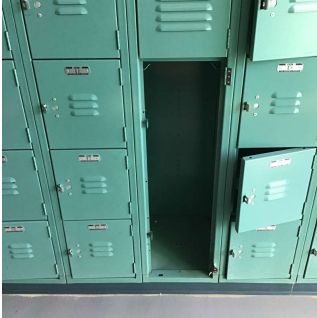
Instance on 4th Floor - Girls (760 Lockers)	Inspected
Condition	2 - Between Good and Fair
Deficiency	DAMAGED UNITS
Deficiency Location/Instance	Lockers 43, 200, 203, 242, 647
Deficiency Quantity	5

Question	Response
INTERIOR	
LOCKER ROOM	
Locker Room Lockers	
Quantity Uom	EACH
Potential Action	REPLACE
Urgency of Action	PRIORITY 3
Purpose of Action	LEVEL 2
Deficiency Photo1

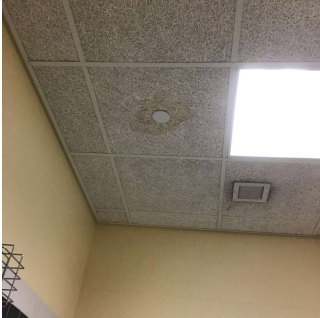
Question	Response
INTERIOR	
TOILET ROOMS - STAFF	Inspected
Walls	Inspected
Violations	No violations recorded.
TOILET ROOMS - STUDENTS	Inspected
Ceiling	Inspected
Condition	2 - Between Good and Fair
Deficiency	TECTUM: DAMAGED/MISSING
Deficiency Location/Instance	Room 122A
Deficiency Quantity	10
Quantity Uom	S.F.
Potential Action	REPLACE
Urgency of Action	PRIORITY 3
Purpose of Action	LEVEL 2
Deficiency Photo1

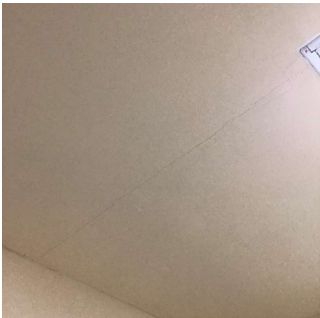
Violations	Room 122A No violations recorded.
Deficiency	GYPSUM BOARD: DAMAGED/DETERIORATED
Deficiency Location/Instance	Rooms 227, 327, 427
Deficiency Quantity	50
Quantity Uom	S.F.
Potential Action	REPLACE
Urgency of Action	PRIORITY 3
Purpose of Action	LEVEL 2
Deficiency Photo1

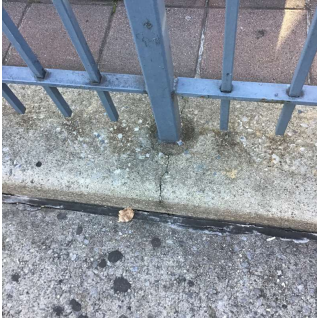
Question	Response
SITE	
FENCES	
Deficiency Quantity	40
Quantity Uom	S.F.
Potential Action	REPLACE
Urgency of Action	PRIORITY 3
Purpose of Action	LEVEL 2
Deficiency Photo1

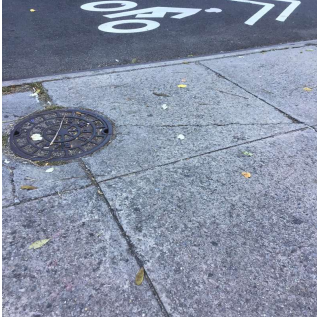
Question	Response
SITE	
PAVING	
DOT Sidewalk	
Concrete	
Deficiency Quantity	250
Quantity Uom	S.F.
Potential Action	REPLACE
Urgency of Action	PRIORITY 3
Purpose of Action	LEVEL 2
Deficiency Photo1

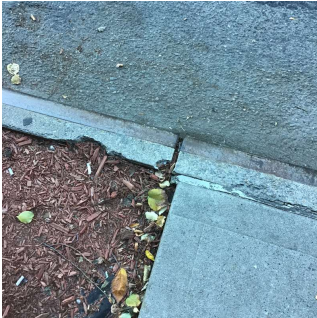
Violations	44th Drive No violations recorded.
Deficiency	DAMAGED CURBS
Deficiency Location/Instance	21st Street, 44th Road, 44th Drive.
Deficiency Quantity	55
Quantity Uom	L.F.
Potential Action	REPLACE
Urgency of Action	PRIORITY 3
Purpose of Action	LEVEL 2
Deficiency Photo1
