NYC Department of Education
Building Condition Assessment Survey 2023 - 2024

Architectural Inspection

Q727

Asset: P.S. 106 TRANSPORTABLE - Q, 180 BEACH 35 STREET, New York, 11691

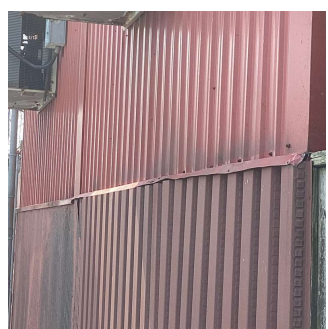
Violations	Facade B No violations recorded.
Deficiency	METAL PANEL: MAJOR RUSTING

Question	Response
EXTERIOR	
EXTERIOR WALLS	
Replacement Quantity	2,000
Replacement Uom	S.F.
Instance on All Facades	Inspected
Instance Condition	5 - Poor
Instance Quantity	2,000
Instance Quantity Uom	S.F.
Deficiency	METAL PANEL: DAMAGED TRIM
Roof Plan reference	<p>Q727

Deficiency Quantity	40
Quantity Uom	L.F.
Potential Action	REPLACE
Urgency of Action	PRIORITY 4
Purpose of Action	LEVEL 2
Deficiency Photo1

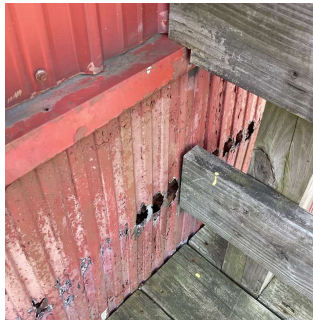
Facade A

Deficiency Quantity

10

REPLACE

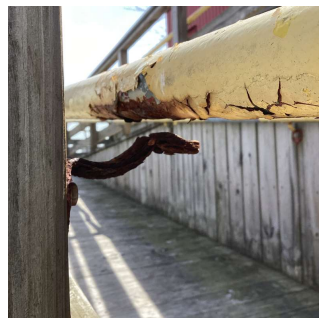
Violations	Facade A No violations recorded.
STAIRS/RAMPS	
	Inspected
Condition	2 - Between Good and Fair
Deficiency	No deficiencies recorded
WINDOWS

Question	Response
EXTERIOR	
ROOF	
Roofing	
ROOFING	
Does the roof have major mechanical equipment sitting on Dunnage Steel less than 18" above the Roofing?	No
Does this roof instance have a Sustainable Roof System?	No
Do solar panels exist on these roofs?	No
Is/Are the roof(s) suitable for Solar Panel installation?	No
Installation Year	2002
Source of Installation	Custodial Staff
Deficiency	No deficiencies recorded
STAIRS/RAMPS: EXTERIOR	
	Inspected
RAILINGS	
	Inspected
Condition	3 - Fair
Deficiency	BROKEN BRACKET
Roof Plan reference	<p>Q727

<p align="center">Beach 35th Street</p>
Deficiency Quantity	1
Quantity Uom	EACH
Potential Action	REPLACE
Urgency of Action	PRIORITY 4
Purpose of Action	LEVEL 2
Deficiency Photo1

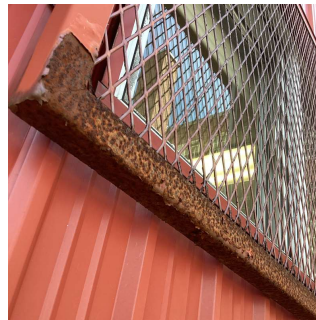
Facade A
 No violations recorded.

Inspected
Replacement Quantity	100
Replacement Uom	S.F.
EXTERIOR GUARDS	
	Inspected
Condition	3 - Fair
Deficiency	RUST - MAJOR

100
 S.F.
 REPLACE
 PRIORITY 4
 LEVEL 2

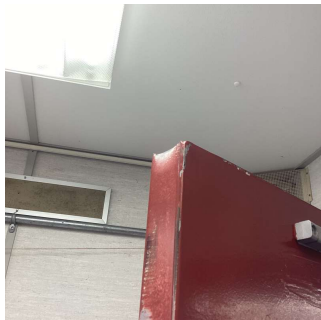
TCU 1/2
Violations	No violations recorded.
Floor Finish	Inspected
Condition	3 - Fair
Deficiency	VINYL TILES: BROKEN/DETERIORATED/MISSING TILES
Deficiency Location/Instance	TCU 1, 2
Deficiency Quantity	50

Question	Response
INTERIOR	
STRUCTURAL	
COLUMNS/BEAMS/BEARING WALLS	Inspected
Condition	2 - Between Good and Fair
Deficiency	No deficiencies recorded
FLOOR STRUCTURE	Inspected
Condition	2 - Between Good and Fair
Deficiency	No deficiencies recorded
ROOF STRUCTURE	Inspected
Condition	2 - Between Good and Fair
Deficiency	No deficiencies recorded
CLASSROOMS/CORRIDORS/ADMIN SPACES	Inspected
Ceiling	Inspected
Condition	2 - Between Good and Fair
Deficiency	No deficiencies recorded
Door(s)	Inspected
Condition	5 - Poor
Deficiency	METAL: DETERIORATED DOOR
Deficiency Location/Instance	TCU 1/2
Deficiency Quantity	1
Quantity Uom	EACH
Potential Action	MAINTENANCE
Urgency of Action	PRIORITY 3
Purpose of Action	LEVEL 2
Deficiency Photo1

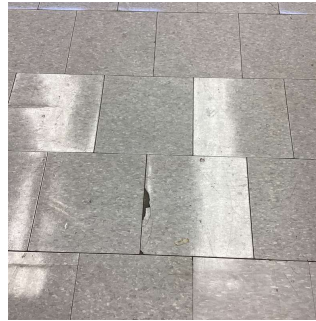
TCU 2

Quantity Uom	S.F.
Potential Action	REPLACE
Urgency of Action	PRIORITY 3
Purpose of Action	LEVEL 2

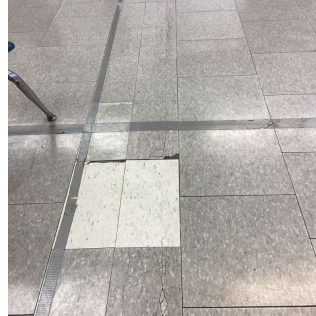
TCU 1

VINYL TILES: DETERIORATED SUBSTRATE

TCU 1, 2

200

REPLACE

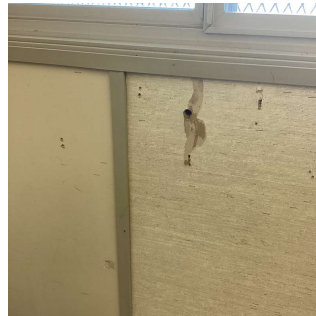
GYPSUM BOARD: DETERIORATED

TCU 1

20

REPLACE
