**NYC Department of Education**  
**Building Condition Assessment Survey 2023 - 2024**

Architectural Inspection

Q732

**Asset:** ALTERNATIVE HS SUPERINTENDENT-Q, 90-27 SUTPHIN BLVD, New York, 11435

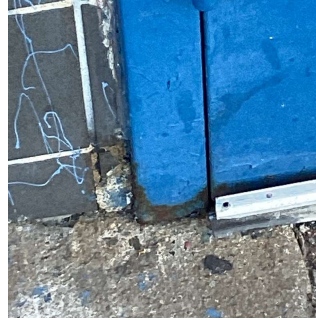
Facade A

Question	Response
<b>Architectural</b>	
<b>EXTERIOR</b>	Inspected
<b>AREAWAY</b>	Inspected
Instance on AW1, AW2	Inaccessible
Instance Quantity	2
Instance Quantity Uom	EACH
<b>AWNINGS AND CANOPIES</b>	Does not Exist
<b>CHIMNEY</b>	Inspected
Material Type(s)	Metal
Condition	2 - Between Good and Fair
Deficiency	No deficiencies recorded
<b>COPING</b>	Not Required
<b>CORNICE</b>	Does not Exist
<b>DOORS</b>	Inspected
<b>DOORS AND FRAMES</b>	Inspected
Condition	3 - Fair
Deficiency	METAL: DETERIORATED DOOR AND FRAME - MINOR DETERIORATION
Roof Plan reference	
Deficiency Quantity	1
Quantity Uom	EACH

MAINTENANCE  
 PRIORITY 3  
 LEVEL 2

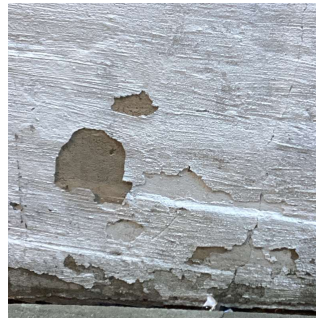
Facade B

STUCCO CEMENT SURFACE: CRACKS, SPALLING

Potential Action

REPLACE

Urgency of Action

PRIORITY 4

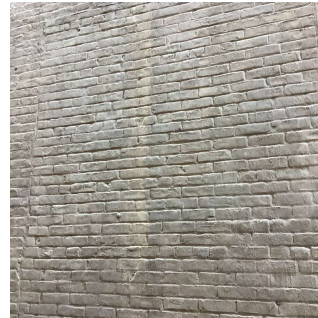
Facade B

BRICK: DETERIORATED JOINTS

Potential Action

REPOINT

PRIORITY 3  
LEVEL 2

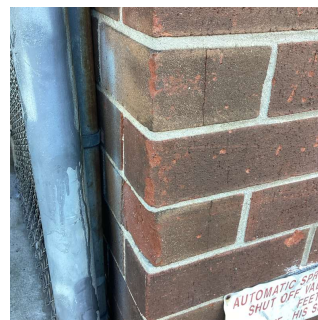
**BRICK: CRACKS/DISPLACED/SPALLED BRICK AT BUILDING CORNERS**

10  
S.F.  
REMOVE AND REBUILD  
PRIORITY 4  
LEVEL 2

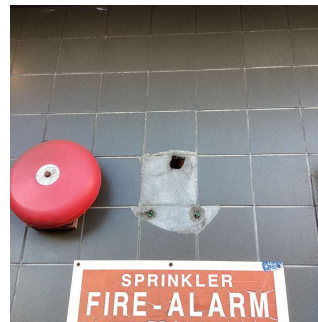
CERAMIC TILE: CHIPPED, SPALLED, BROKEN PIECES

10  
 S.F.  
 REPLACE  
 PRIORITY 3  
 LEVEL 2

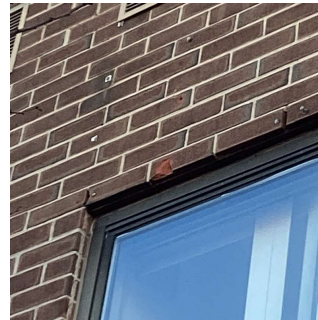
BRICK: MINOR CRACKS AND SPALLING

30  
S.F.  
RESTITCH  
PRIORITY 3  
LEVEL 2

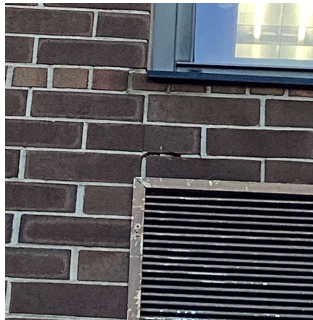
Facade A

BRICK: DETERIORATED JOINTS

Potential Action

REPOINT

Urgency of Action

PRIORITY 4

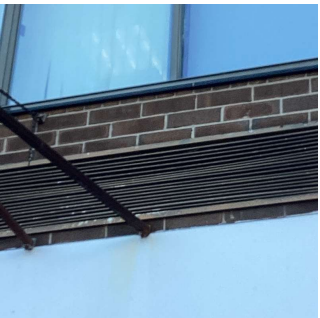
BROKEN/ DENTED BLADES

Question	Response
<b>EXTERIOR</b>	
<b>LOUVER</b>	
Elevation	 
Deficiency Quantity	30
Quantity Uom	S.F.
Potential Action	REPLACE
Urgency of Action	PRIORITY 4
Purpose of Action	LEVEL 2
Deficiency Photo1

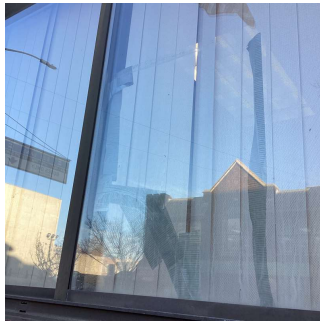
Material Type(s)	Inspected Aluminum
Instance on Aluminum - Double Hung: Facade C	Inspected
Instance Condition	3 - Fair
Instance Quantity	400
Instance Quantity Uom	S.F.
Are these windows insulated	No
Installation Year	2001
Source of Installation	Custodial Staff
Deficiency	No deficiencies recorded
Instance on Aluminum - Other: Facade A	Inspected
Instance Condition	3 - Fair
Instance Quantity	2,600
Instance Quantity Uom	S.F.
Are these windows insulated	Yes
Installation Year	2001
Source of Installation	Custodial Staff
Deficiency	ALUMINUM - OTHER: BROKEN PANE
Roof Plan reference	Q732

Deficiency Quantity	30
Quantity Uom	S.F.
Potential Action	MAINTENANCE
Urgency of Action	PRIORITY 3
Purpose of Action	LEVEL 2

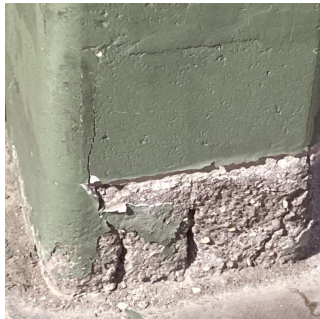
Violations	Facade A No violations recorded.
<b>INTERIOR</b>	Inspected
<b>POOLS</b>	Does not Exist
<b>STRUCTURAL</b>	Inspected
<b>COLUMNS/BEAMS/BEARING WALLS</b>	Inspected
Condition	3 - Fair
Deficiency	STEEL COLUMNS/BEAMS: DETERIORATED MASONRY FIREPROOFING
Deficiency Location/Instance	Basement - Garage
Deficiency Quantity	10
Quantity Uom	S.F.
Potential Action	REPLACE
Urgency of Action	PRIORITY 3
Purpose of Action	LEVEL 5
Deficiency Photo1

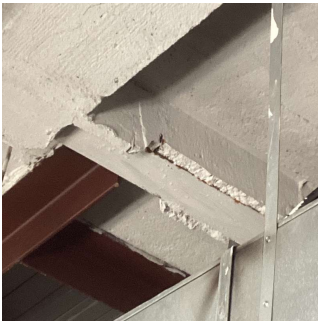
Violations	Basement - Garage No violations recorded.
Deficiency	STEEL COLUMNS/BEAMS: DETERIORATED CONCRETE FIREPROOFING
Deficiency Location/Instance	2nd Floor - Mechanical Room, 1st Floor - Mechanical Room
Deficiency Quantity	30
Quantity Uom	S.F.
Potential Action	REPLACE
Urgency of Action	PRIORITY 3
Purpose of Action	LEVEL 5

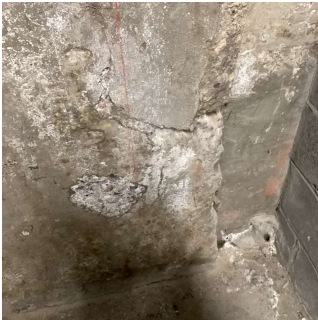
Violations	2nd Floor - Mechanical Room No violations recorded.
<b>FLOOR STRUCTURE</b>	Inspected
Condition	2 - Between Good and Fair
Deficiency	No deficiencies recorded
<b>FOUNDATION WALLS</b>	Inspected
Material Type(s)	Concrete
Condition	3 - Fair
Deficiency	CONCRETE: CRACKED/SPALLED/REINFORCEMENT EXPOSED
Deficiency Location/Instance	Basement - Electrical Panel Room
Deficiency Quantity	30
Quantity Uom	S.F.
Potential Action	REPAIR
Urgency of Action	PRIORITY 3
Purpose of Action	LEVEL 5
Deficiency Photo1

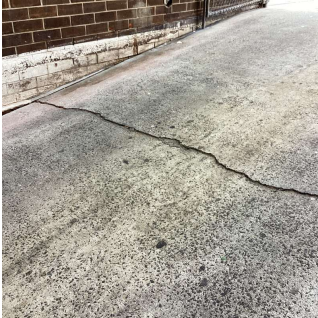
Question	Response
<b>SITE</b>	
<b>PAVING</b>	Inspected
<b>Student Non-Use</b>	Inspected
Gravel Exists?	No
<b>Asphalt</b>	Does not Exist
<b>Concrete</b>	Inspected
Condition	3 - Fair
Deficiency	DAMAGED/DETERIORATED/MISSING SECTIONS
Deficiency Location/Instance	Driveway
Deficiency Quantity	50
Quantity Uom	S.F.
Potential Action	REPLACE
Urgency of Action	PRIORITY 3
Purpose of Action	LEVEL 2
Deficiency Photo1

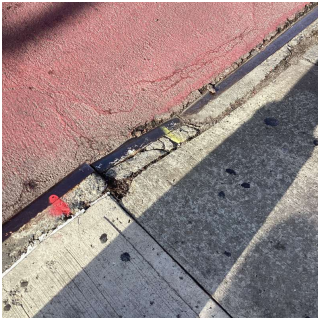
Question	Response
<b>SITE</b>	
<b>PAVING</b>	
<b>Site Sidewalks &amp; Walkways</b>	Inspected
<b>Pavers</b>	Does not Exist
<b>DOT Sidewalk</b>	Inspected
<b>Asphalt</b>	Does not Exist
<b>Concrete</b>	Inspected
Condition	3 - Fair
Deficiency	DAMAGED CURBS
Deficiency Location/Instance	Sutphin Boulevard
Deficiency Quantity	10
Quantity Uom	L.F.
Potential Action	REPLACE
Urgency of Action	PRIORITY 3
Purpose of Action	LEVEL 2
Deficiency Photo1

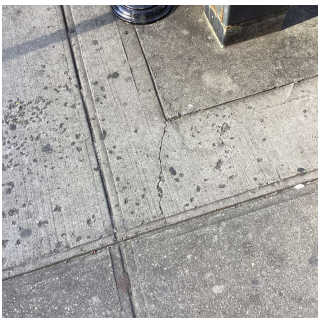
Sutphin Boulevard
Violations	No violations recorded.
Deficiency	DAMAGED/DETERIORATED/MISSING SECTIONS
Deficiency Location/Instance	Sutphin Boulevard
Deficiency Quantity	150
Quantity Uom	S.F.
Potential Action	REPLACE
Urgency of Action	PRIORITY 3
Purpose of Action	LEVEL 2
Deficiency Photo1
