**NYC Department of Education
Building Condition Assessment Survey 2023 - 2024**

Architectural Inspection

Q733

Asset: ALTERNATIVE HS SUPERINTENDENT-Q, 90-01 SUTPHIN BLVD, New York, 11435

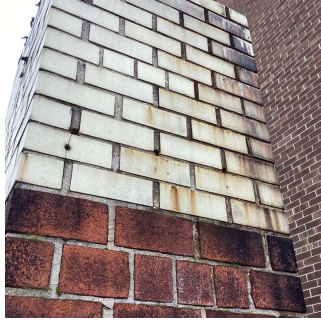
Question	Response
Architectural	
EXTERIOR	Inspected
AREAWAY	Does not Exist
AWNINGS AND CANOPIES	Does not Exist
CHIMNEY	Inspected
Material Type(s)	Masonry
Condition	3 - Fair
Deficiency	BRICK: DETERIORATED JOINTS
Roof Plan reference	
Deficiency Quantity	30
Quantity Uom	S.F.
Potential Action	REPOINT
Urgency of Action	PRIORITY 3
Purpose of Action	LEVEL 2

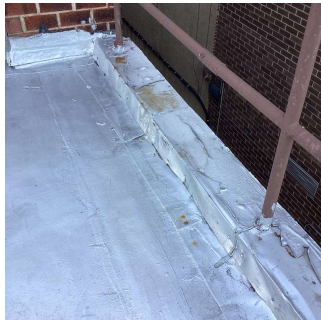
Violations	Roof 1 No violations recorded.
COPING	Inspected
Condition	3 - Fair
Deficiency	METAL: DETERIORATED
Roof Plan reference

Deficiency Quantity	40
Quantity Uom	L.F.
Potential Action	REPLACE-IN-KIND
Urgency of Action	PRIORITY 4
Purpose of Action	LEVEL 2
Deficiency Photo1

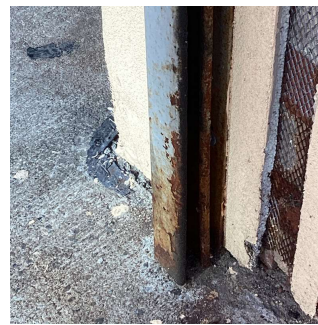
Facade A

Violations	Roof 1 No violations recorded.
CORNICE	Does not Exist
DOORS	Inspected
DOORS AND FRAMES	Inspected
Condition	3 - Fair
Deficiency	ROLL-UP DOOR: DETERIORATED DOOR AND FRAME - MINOR DETERIORATION

60
S.F.
MAINTENANCE
PRIORITY 3
LEVEL 2

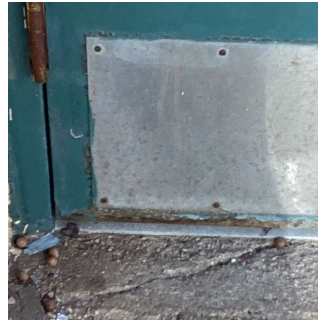
Facade A

METAL: DETERIORATED DOOR AND FRAME - MINOR DETERIORATION

1
EACH
MAINTENANCE
PRIORITY 3
LEVEL 2

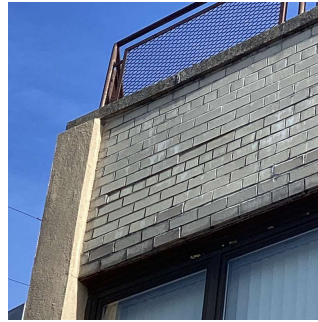
Facade D

BRICK: MINOR CRACKS AND SPALLING

30

RESTITCH

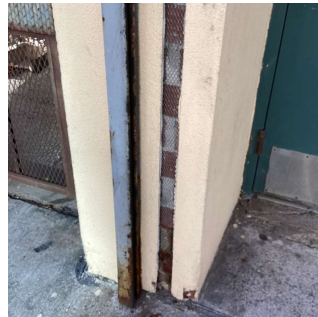
Facade A

STUCCO CEMENT SURFACE: CRACKS, SPALLING

REPLACE

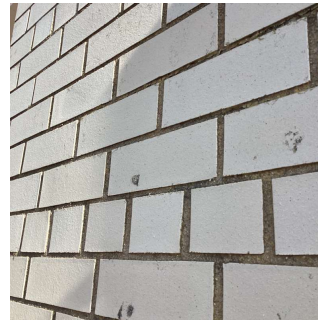
Facade D

BRICK: DETERIORATED JOINTS

REPOINT

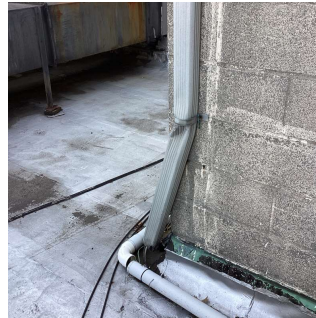
Roof 1

Deficiency	DAMAGED/MISSING
------------	-----------------

REPLACE

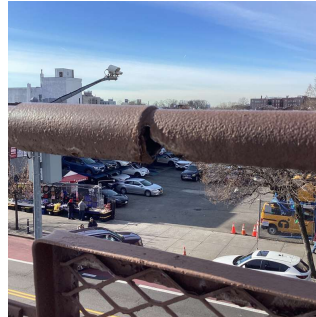
Roof 1

Deficiency	RAILINGS/PANELS: DETERIORATED, MAJOR RUSTING
------------	----------------------------------------------

REPLACE

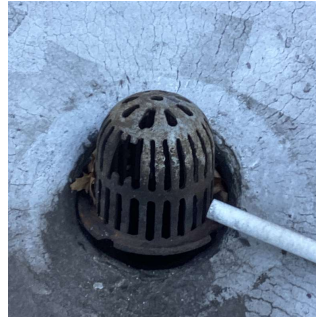
Roof 1

DETERIORATED

Deficiency Quantity	1
Quantity Uom	EACH
Potential Action	REPLACE
Urgency of Action	PRIORITY 4
Purpose of Action	LEVEL 2
Deficiency Photo1

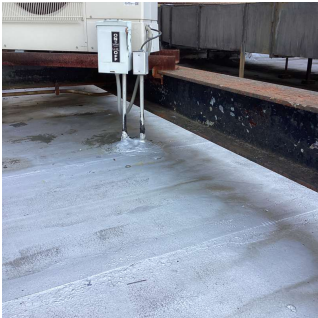
Deficiency	HEIGHT LESS THAN 18"
------------	----------------------

Deficiency Quantity	100
Quantity Uom	L.F.
Potential Action	REPLACE
Urgency of Action	PRIORITY 3
Purpose of Action	LEVEL 2

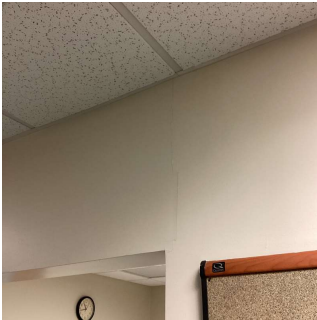
Question	Response
INTERIOR	
CLASSROOMS/CORRIDORS/ADMIN SPACES	
Floor Finish	
Deficiency Photo1	 
	Lunchroom
Violations	No violations recorded.
Walls	
Condition	Inspected
	2 - Between Good and Fair
Deficiency	GYPNUM BOARD: DETERIORATED
Deficiency Location/Instance	Corridor near Rooms 206, 225
Deficiency Quantity	10
Quantity Uom	S.F.
Potential Action	REPLACE
Urgency of Action	PRIORITY 3
Purpose of Action	LEVEL 2
Deficiency Photo1

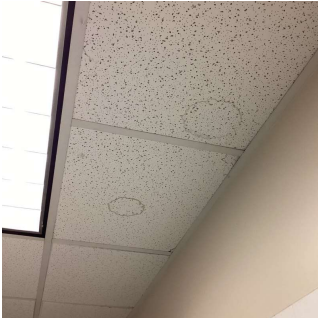
Question	Response
INTERIOR	
STAIRS/RAMPS: INTERIOR	
Stairs and Landings	
Deficiency	CONCRETE: CRACKS/SPALLING - MAJOR
Deficiency Location/Instance	Stair A/2
Deficiency Quantity	10
Quantity Uom	S.F.
Potential Action	REPLACE
Urgency of Action	PRIORITY 3
Purpose of Action	LEVEL 2
Deficiency Photo1	 
Violations	Stair A/2 No violations recorded.
Walls	Inspected
Condition	2 - Between Good and Fair
Deficiency	No deficiencies recorded
TOILET ROOMS - STAFF	
Ceiling	Inspected
Condition	5 - Poor
Deficiency	ACOUSTIC TILES: DAMAGED/MISSING
Deficiency Location/Instance	2nd Floor Men, 2nd Floor Women
Deficiency Quantity	25
Quantity Uom	S.F.
Potential Action	REPLACE
Urgency of Action	PRIORITY 3
Purpose of Action	LEVEL 2
Deficiency Photo1

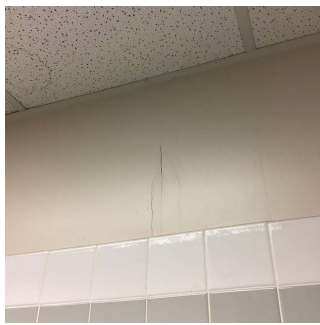
Question	Response
INTERIOR	
TOILET ROOMS - STAFF	
Floor Finish	Inspected
Deficiency	No deficiencies recorded
Stalls	Inspected
Condition	2 - Between Good and Fair
Deficiency	No deficiencies recorded
Walls	Inspected
Condition	2 - Between Good and Fair
Deficiency	GYPSUM BOARD: DETERIORATED
Deficiency Location/Instance	2nd Floor Men
Deficiency Quantity	10
Quantity Uom	S.F.
Potential Action	REPLACE
Urgency of Action	PRIORITY 3
Purpose of Action	LEVEL 2
Deficiency Photo1

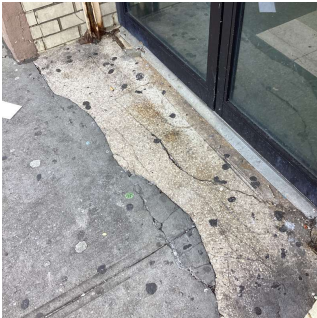
Student Use	Does not Exist
Site Sidewalks & Walkways	Inspected
Asphalt	Does not Exist
Concrete	Inspected
Condition	3 - Fair
Deficiency	DAMAGED/DETERIORATED/MISSING SECTIONS
Deficiency Location/Instance	Sutphin Boulevard, 90th Avenue
Deficiency Quantity	50

Question	Response
SITE	
PAVING	
Site Sidewalks & Walkways	
Concrete	
Quantity Uom	S.F.
Potential Action	REPLACE
Urgency of Action	PRIORITY 3
Purpose of Action	LEVEL 2
Deficiency Photo1

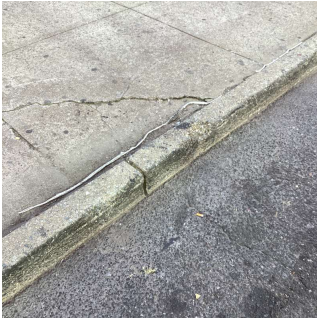
Sutphin Boulevard
Violations	No violations recorded.
Pavers	Does not Exist
DOT Sidewalk	Inspected
Asphalt	Does not Exist
Concrete	Inspected
Condition	3 - Fair
Deficiency	DAMAGED CURBS
Deficiency Location/Instance	90th Avenue
Deficiency Quantity	20
Quantity Uom	L.F.
Potential Action	REPLACE
Urgency of Action	PRIORITY 3
Purpose of Action	LEVEL 2
Deficiency Photo1

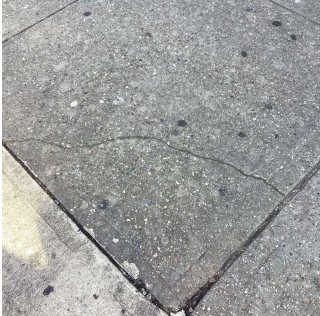
Sutphin Boulevard
Violations	No violations recorded.
Pavers	Does not Exist
PLAYGROUNDS	Does not Exist
PLAYING SURFACE	Does not Exist
RETAINING WALLS	Does not Exist
SEATING	Does not Exist
SITE WALLS (NOT RETAINING WALLS)	Does not Exist
STAIRS/RAMPS: EXTERIOR	Does not Exist
ARTWORK	Does not Exist

90th Avenue
Violations	No violations recorded.
Deficiency	DAMAGED/DETERIORATED/MISSING SECTIONS
Deficiency Location/Instance	Sutphin Boulevard, 90th Avenue
Deficiency Quantity	400
Quantity Uom	S.F.
Potential Action	REPLACE
Urgency of Action	PRIORITY 3
Purpose of Action	LEVEL 2
