NYC Department of Education
Building Condition Assessment Survey 2023 - 2024

Architectural Inspection

Q735

Asset: QUEENS HIGH SCHOOL COMPLEX - Q, 30-20 THOMSON AVE, New York, 11101

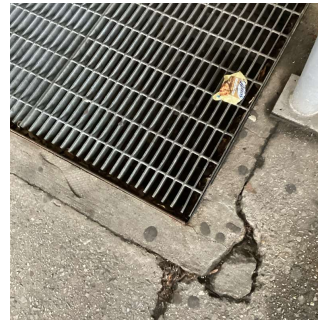
Question	Response
Architectural	
EXTERIOR	Inspected
AREAWAY	Inspected
Instance on AW1 - AW7	Inspected
Instance Condition	3 - Fair
Instance Quantity	7
Instance Quantity Uom	EACH
Deficiency	AREAWAY WALLS: CRACKS AND SPALLING

REPLACE

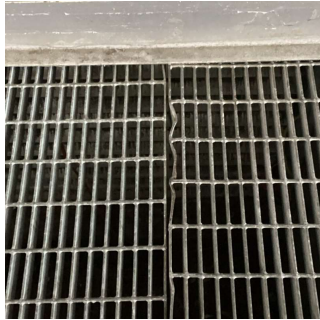
AREAWAY GRATINGS: MAJOR RUSTING / OR BROKEN

Violations	AW7 No violations recorded.
AWNINGS AND CANOPIES	
Condition	Inspected 3 - Fair
Deficiency	CONCRETE: MAJOR CRACKS/SPALLING
Roof Plan reference

REPLACE

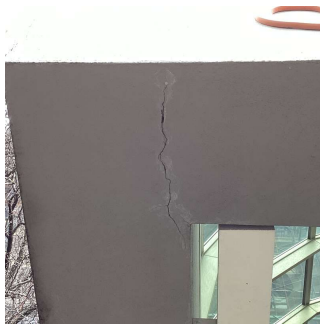
Deficiency Quantity	20
Quantity Uom	S.F.
Potential Action	REPAIR
Urgency of Action	PRIORITY 4
Purpose of Action	LEVEL 2
Deficiency Photo1

Violations	Facade A No violations recorded.
CHIMNEY	
Material Type(s)	Inspected Metal
Condition	2 - Between Good and Fair
Deficiency	No deficiencies recorded
COPING	
	Under Construction
CORNICE	
	Does not Exist
DOORS	
	Inspected
DOORS AND FRAMES	
	Inspected

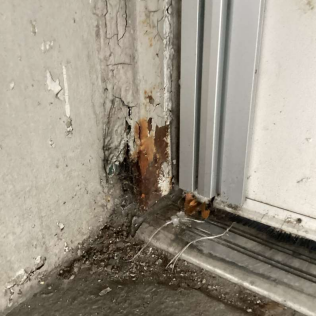
Question	Response
EXTERIOR	
DOORS	
DOORS AND FRAMES	
Condition	4 - Between Fair and Poor
Deficiency	METAL: DETERIORATED DOOR AND FRAME - MAJOR DETERIORATION
Roof Plan reference

Deficiency Quantity	2
Quantity Uom	EACH
Potential Action	REPLACE
Urgency of Action	PRIORITY 4
Purpose of Action	LEVEL 2
Deficiency Photo1

Violations	Facade B No violations recorded.
DOOR HARDWARE	Inspected
Condition	3 - Fair
Deficiency	No deficiencies recorded
LINTELS	Inspected
Condition	2 - Between Good and Fair
Deficiency	No deficiencies recorded
TRANSOM/SIDE LIGHT	Inspected
Condition	2 - Between Good and Fair
Deficiency	No deficiencies recorded
EXTERIOR WALLS	Inspected
Material Type(s)	Concrete, Masonry
Replacement Quantity	120,000
Replacement Uom	S.F.
Instance on All Facades	Under Construction
Instance Quantity	120,000
Instance Quantity Uom	S.F.
EXTERIOR SOFFITS	Inspected
Condition	2 - Between Good and Fair

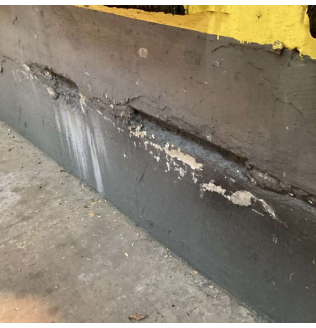
Question	Response
EXTERIOR	
EXTERIOR SOFFITS	Inspected
Deficiency	No deficiencies recorded
LOADING DOCK	Inspected
Condition	5 - Poor
Deficiency	CHEEK WALL/CRACKS, SPALLING - MAJOR
Roof Plan reference

Deficiency Quantity	40
Quantity Uom	S.F.
Potential Action	REPLACE
Urgency of Action	PRIORITY 4
Purpose of Action	LEVEL 2
Deficiency Photo1

Violations	Facade D No violations recorded.
Deficiency	DETERIORATED CONCRETE PLATFORM WITH CRACKED, SPALLED CONCRETE OR EXPOSED REINFORCING
Roof Plan reference

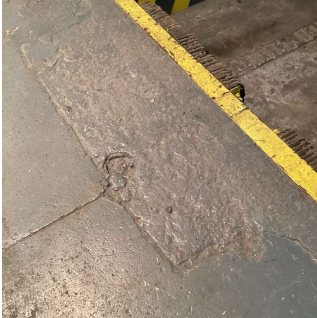
Deficiency Quantity	40
Quantity Uom	S.F.
Potential Action	REPAIR
Urgency of Action	PRIORITY 4
Purpose of Action	LEVEL 2

Violations	Facade D No violations recorded.
LOUVER	Inaccessible
PARAPETS	Inspected
Material Type(s)	Masonry
Replacement Quantity	8,000
Replacement Uom	C.F.
Instance on All Facades	Under Construction
Instance Quantity	8,000
Instance Quantity Uom	C.F.
PLAZA DECK	Does not Exist
ROOF	Inspected
Roofing	Inspected
Replacement Quantity	62,000
Replacement Uom	S.F.
ROOF HATCH/SMOKE HATCH	Inspected
Condition	2 - Between Good and Fair
Deficiency	No deficiencies recorded
LEADERS, GUTTERS, DOWNSPOUTS, SCUPPERS	Inspected
Condition	3 - Fair
Deficiency	DAMAGED/MISSING
RooF Plan reference

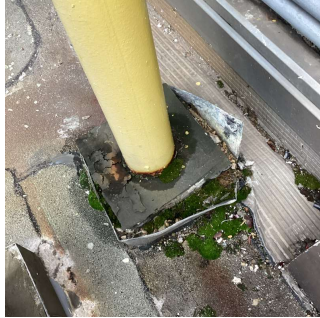
Roof 1
Instance Quantity	62,000
Instance Quantity Uom	S.F.
Does the roof have major mechanical equipment sitting on Dunnage Steel less than 18" above the Roofing?	No
Does this roof instance have a Sustainable Roof System?	No
Do solar panels exist on these roofs?	No
Is/Are the roof(s) suitable for Solar Panel installation?	No
Installation Year	2005
Source of Installation	Custodial Staff
Deficiency	MODIFIED BITUMEN: FLASHING: PITCH POCKET DETERIORATED - MAJOR
Roof Plan reference

Deficiency Quantity	1
Quantity Uom	EACH
Potential Action	REPLACE
Urgency of Action	PRIORITY 4
Purpose of Action	LEVEL 2
Deficiency Photo1

Roof 1
Violations	No violations recorded.
Deficiency	MODIFIED BITUMEN: ROOFING: DELAMINATION

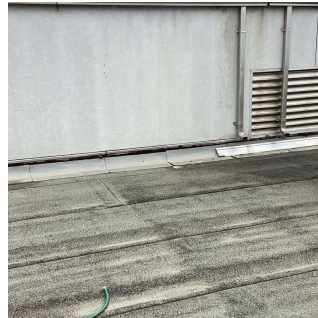
PH2

MODIFIED BITUMEN: FLASHING: CAP FLASHING DAMAGED

REPLACE

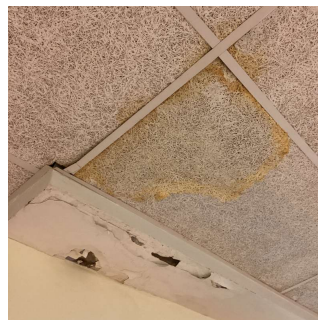
Roof 1 - Corridor near Room 825 (Roof 1 - Corridor near Stair
D/8 similar)

**MODIFIED BITUMEN: ROOFING: MAJOR ACTIVE ROOF
LEAKS IN INSTRUCTIONAL SPACE**

**REPLACE ROOFING WITHOUT MAJOR EQUIPMENT
REMOVAL**

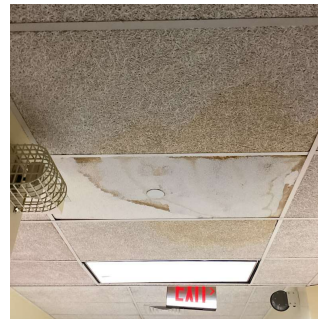
Roof 1 - Corridor near Boiler Room

**MODIFIED BITUMEN: ROOFING: MAJOR ACTIVE ROOF
LEAKS IN NON-INSTRUCTIONAL SPACE**

REPLACE ROOFING WITHOUT MAJOR EQUIPMENT REMOVAL

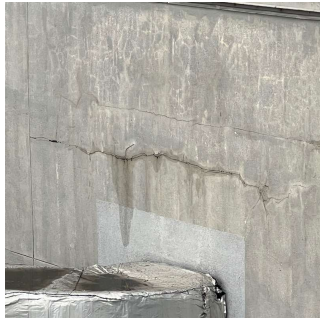
Deficiency **BULKHEAD/PENTHOUSE WALLS/EXTERIOR:
CRACKS/SPALLING - MAJOR**

80
S.F.
REPLACE
PRIORITY 4
LEVEL 2

Violations	PH3 No violations recorded.
CUPOLA/ SPIRES/ TOWERS	Does not Exist
DORMER	Does not Exist
DUNNAGE STEEL	Inspected
Condition	2 - Between Good and Fair
Deficiency	No deficiencies recorded
SKYLIGHT/ROOF VENT	Inspected
Material Type(s)	Plastic
Condition	3 - Fair
Deficiency	WATER INFILTRATION
Roof Plan reference

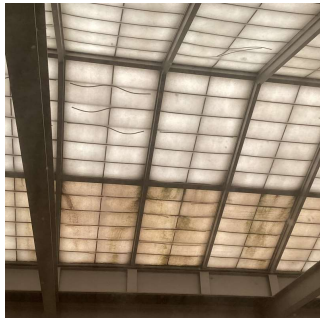
Deficiency Quantity	100
Quantity Uom	S.F.
Potential Action	MAINTENANCE
Urgency of Action	PRIORITY 3
Purpose of Action	LEVEL 2
Deficiency Photo1

Violations	SK2 No violations recorded.

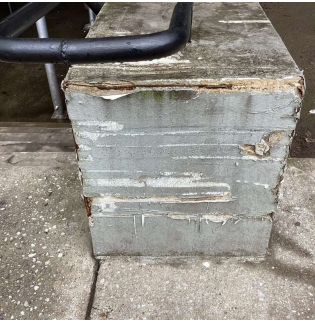
Question	Response
EXTERIOR	
ROOF	Inspected
Specialties	
ROOF/GRAVITY TANK	Inspected
Condition	2 - Between Good and Fair
Deficiency	No deficiencies recorded
STAIRS/RAMPS: EXTERIOR	Inspected
BUILDING CHEEK/FLANK WALLS	Inspected
Condition	4 - Between Fair and Poor
Deficiency	CAST IN PLACE CONCRETE: CRACKS/SPALLING - MAJOR
Roof Plan reference

Deficiency Quantity	20
Quantity Uom	S.F.
Potential Action	REPLACE
Urgency of Action	PRIORITY 4
Purpose of Action	LEVEL 2
Deficiency Photo1

Violations	Facade A No violations recorded.
RAILINGS	Inspected
Condition	2 - Between Good and Fair
Deficiency	No deficiencies recorded
STAIRS/RAMPS	Inspected
Condition	5 - Poor
Deficiency	CONCRETE: CRACKS/SPALLING - MINOR

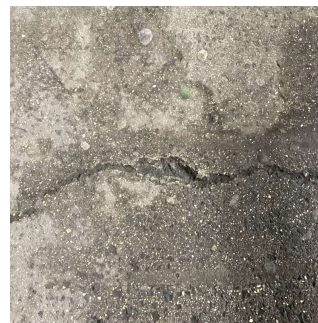
Facade A

CONCRETE: CRACKS/SPALLING - MAJOR

REPLACE

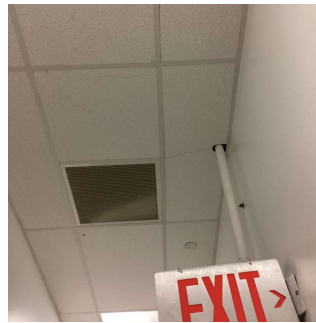
Violations	PH1 No violations recorded.
VAULTS-BUNKERS	Does not Exist
AUDITORIUM	Inspected
Instance on 8th Floor (342 Seats)	Inspected
Ceiling	
Instance on 8th Floor (342 Seats)	Inspected
Condition	2 - Between Good and Fair
Deficiency	ACOUSTIC TILES: DAMAGED/MISSING
Deficiency Location/Instance	Left Side of Stage
Deficiency Quantity	10
Quantity Uom	S.F.
Potential Action	REPLACE
Urgency of Action	PRIORITY 3
Purpose of Action	LEVEL 2

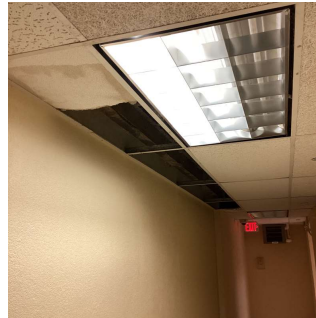
Corridor Near Stair D/8

ACOUSTIC TILES: DAMAGED/MISSING - ACTIVE LEAK

REPLACE

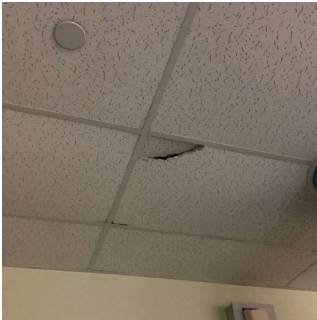
Violations	Near Entrance No violations recorded.
Window Curtains/Shades/Blinds	
Instance on 5th Floor	Does not Exist
Instance on 7th Floor	Does not Exist
CLASSROOMS/CORRIDORS/ADMIN SPACES	
Ceiling	Inspected
Condition	2 - Between Good and Fair
Deficiency	ACOUSTIC TILES: DAMAGED/MISSING
Deficiency Location/Instance	Rooms 750/750A, 732, 702, 648, 639 and others
Deficiency Quantity	120
Quantity Uom	S.F.
Potential Action	REPLACE
Urgency of Action	PRIORITY 3
Purpose of Action	LEVEL 2
Deficiency Photo1

Violations	Room 750/750A No violations recorded.
Deficiency	TECTUM: DAMAGED/MISSING
Deficiency Location/Instance	Corridor near Rooms 748, 740A, 735, 702, 614 and others
Deficiency Quantity	160
Quantity Uom	S.F.
Potential Action	REPLACE
Urgency of Action	PRIORITY 3
Purpose of Action	LEVEL 2

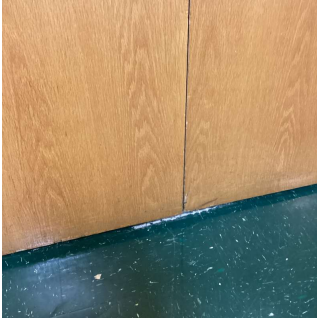
Question	Response
INTERIOR	
CLASSROOMS/CORRIDORS/ADMIN SPACES	
Door(s)	Inspected
Condition	5 - Poor
Deficiency	WOOD: DETERIORATED DOOR
Deficiency Location/Instance	Rooms 750, 748, 737, 708, 618 and others
Deficiency Quantity	20
Quantity Uom	EACH
Potential Action	MAINTENANCE
Urgency of Action	PRIORITY 3
Purpose of Action	LEVEL 2
Deficiency Photo1

Violations	Room 708 No violations recorded.
Floor Finish	Inspected
Condition	2 - Between Good and Fair
Deficiency	TERRAZZO: CRACKS
Deficiency Location/Instance	Corridor near 1st Floor Elevators , Main Entrance Lobby
Deficiency Quantity	80
Quantity Uom	S.F.
Potential Action	REPLACE
Urgency of Action	PRIORITY 3
Purpose of Action	LEVEL 2
Deficiency Photo1	 
Violations	Corridor near 1st Floor Elevators No violations recorded.
Deficiency	VINYL TILES: DETERIORATED SUBSTRATE
Deficiency Location/Instance	Corridor near Rooms 651, 561, 559, 457, 454 and others
Deficiency Quantity	140

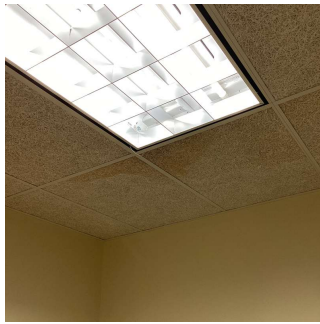
Violations	Left Side No violations recorded.
STAIRS/RAMPS: INTERIOR	
Do Letter Stair Signs Exist?	Inspected Yes
Ceiling	Inspected
Condition	2 - Between Good and Fair
Deficiency	TECTUM: DAMAGED/MISSING
Deficiency Location/Instance	Stairs D/7, E/4
Deficiency Quantity	20
Quantity Uom	S.F.
Potential Action	REPLACE
Urgency of Action	PRIORITY 3
Purpose of Action	LEVEL 2
Deficiency Photo1

Violations	Stair D/7 No violations recorded.
Deficiency	ACOUSTIC TILES: DAMAGED/MISSING
Deficiency Location/Instance	Stairs E/7, F/7, G/7, 6
Deficiency Quantity	80
Quantity Uom	S.F.
Potential Action	REPLACE
Urgency of Action	PRIORITY 3
Purpose of Action	LEVEL 2

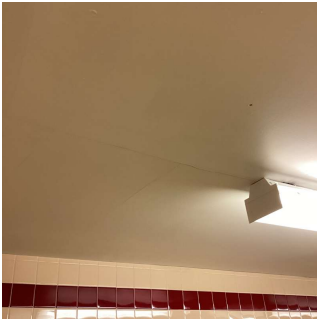
Violations	Room 711 No violations recorded.
TOILET ROOMS - STUDENTS	Inspected
Ceiling	Inspected
Condition	2 - Between Good and Fair
Deficiency	GYPSUM BOARD: DAMAGED/DETERIORATED
Deficiency Location/Instance	Room 747
Deficiency Quantity	20
Quantity Uom	S.F.
Potential Action	REPLACE
Urgency of Action	PRIORITY 3
Purpose of Action	LEVEL 2
Deficiency Photo1

Violations	Room 747 No violations recorded.
Door(s)	Inspected
Condition	5 - Poor
Deficiency	WOOD: DAMAGED LOUVER
Deficiency Location/Instance	Rooms 747, 627, 511, 507, 407 and others
Deficiency Quantity	6
Quantity Uom	EACH
Potential Action	MAINTENANCE
Urgency of Action	PRIORITY 3
Purpose of Action	LEVEL 2
