**NYC Department of Education**  
**Building Condition Assessment Survey 2023 - 2024**

Architectural Inspection

Q739

**Asset:**        **YOUNG WOMEN'S LEADERSHIP ACADEMY- QUEENS, 23-15 NEWTOWN AVENUE,  
New York, 11102**

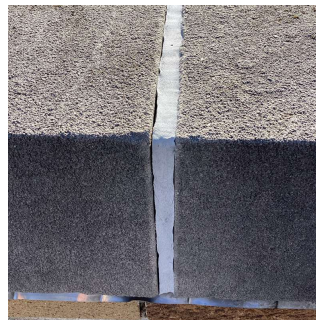
Roof 1

CAST STONE: DETERIORATED TRANSVERSE JOINTS

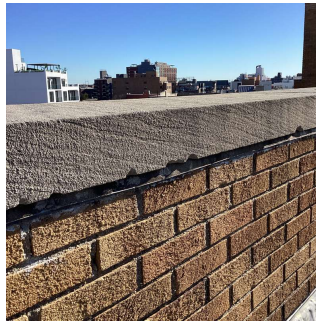
Roof 1  
No violations recorded.

CAST STONE: CRACKED/BROKEN PIECES

20  
L.F.  
REPLACE-IN-KIND  
PRIORITY 4  
LEVEL 2

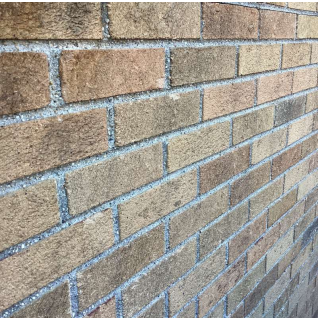
Question	Response
<b>EXTERIOR</b>	
<b>EXTERIOR WALLS</b>	
Material Type(s)	Masonry
Replacement Quantity	19,000
Replacement Uom	S.F.
Instance on All Facades	Inspected
Instance Condition	4 - Between Fair and Poor
Instance Quantity	19,000
Instance Quantity Uom	S.F.
Deficiency	BRICK: DETERIORATED JOINTS
Roof Plan reference	<p><b>Q739</b></p>

Deficiency Quantity	800
Quantity Uom	S.F.
Potential Action	REPOINT
Urgency of Action	PRIORITY 3
Purpose of Action	LEVEL 2
Deficiency Photo1

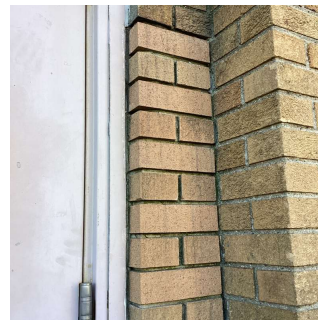
Facade B

Violations	Facade C No violations recorded.
Deficiency	BRICK: DETERIORATED JOINTS

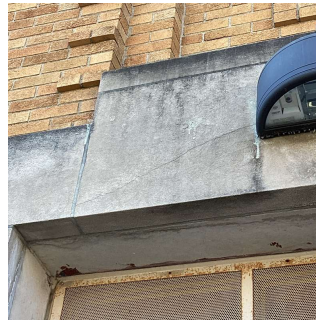
Facade C

STONE: CHIPPED/SPALLED/BROKEN PIECES - MINOR

REPAIR

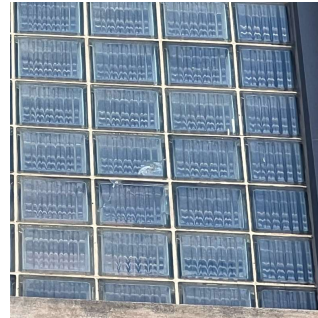
Facade B

GLASS BLOCK: CHIPPED/ BROKEN PIECES

REPLACE-IN-KIND

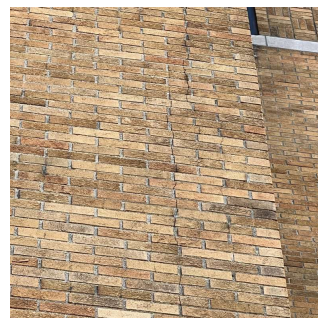
BRICK: CRACKS/DISPLACED/SPALLED BRICK AT BUILDING CORNERS

200  
S.F.  
REMOVE AND REBUILD  
PRIORITY 4  
LEVEL 2

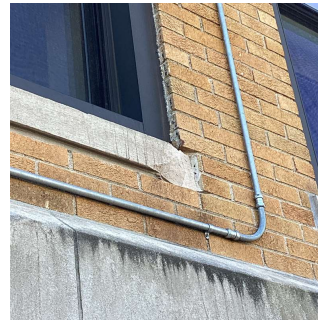
Facade C

BRICK: DETERIORATED MASONRY SILLS - MAJOR

REMOVE AND REPLACE

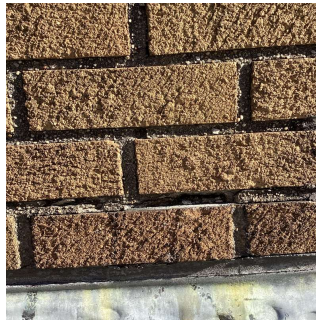
Roof 1  
 No violations recorded.

BRICK: DETERIORATED JOINTS

20  
 S.F.  
 REPOINT  
 PRIORITY 4  
 LEVEL 2

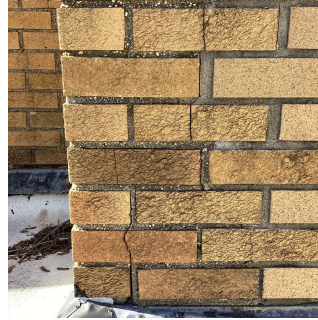
Roof 1

**BRICK: MAJOR DETERIORATION/CRACKS**

20  
 S.F.  
 REMOVE AND REBUILD  
 PRIORITY 4  
 LEVEL 2

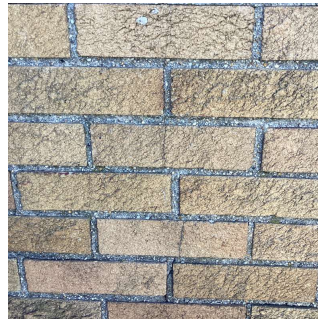
Roof 1

BRICK: MINOR CRACKS, SPALLING

REPAIR

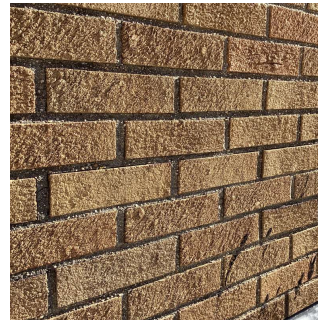
Roof 1

BRICK: DETERIORATED JOINTS

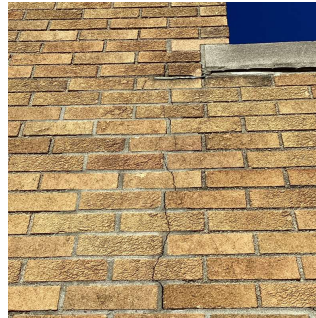
BH1

**BULKHEAD/PENTHOUSE WALLS/EXTERIOR:  
 CRACKS/SPALLING - MAJOR**

40  
 S.F.  
 REPLACE  
 PRIORITY 4  
 LEVEL 2

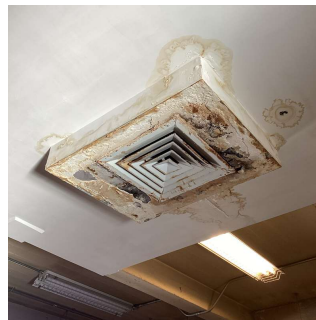
BH2

**BULKHEAD/PENTHOUSE CEILING: PLASTER DAMAGED/DETERIORATED**

REPLACE

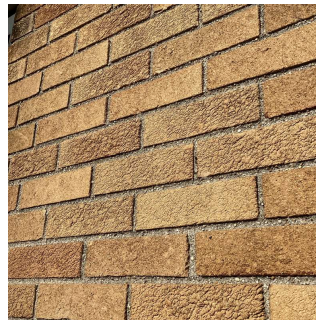
PH2  
No violations recorded.

**BULKHEAD/PENTHOUSE WALLS/EXTERIOR: DETERIORATED JOINTS**

200  
S.F.  
REPOINT  
PRIORITY 3  
LEVEL 2

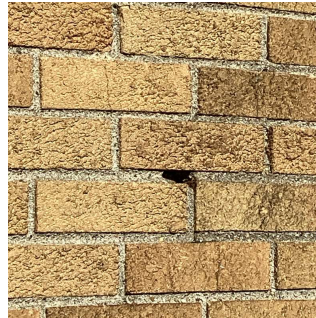
BH1

**BULKHEAD/PENTHOUSE WALLS/EXTERIOR: DETERIORATED JOINTS**

40  
S.F.  
REPOINT  
PRIORITY 4  
LEVEL 2

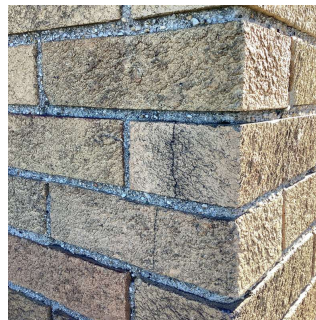
PH1

**BULKHEAD/PENTHOUSE WALLS/EXTERIOR:  
CRACKS/SPALLING - MINOR**

REPAIR

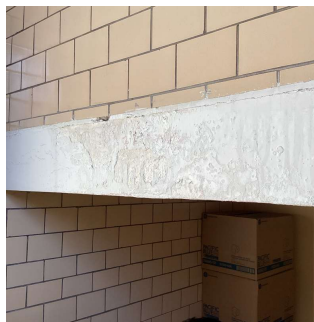
BH2  
No violations recorded.

**BULKHEAD/PENTHOUSE WALLS/INTERIOR: PLASTER  
CRACKS/SPALLING**

100  
S.F.  
REPLACE  
PRIORITY 4  
LEVEL 2

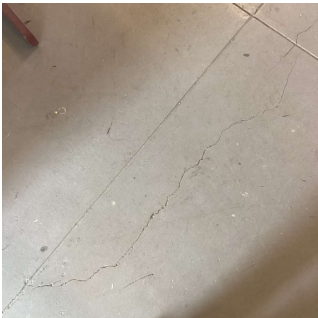
Question	Response
<b>INTERIOR</b>	
<b>STRUCTURAL</b>	
<b>FLOOR STRUCTURE</b>	
Deficiency	CONCRETE: CRACKS/SPALLED/REINFORCEMENT EXPOSED
Deficiency Location/Instance	BH2
Deficiency Quantity	10
Quantity Uom	S.F.
Potential Action	REPAIR
Urgency of Action	PRIORITY 4
Purpose of Action	LEVEL 5
Deficiency Photo1	 
Violations	PH2 No violations recorded.
Deficiency	CONCRETE: CRACKS/SPALLED/REINFORCEMENT EXPOSED
Deficiency Location/Instance	BH2
Deficiency Quantity	20
Quantity Uom	S.F.
Potential Action	REPAIR
Urgency of Action	PRIORITY 3
Purpose of Action	LEVEL 5
Deficiency Photo1

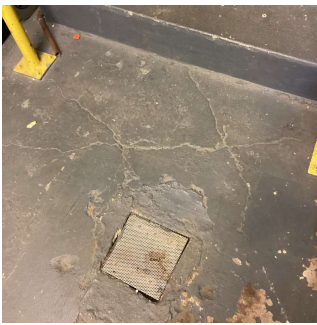
Violations	PH2 No violations recorded.
Deficiency	CONCRETE SLAB ON GRADE: THRU CRACKS
Deficiency Location/Instance	Boiler Room
Deficiency Quantity	80
Quantity Uom	S.F.
Potential Action	REPAIR
Urgency of Action	PRIORITY 3
Purpose of Action	LEVEL 5

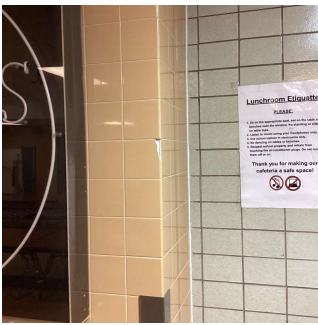
Deficiency	CERAMIC TILE: BROKEN/ MISSING
Deficiency Location/Instance	Near Windows
Deficiency Quantity	10
Quantity Uom	S.F.
Potential Action	REPLACE
Urgency of Action	PRIORITY 3
Purpose of Action	LEVEL 2

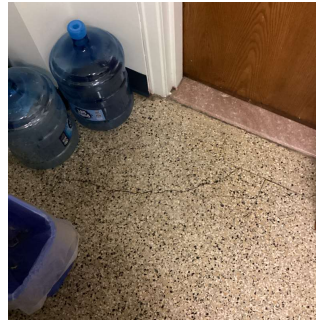
Violations	Room 119 No violations recorded.
Deficiency	TERRAZZO: CRACKS
Deficiency Location/Instance	Corridor near Rooms 207, 205, 202, Corridor near Exit , Room 117 and others
Deficiency Quantity	150
Quantity Uom	S.F.
Potential Action	REPLACE
Urgency of Action	PRIORITY 3
Purpose of Action	LEVEL 2

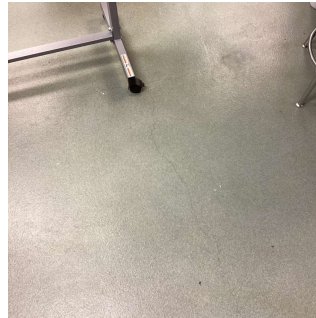
Room 511

**EPOXY FLOORING: CRACKS/SPALLING**

REPLACE

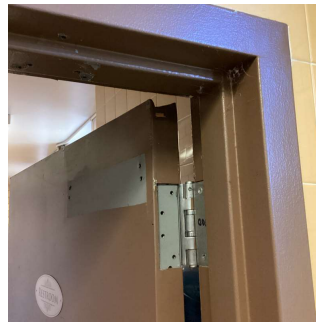
Room 313
Violations	No violations recorded.
<hr/>	
Deficiency	METAL: DETERIORATED DOOR
Deficiency Location/Instance	Room 005
Deficiency Quantity	1
Quantity Uom	EACH
Potential Action	MAINTENANCE
Urgency of Action	PRIORITY 3
Purpose of Action	LEVEL 2

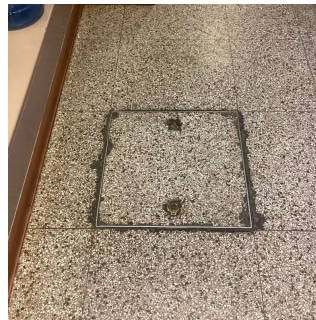
Room 005

TERRAZZO: CRACKS

REPLACE

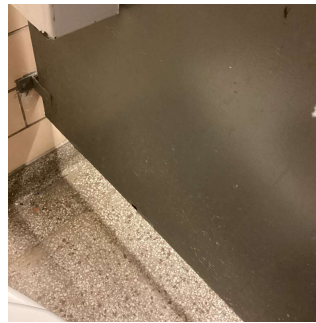
Room 005

RUST - MAJOR

REPLACE

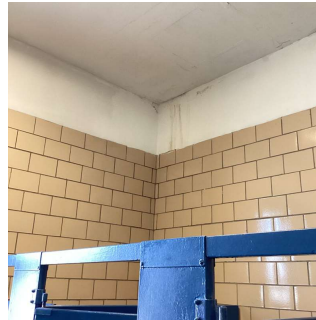
Room 313

PLASTER: CRACKS/SPALLING

REPLACE
