**NYC Department of Education**  
**Building Condition Assessment Survey 2023 - 2024**

Architectural Inspection

**Asset:** ELMHURST EDUCATIONAL CAMPUS - Q, 45-10 94TH STREET, New York, 11373

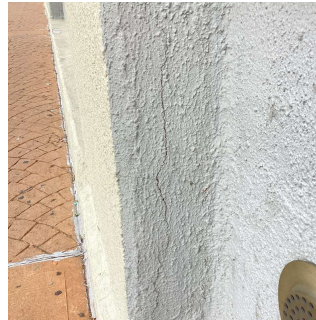
Facade A

Question	Response
<b>EXTERIOR</b>	
<b>DOORS</b>	
<b>DOOR HARDWARE</b>	Inspected
Condition	3 - Fair
Deficiency	No deficiencies recorded
<b>LINTELS</b>	Does not Exist
<b>TRANSOM/SIDE LIGHT</b>	Inspected
Condition	2 - Between Good and Fair
Deficiency	No deficiencies recorded
<b>EXTERIOR WALLS</b>	Inspected
Material Type(s)	Concrete
Replacement Quantity	24,200
Replacement Uom	S.F.
Instance on All Facades	Inspected
Instance Condition	3 - Fair
Instance Quantity	24,200
Instance Quantity Uom	S.F.
Deficiency	CAST IN PLACE / PRE-CAST CONCRETE: MINOR CRACKS/SPALLING

100  
S.F.  
REPAIR  
PRIORITY 3  
LEVEL 2

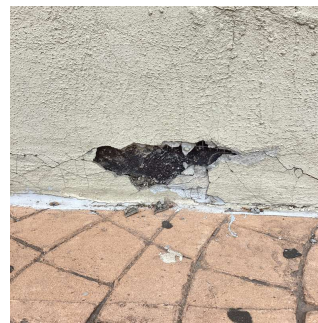
Facade A

CAST IN PLACE / PRE-CAST CONCRETE: MAJOR CRACKS/SPALLING

REPLACE

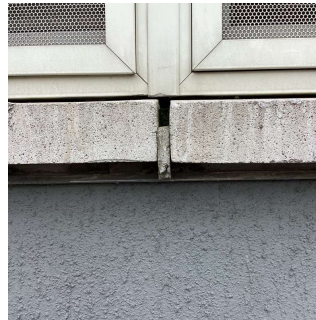
Facade C

STONE: MASONRY SILLS - DETERIORATED JOINTS

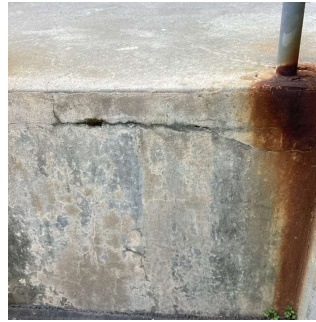
Facade C

CHEEK WALL/CRACKS, SPALLING - MINOR

REPAIR

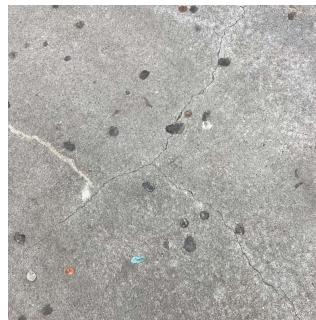
Loading Dock 2

**DETERIORATED CONCRETE PLATFORM WITH CRACKED, SPALLED CONCRETE OR EXPOSED REINFORCING**

REPAIR

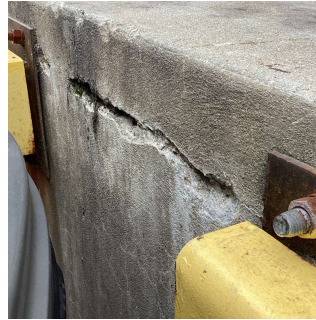
Loading Dock 1  
No violations recorded.

**CHEEK WALL/CRACKS, SPALLING - MAJOR**

25  
S.F.  
REPLACE  
PRIORITY 4  
LEVEL 2

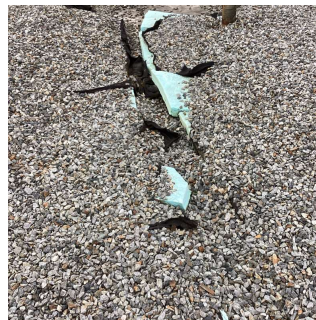
Roof 1

IRMA: ROOFING: DAMAGED INSULATION

REPLACE

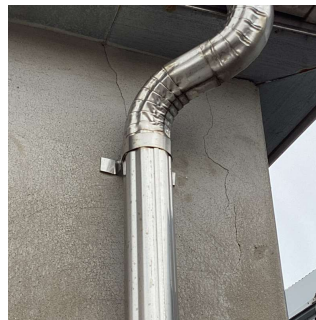
BH

**BULKHEAD/PENTHOUSE WALLS/EXTERIOR:  
CRACKS/SPALLING - MINOR**

REPAIR

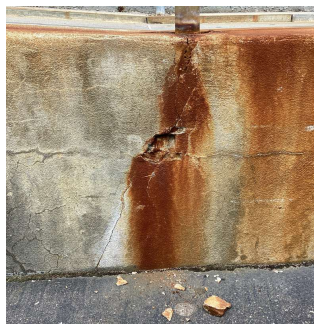
Violations	Facade C No violations recorded.
Deficiency	CONCRETE: CRACKS/SPALLING - MAJOR

10  
S.F.  
REPLACE  
PRIORITY 4  
LEVEL 2

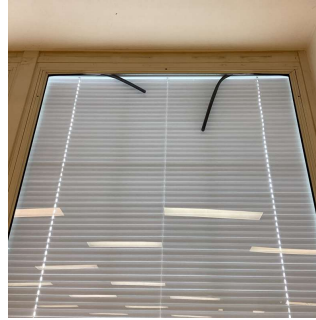
Facade C - 4th Floor Multi-purpose Room  
No violations recorded.

ALUMINUM - OTHER: DETERIORATED

REPLACE WINDOW  
PRIORITY 4  
LEVEL 2

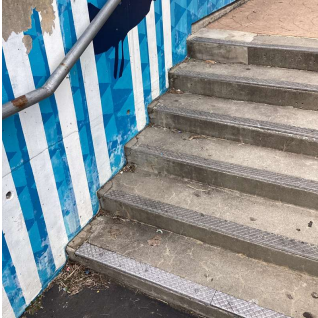
Near Main Entrance
Violations	No violations recorded.
Deficiency	CAST IN PLACE CONCRETE: CRACKS/SPALLING - MAJOR
Deficiency Location/Instance	Near Main Entrance
Deficiency Quantity	10
Quantity Uom	S.F.
Potential Action	REPLACE
Urgency of Action	PRIORITY 5
Purpose of Action	LEVEL 6
