NYC Department of Education
Building Condition Assessment Survey 2023 - 2024

Architectural Inspection

Asset: AVIATION HS ANNEX - QUEENS, 141 JFK AIRPORT, BUILDING #141, New York, 11434

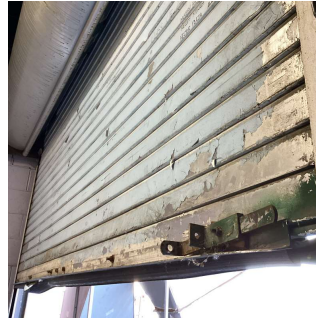
Facade B

Question	Response
Architectural	
EXTERIOR	Inspected
AREAWAY	Does not Exist
AWNINGS AND CANOPIES	Does not Exist
CHIMNEY	Does not Exist
COPING	Does not Exist
CORNICE	Does not Exist
DOORS	Inspected
DOORS AND FRAMES	Inspected
Condition	5 - Poor
Deficiency	ROLL-UP DOOR: DETERIORATED DOOR AND FRAME - MAJOR DETERIORATION
Roof Plan reference

Deficiency Quantity	900
Quantity Uom	S.F.
Potential Action	REPLACE
Urgency of Action	PRIORITY 4
Purpose of Action	LEVEL 2
Deficiency Photo1

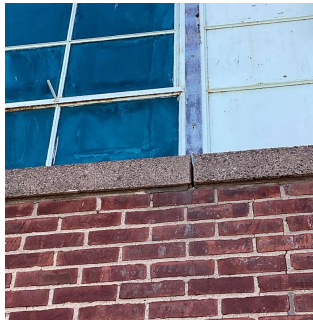
Facade B

Material Type(s)	Inspected
Replacement Quantity	Masonry
Replacement Uom	5,000
	S.F.
Instance on Facades A, B	Inspected
Instance Condition	4 - Between Fair and Poor
Instance Quantity	5,000
Instance Quantity Uom	S.F.
Deficiency	BRICK: MASONRY SILLS - DETERIORATED JOINTS
Roof Plan reference

Deficiency Quantity

30

L.F.

REPOINT

PRIORITY 3

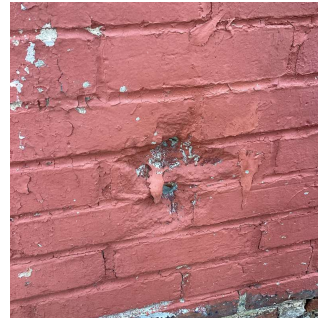
Facade B

BRICK: MAJOR / THRU CRACKS

Deficiency Quantity

60

REMOVE AND REBUILD

PRIORITY 4
LEVEL 2

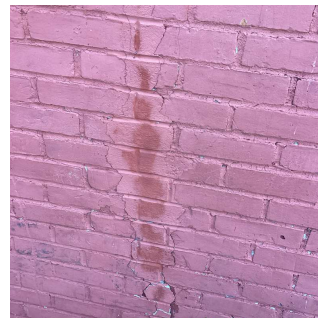
Facade B

BRICK: MINOR CRACKS AND SPALLING

Deficiency Quantity

50

RESTITCH

PRIORITY 3

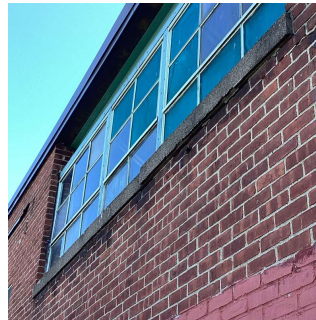
Facade B

BRICK: DETERIORATED MASONRY SILLS - MINOR

Deficiency Quantity

10

REPAIR

PRIORITY 3

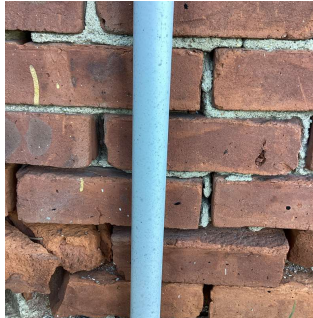
Facade B

BRICK: DETERIORATED JOINTS

Deficiency Quantity

30

REPOINT

PRIORITY 4

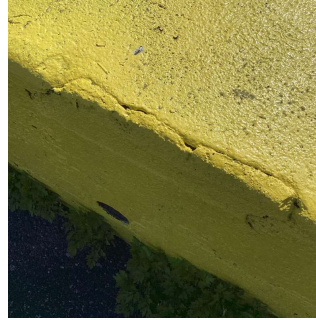
Loading Dock

CHEEK WALL/CRACKS, SPALLING - MINOR

Deficiency Quantity

20

REPAIR

PRIORITY 3

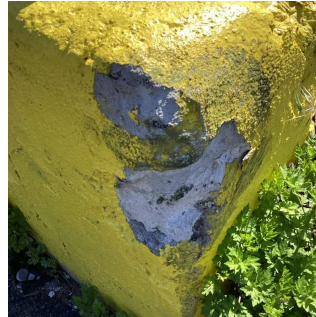
Loading Dock

CHEEK WALL/CRACKS, SPALLING - MAJOR

Deficiency Quantity

10

REPLACE

PRIORITY 4

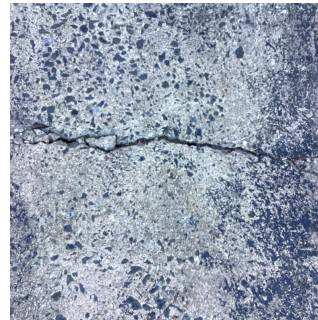
Loading Dock

DETERIORATED CONCRETE PLATFORM WITH CRACKED, SPALLED CONCRETE OR EXPOSED REINFORCING

Deficiency Quantity
Quantity Uom
Potential Action
Urgency of Action
Purpose of Action
Deficiency Photo1

30
S.F.
REPAIR
PRIORITY 3
LEVEL 2

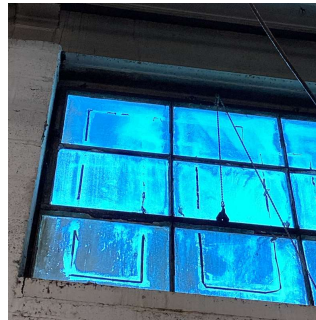
Facade B
No violations recorded.

Instance on Steel: Facade B	Inspected
Instance Condition	5 - Poor
Instance Quantity	1,000
Instance Quantity Uom	S.F.
Are these windows insulated	No
Installation Year	1950
Source of Installation	Custodial Staff
Deficiency	STEEL: DETERIORATED
Roof Plan reference	Q750

Deficiency Quantity
Quantity Uom
Potential Action
Urgency of Action
Purpose of Action
Deficiency Photo1

1,000
S.F.
REPLACE WINDOW
PRIORITY 4
LEVEL 2

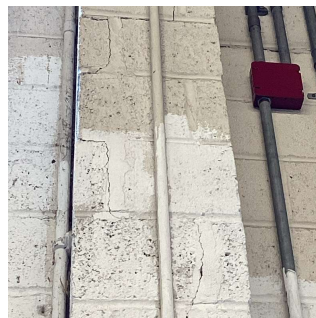
STEEL COLUMNS/BEAMS: DETERIORATED MASONRY
FIREPROOFING

Room 2014

Deficiency Quantity

20

REPLACE

PRIORITY 3

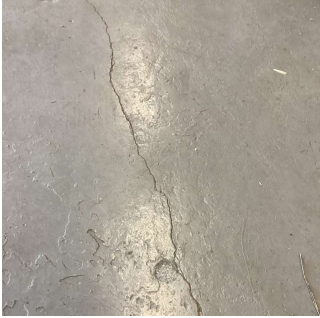
Question	Response
INTERIOR	
STRUCTURAL	
COLUMNS/BEAMS/BEARING WALLS	
Violations	Room 2014 No violations recorded.
Deficiency	STEEL COLUMNS/BEAMS: DETERIORATED MASONRY FIREPROOFING
Deficiency Location/Instance	Room 2006
Deficiency Quantity	60
Quantity Uom	S.F.
Potential Action	REPLACE
Urgency of Action	PRIORITY 4
Purpose of Action	LEVEL 5
Deficiency Photo1	 
Violations	Room 2006 No violations recorded.
FLOOR STRUCTURE	
Condition	Inspected 3 - Fair
Deficiency	CONCRETE SLAB ON GRADE: THRU CRACKS
Deficiency Location/Instance	Room 2014
Deficiency Quantity	50
Quantity Uom	S.F.
Potential Action	REPAIR
Urgency of Action	PRIORITY 3
Purpose of Action	LEVEL 5
Deficiency Photo1

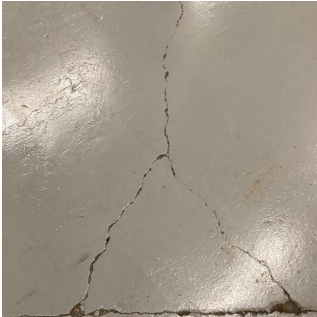
Violations	Room 2014 No violations recorded.
Deficiency	CONCRETE SLAB ON GRADE: THRU CRACKS
Deficiency Location/Instance	Rooms 2006, 2014
Deficiency Quantity	70
Quantity Uom	S.F.
Potential Action	REPLACE
Urgency of Action	PRIORITY 4

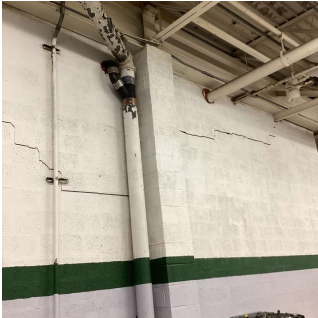
Yes	Potential Falling Debris	Severely damaged CMU walls with large cracks and displaced sections is potential safety hazard.	INTERIOR CLASSROOMS /CORRIDORS/ ADMIN SPACES Walls	Room 2006	Dennis Dominguez	Fireman
-----	--------------------------	---	--	-----------	------------------	---------

Question	Response
INTERIOR	
CLASSROOMS/CORRIDORS/ADMIN SPACES	
Walls	
Deficiency	MASONRY: CRACKS/SPALLING
Deficiency Location/Instance	Rooms 2006, 2014
Deficiency Quantity	1,000
Quantity Uom	S.F.
Potential Action	REPLACE
Urgency of Action	PRIORITY 5
Purpose of Action	LEVEL 6
Deficiency Photo1

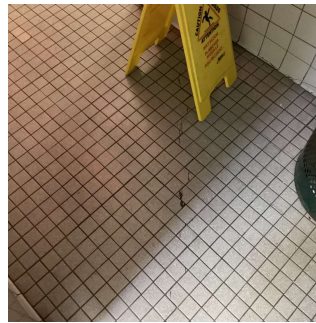
Question	Response
INTERIOR	
TOILET ROOMS - STAFF	
Walls	
Deficiency Photo1	 
Violations	Room 2007 No violations recorded.
TOILET ROOMS - STUDENTS	
Ceiling	Inspected
Condition	3 - Fair
Deficiency	ACOUSTIC TILES: DAMAGED/MISSING
Deficiency Location/Instance	1st Floor - Boys
Deficiency Quantity	20
Quantity Uom	S.F.
Potential Action	REPLACE
Urgency of Action	PRIORITY 3
Purpose of Action	LEVEL 2
Deficiency Photo1	 
Violations	1st Floor - Boys No violations recorded.
Door(s)	Inspected
Condition	2 - Between Good and Fair
Deficiency	No deficiencies recorded
Floor Finish	Inspected
Condition	2 - Between Good and Fair
Deficiency	CERAMIC TILE: DETERIORATED SUBSTRATE
Deficiency Location/Instance	1st Floor - Boys
Deficiency Quantity	10
Quantity Uom	S.F.
Potential Action	REPLACE
Urgency of Action	PRIORITY 3
Purpose of Action	LEVEL 2

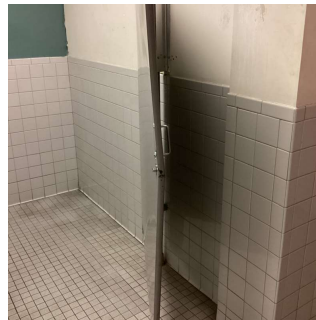
BROKEN/MISSING

1st Floor - Boys

Deficiency Quantity

1

REPLACE

PRIORITY 3

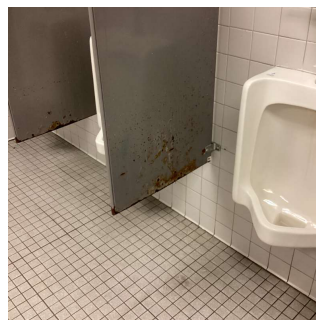
RUST - MAJOR

1st Floor - Boys

Deficiency Quantity

4

REPLACE

PRIORITY 3

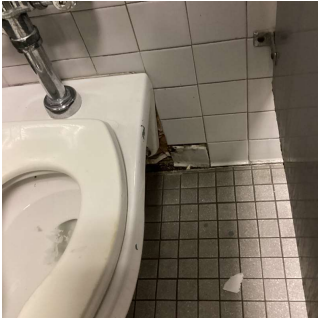
1st Floor - Boys
Violations	No violations recorded.
LIFE SAFETY	Inspected
F.D. HOLDING AREA	Does not Exist
STEEL STAIRS	Does not Exist
SITE	Not Required
ARTWORK	Does not Exist

Question	Response
INTERIOR	
TOILET ROOMS - STUDENTS	
Stalls	Inspected
	1st Floor - Boys
Violations	No violations recorded.
Walls	Inspected
Condition	2 - Between Good and Fair
Deficiency	GYP SUM BOARD: DETERIORATED
Deficiency Location/Instance	1st Floor - Boys
Deficiency Quantity	10
Quantity Uom	S.F.
Potential Action	REPLACE
Urgency of Action	PRIORITY 3
Purpose of Action	LEVEL 2
Deficiency Photo1	 
	1st Floor - Boys
Violations	No violations recorded.
Deficiency	CERAMIC TILE: BROKEN/ MISSING
Deficiency Location/Instance	1st Floor - Boys
Deficiency Quantity	10
Quantity Uom	S.F.
Potential Action	REPLACE
Urgency of Action	PRIORITY 3
Purpose of Action	LEVEL 2
Deficiency Photo1
