**NYC Department of Education  
Building Condition Assessment Survey 2023 - 2024**

Architectural Inspection

**Asset: QUEENS HS FOR THE SCIENCES - QUEENS, 94-50 159 STREET, New York, 11433**

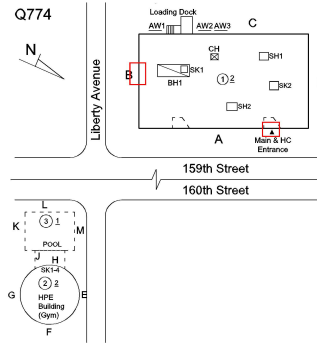
Facade A

Question	Response
<b>Architectural</b>	
<b>EXTERIOR</b>	Inspected
<b>AREAWAY</b>	Not Required
<b>AWNINGS AND CANOPIES</b>	Not Required
<b>CHIMNEY</b>	Inspected
Material Type(s)	Masonry
Condition	2 - Between Good and Fair
Deficiency	No deficiencies recorded
<b>COPING</b>	Inspected
Condition	2 - Between Good and Fair
Deficiency	No deficiencies recorded
<b>CORNICE</b>	Does not Exist
<b>DOORS</b>	Inspected
<b>DOORS AND FRAMES</b>	Inspected
Condition	3 - Fair
Deficiency	METAL: DETERIORATED DOOR AND FRAME - MAJOR DETERIORATION

4  
EACH  
REPLACE  
PRIORITY 4  
LEVEL 2

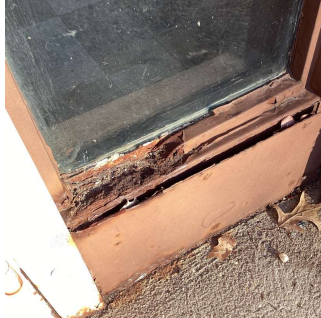
METAL: DENTED, MAJOR RUSTING

Question	Response
<b>EXTERIOR</b>	
<b>DOORS</b>	
<b>TRANSOM/SIDE LIGHT</b>	
Urgency of Action	PRIORITY 4
Purpose of Action	LEVEL 2
Deficiency Photo1

20  
S.F.  
REPLACE

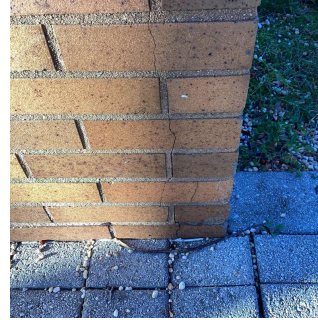
Facade A

Violations	Facade B No violations recorded.
<b>EXTERIOR WALLS</b>	Inspected
Material Type(s)	Concrete, Masonry
Replacement Quantity	16,000
Replacement Uom	S.F.
Instance on All Facades	Inspected
Instance Condition	3 - Fair
Instance Quantity	16,000
Instance Quantity Uom	S.F.
Deficiency	BRICK: CRACKS/DISPLACED/SPALLED BRICK AT BUILDING CORNERS
Roof Plan reference	<p>Q774</p>

Deficiency Quantity	30
Quantity Uom	S.F.
Potential Action	REMOVE AND REBUILD
Urgency of Action	PRIORITY 4
Purpose of Action	LEVEL 2

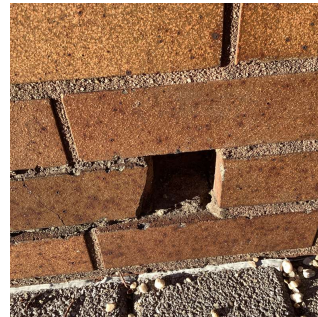
Facade A

**BRICK: MAJOR / THRU CRACKS**

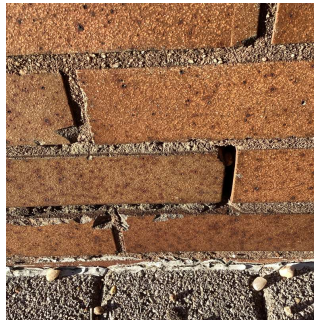
Facade A

**BRICK: DETERIORATED JOINTS**

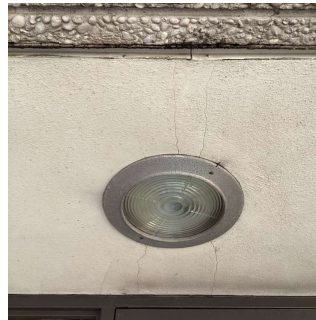
Facade A

CONCRETE: MINOR CRACKS/SPALLING

REPAIR

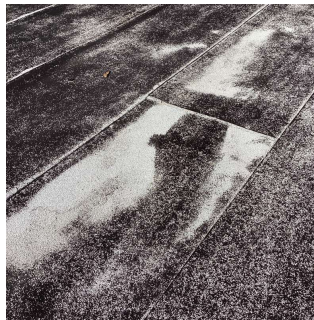
Roof 1

Deficiency	MODIFIED BITUMEN: ROOFING: DELAMINATION
------------	---

REPLACE ROOFING WITHOUT MAJOR EQUIPMENT REMOVAL

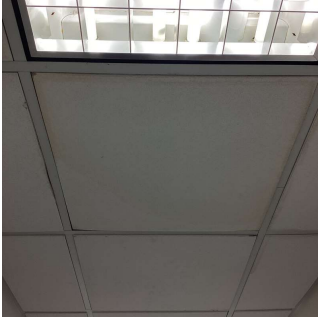
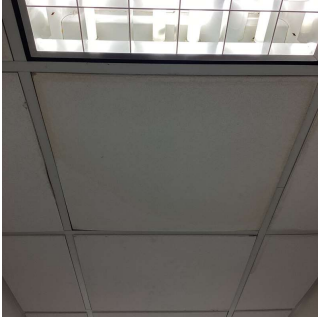
Roof 1 - Room 218, also Roof 1 - Room 222  
No violations recorded.

MODIFIED BITUMEN: ROOFING: MAJOR ACTIVE ROOF LEAKS IN INSTRUCTIONAL SPACE

Deficiency Quantity	200
Quantity Uom	S.F.
Potential Action	REPLACE ROOFING WITHOUT MAJOR EQUIPMENT REMOVAL
Urgency of Action	PRIORITY 5
Purpose of Action	LEVEL 2
Deficiency Photo1

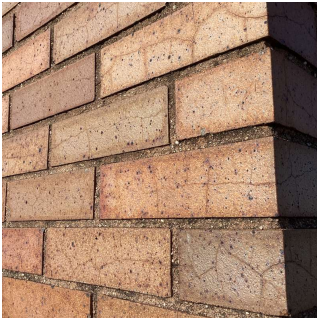
Condition	3 - Fair
Deficiency	BULKHEAD/PENTHOUSE WALLS/EXTERIOR: CRACKS/SPALLING - MINOR

Violations	Roof 1 - Bulkhead No violations recorded.
Deficiency	<b>BULKHEAD/PENTHOUSE WALLS/EXTERIOR: CRACKS/SPALLING - MAJOR</b>
Roof Plan reference

Deficiency Quantity	50
Quantity Uom	S.F.
Potential Action	REPAIR
Urgency of Action	PRIORITY 3
Purpose of Action	LEVEL 2

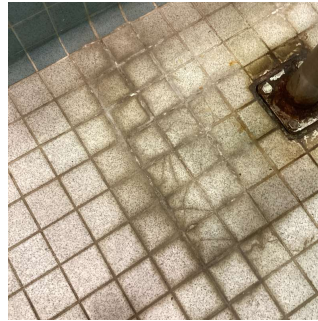
<b>CEILING</b>	
Instance on 1st Floor - HPE Building	Inspected
Condition	2 - Between Good and Fair
Deficiency	No deficiencies recorded
<b>DECK/FLOOR</b>	
Instance on 1st Floor - HPE Building	Inspected
Condition	3 - Fair
Deficiency	CERAMIC TILES: BROKEN/MISSING/WORN TILES
Deficiency Location/Instance	1st Floor - HPE Building
Deficiency Quantity	30
Quantity Uom	S.F.
Potential Action	REPLACE
Urgency of Action	PRIORITY 4
Purpose of Action	LEVEL 2

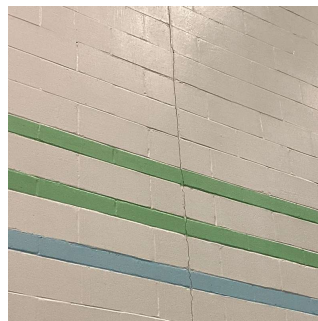
1st Floor - HPE Building

CONCRETE MASONRY BLOCKS: CRACKS/SPALLED

REPAIR

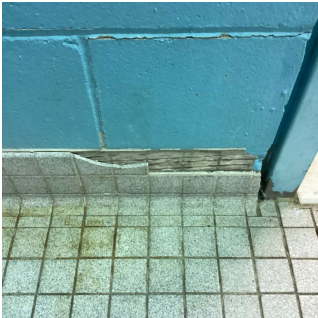
Question	Response
<b>INTERIOR</b>	
<b>POOLS</b>	
<b>WALLS</b>	
Violations	No violations recorded.
Deficiency	CERAMIC TILES: BROKEN/MISSING TILES
Deficiency Location/Instance	1st Floor - HPE Building
Deficiency Quantity	10
Quantity Uom	S.F.
Potential Action	REPLACE
Urgency of Action	PRIORITY 4
Purpose of Action	LEVEL 2
Deficiency Photo1

Violations	1st Floor - HPE Building No violations recorded.
<b>STRUCTURAL</b>	
	Inspected
<b>COLUMNS/BEAMS/BEARING WALLS</b>	
	Inspected
Condition	3 - Fair
Deficiency	STEEL COLUMNS/BEAMS: DETERIORATED/MISSING SPRAY-ON FIREPROOFING
Deficiency Location/Instance	Roof 2 - HPE Building- Mechanical Room 304
Deficiency Quantity	30
Quantity Uom	S.F.
Potential Action	REPLACE
Urgency of Action	PRIORITY 3
Purpose of Action	LEVEL 5
Deficiency Photo1

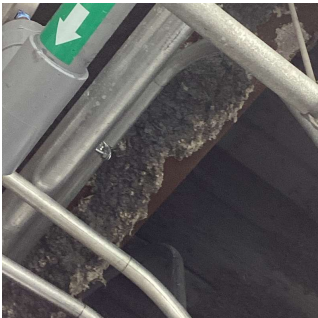
Violations	Roof 2 - HPE Building - Mechanical Room 304 No violations recorded.
<b>FLOOR STRUCTURE</b>	
	Inspected
Condition	2 - Between Good and Fair

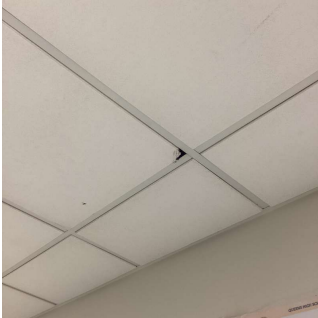
Question	Response
<b>INTERIOR</b>	
<b>CLASSROOMS/CORRIDORS/ADMIN SPACES</b>	
<b>Ceiling</b>	
Deficiency Location/Instance	Rooms 203A, 216A
Deficiency Quantity	20
Quantity Uom	S.F.
Potential Action	REPLACE
Urgency of Action	PRIORITY 3
Purpose of Action	LEVEL 2
Deficiency Photo1

Room 203A
Violations	No violations recorded.
<b>Door(s)</b>	Inspected
Condition	2 - Between Good and Fair
Deficiency	No deficiencies recorded
<b>Floor Finish</b>	Inspected
Condition	2 - Between Good and Fair
Deficiency	VINYL TILES: BROKEN/DETERIORATED/MISSING TILES
Deficiency Location/Instance	Rooms 213, 228, Corridor near Room 226
Deficiency Quantity	20
Quantity Uom	S.F.
Potential Action	REPLACE
Urgency of Action	PRIORITY 3
Purpose of Action	LEVEL 2
Deficiency Photo1

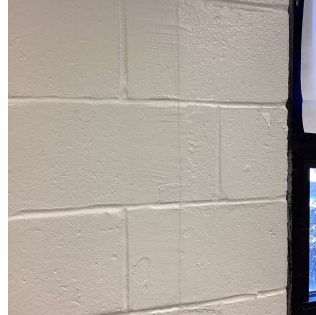
Room 203

Room 228
Violations	No violations recorded.
<b>Walls</b>	Inspected
Condition	2 - Between Good and Fair
Deficiency	MASONRY: CRACKS/SPALLING
Deficiency Location/Instance	Rooms 001, 203, 234

Deficiency Quantity	30
Quantity Uom	S.F.
Potential Action	REPLACE

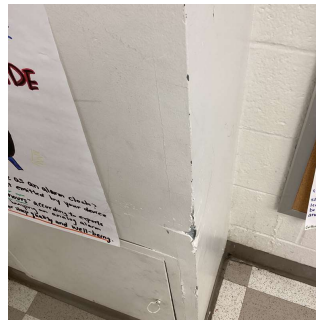
Room 001

GYPNUM BOARD: DETERIORATED  
Rooms 001, 218, 222, 228, 234, and others.  
100  
S.F.  
REPLACE  
PRIORITY 3  
LEVEL 2

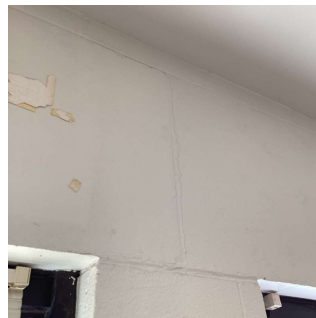
PLASTER: CRACKS/SPALLING  
Room 001  
10  
S.F.  
REPLACE  
PRIORITY 3  
LEVEL 2

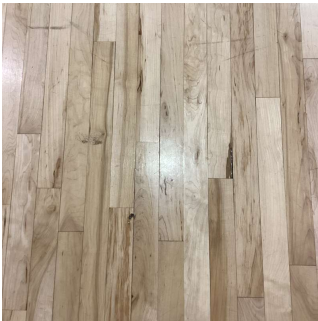
Instance on 2nd Floor - HPE Building	Inspected
Condition	2 - Between Good and Fair
Deficiency	WOOD: DAMAGED/DETERIORATED
Deficiency Location/Instance	Near Entrance
Deficiency Quantity	20
Quantity Uom	S.F.
Potential Action	REPLACE
Urgency of Action	PRIORITY 3
Purpose of Action	LEVEL 2

Violations	Near Entrance No violations recorded.
Deficiency	CONCRETE: CRACKS
Deficiency Location/Instance	Storage Room, columns Running Track
Deficiency Quantity	50
Quantity Uom	S.F.
Potential Action	REPLACE
Urgency of Action	PRIORITY 3
Purpose of Action	LEVEL 2
Deficiency Photo1

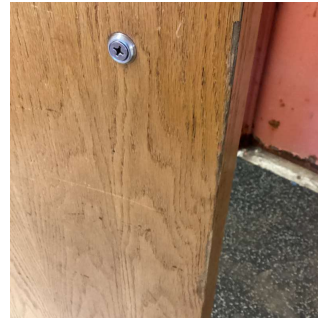
Question	Response
<b>INTERIOR</b>	
<b>LOCKER ROOM</b>	
<b>Ceiling</b>	
Deficiency	ACOUSTIC TILES: DAMAGED/MISSING
Deficiency Location/Instance	Near Entrance, Center, Shower Room
Deficiency Quantity	50
Quantity Uom	S.F.
Potential Action	REPLACE
Urgency of Action	PRIORITY 3
Purpose of Action	LEVEL 2
Deficiency Photo1	 
Violations	Near Entrance No violations recorded.
Instance on 1st Floor - Girls HPE Building	Inspected
Condition	2 - Between Good and Fair
Deficiency	ACOUSTIC TILES: DAMAGED/MISSING
Deficiency Location/Instance	Near Entrance, Center
Deficiency Quantity	30
Quantity Uom	S.F.
Potential Action	REPLACE
Urgency of Action	PRIORITY 3
Purpose of Action	LEVEL 2
Deficiency Photo1	 
Violations	Near center No violations recorded.
<b>Door(s)</b>	
Instance on 1st Floor - Girls HPE Building	Inspected
Condition	3 - Fair
Deficiency	WOOD: DETERIORATED DOOR
Deficiency Location/Instance	Entrance
Deficiency Quantity	1
Quantity Uom	EACH

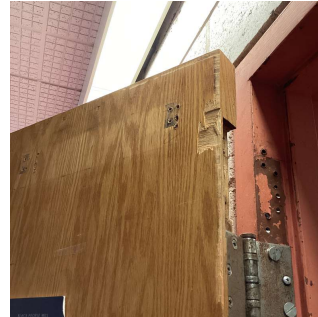
Entrance

WOOD: DETERIORATED DOOR

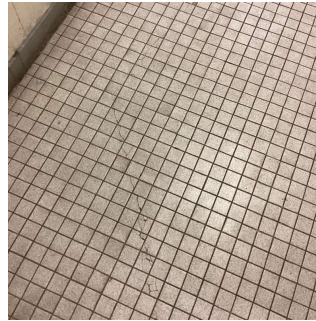
Entrance

CERAMIC TILE: BROKEN/MISSING TILES

REPLACE

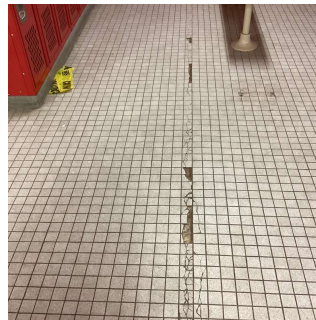
Near Shower Rooms

CERAMIC TILE: DETERIORATED SUBSTRATE

REPLACE

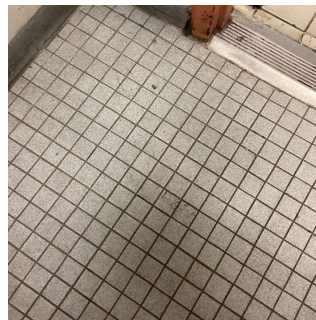
CERAMIC TILE: BROKEN/MISSING TILES

Question	Response
<b>INTERIOR</b>	
<b>LOCKER ROOM</b>	
<b>Floor Finish</b>	
Violations	Near Entrance No violations recorded.
<b>Locker Room Lockers</b>	
Instance on 1st Floor - Boys - HPE Building	Inspected
Condition	2 - Between Good and Fair
Deficiency	No deficiencies recorded
Instance on 1st Floor - Girls HPE Building	Inspected
Condition	2 - Between Good and Fair
Deficiency	No deficiencies recorded
<b>Walls</b>	
Instance on 1st Floor - Boys - HPE Building	Inspected
Condition	2 - Between Good and Fair
Deficiency	No deficiencies recorded
Instance on 1st Floor - Girls HPE Building	Inspected
Condition	2 - Between Good and Fair
Deficiency	No deficiencies recorded
<b>MULTI-PURPOSE ROOM</b>	
Instance on Basement	Inspected
<b>Ceiling</b>	
Instance on Basement	Inspected
Condition	2 - Between Good and Fair
Deficiency	ACOUSTIC TILES: DAMAGED/MISSING
Deficiency Location/Instance	Near lateral Entrance
Deficiency Quantity	10
Quantity Uom	S.F.

REPLACE

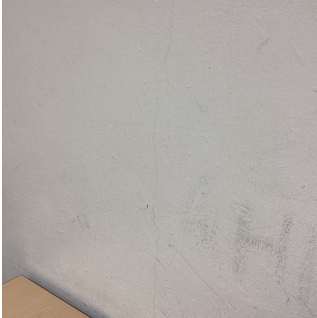
Question	Response
<b>INTERIOR</b>	
<b>MULTI-PURPOSE ROOM</b>	
<b>Floor Finish</b>	
Condition	2 - Between Good and Fair
Deficiency	VINYL TILES: BROKEN/DETERIORATED/MISSING TILES
Deficiency Location/Instance	Near Lateral Entrance
Deficiency Quantity	20
Quantity Uom	S.F.
Potential Action	REPLACE
Urgency of Action	PRIORITY 3
Purpose of Action	LEVEL 2
Deficiency Photo1	 
Violations	Near Lateral Entrance No violations recorded.
<b>Sliding-folding Partition</b>	
Instance on Basement	Does not Exist
<b>Stage</b>	
Instance on Basement	Does not Exist
<b>Walls</b>	
Instance on Basement	Inspected
Condition	2 - Between Good and Fair
Deficiency	GYPSUM BOARD: DETERIORATED
Deficiency Location/Instance	Near center
Deficiency Quantity	10
Quantity Uom	S.F.
Potential Action	REPLACE
Urgency of Action	PRIORITY 3
Purpose of Action	LEVEL 2
Deficiency Photo1	 
Violations	Near center No violations recorded.
Deficiency	PLASTER: CRACKS/SPALLING
Deficiency Location/Instance	Near Windows

Near Windows
Violations	No violations recorded.
<b>Window Curtains/Shades/Blinds</b>	
Instance on Basement	Does not Exist
<b>SCIENCE DEMO ROOM</b>	Does not Exist
<b>SCIENCE LAB</b>	Inspected
Instance on Room 221	Inspected
Alternative use	Yes
Instance on Rooms 218, 219	Inspected
Alternative use	No
Instance on Rooms 222, 224	Inspected
Alternative use	No
<b>Fixed Equipment</b>	
Instance on Rooms 222, 224	Inspected
Condition	3 - Fair
Deficiency	CABINETS: MISSING/DAMAGED
Deficiency Location/Instance	Rooms 222, 224
Deficiency Quantity	10
Quantity Uom	L.F.
Potential Action	REPLACE
Urgency of Action	PRIORITY 3
Purpose of Action	LEVEL 2
Deficiency Photo1

Question	Response
<b>INTERIOR</b>	
<b>MULTI-PURPOSE ROOM</b>	
<b>Walls</b>	
Quantity Uom	S.F.
Potential Action	REPLACE
Urgency of Action	PRIORITY 3
Purpose of Action	LEVEL 2
Deficiency Photo1

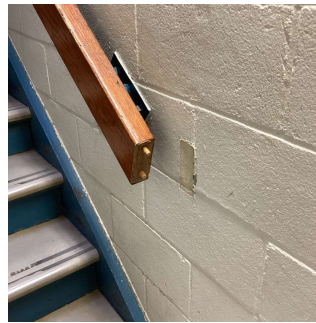
Stair B/1

Question	Response
<b>INTERIOR</b>	
<b>STAIRS/RAMPS: INTERIOR</b>	
<b>Ceiling</b>	
Deficiency Photo1	 
	Stair - Track 2/3
Violations	No violations recorded.
Deficiency	PLASTER: CRACKS/SPALLING
Deficiency Location/Instance	Stair B/2
Deficiency Quantity	20
Quantity Uom	S.F.
Potential Action	REPLACE
Urgency of Action	PRIORITY 3
Purpose of Action	LEVEL 2
Deficiency Photo1	 
	Stair B/2
Violations	No violations recorded.
<b>Door(s)</b>	Inspected
Condition	2 - Between Good and Fair
Deficiency	No deficiencies recorded
<b>Partition</b>	Does not Exist
<b>Railings</b>	Inspected
Condition	3 - Fair
Deficiency	WOOD: DAMAGED
Deficiency Location/Instance	Stairs A/Basement, B/1
Deficiency Quantity	10
Quantity Uom	L.F.
Potential Action	REPLACE
Urgency of Action	PRIORITY 3
Purpose of Action	LEVEL 2

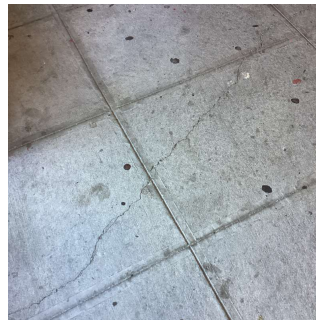
Stair - Track 2/3

CONCRETE: CRACKS/SPALLING - MAJOR

REPLACE

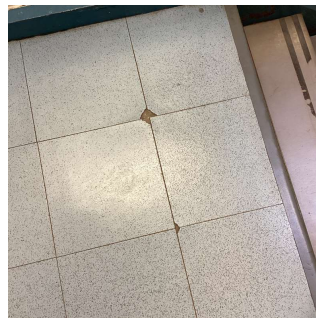
VINYL TILES: BROKEN/DETERIORATED/MISSING TILES

Question	Response
<b>INTERIOR</b>	
<b>STAIRS/RAMPS: INTERIOR</b>	
<b>Stairs and Landings</b>	
Violations	Stair B/1 No violations recorded.
Deficiency	VINYL TILES: WORN-OUT TREAD/NOSINGS
Deficiency Location/Instance	Stairs B/1, D/2, Track 2/1
Deficiency Quantity	20
Quantity Uom	S.F.
Potential Action	REPLACE
Urgency of Action	PRIORITY 3
Purpose of Action	LEVEL 2
Deficiency Photo1

REPLACE

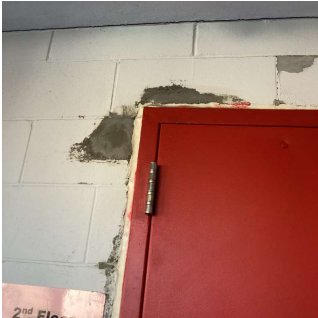
Violations	Stair B/1 No violations recorded.
<b>Walls</b>	Inspected
Condition	2 - Between Good and Fair
Deficiency	MASONRY: CRACKS/SPALLING
Deficiency Location/Instance	Stair - Track 2/2
Deficiency Quantity	10
Quantity Uom	S.F.
Potential Action	REPLACE
Urgency of Action	PRIORITY 3
Purpose of Action	LEVEL 2
Deficiency Photo1

Violations	Stair - Track 2/2 No violations recorded.
Deficiency	GYPSUM BOARD: DETERIORATED
Deficiency Location/Instance	Stair D/2, Track 2/3
Deficiency Quantity	30
Quantity Uom	S.F.
Potential Action	REPLACE
Urgency of Action	PRIORITY 3

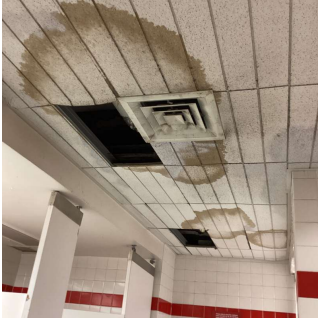
Violations	Girls 2nd Floor - HPE Building No violations recorded.
Deficiency	ACOUSTIC TILES: DAMAGED/MISSING

Question	Response
<b>INTERIOR</b>	
<b>TOILET ROOMS - STUDENTS</b>	
<b>Ceiling</b>	
Deficiency Location/Instance	Girls 2nd Floor - HPE Building, Boys 2nd Floor - HPE Building
Deficiency Quantity	100
Quantity Uom	S.F.
Potential Action	REPLACE
Urgency of Action	PRIORITY 3
Purpose of Action	LEVEL 2
Deficiency Photo1

Violations	Girls 2nd Floor - HPE Building No violations recorded.
<b>Door(s)</b>	Inspected
Condition	5 - Poor
Deficiency	WOOD: DETERIORATED DOOR
Deficiency Location/Instance	Boys 2nd Floor - HPE Building, Girls 2nd Floor - HPE Building
Deficiency Quantity	2
Quantity Uom	EACH
Potential Action	MAINTENANCE
Urgency of Action	PRIORITY 3
Purpose of Action	LEVEL 2
Deficiency Photo1
