NYC Department of Education
Building Condition Assessment Survey 2023 - 2024

Architectural Inspection

Asset: P.S. 199 ANNEX (@ ST. TERESA'S) - QUEENS, 50-15 44TH STREET, New York, 11377

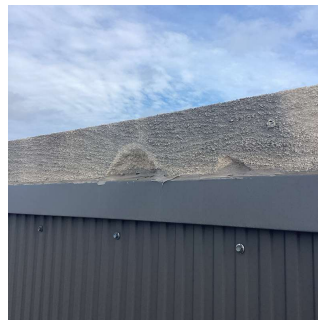
Roof 1

CAST STONE: CRACKED/BROKEN PIECES

REPLACE-IN-KIND

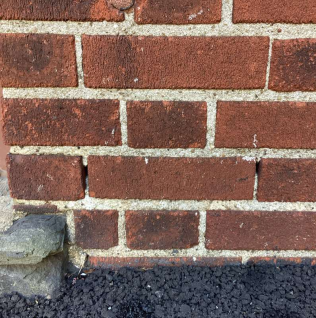
Violations	Facade D No violations recorded.
Deficiency	BRICK: DETERIORATED JOINTS

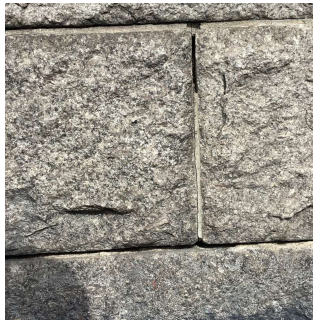
Facade J

STONE: DETERIORATED JOINTS

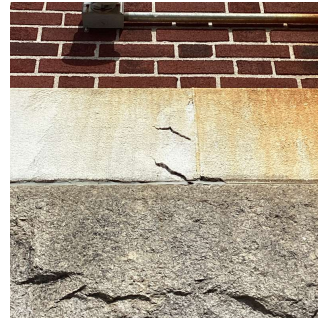
Facade B

STONE: CHIPPED/SPALLED/BROKEN PIECES - MINOR

REPAIR

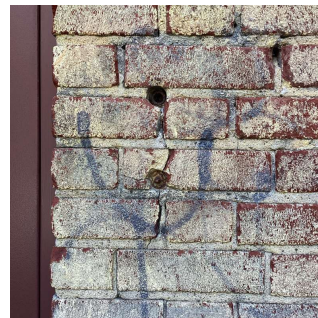
Facade D

BRICK: MINOR CRACKS AND SPALLING

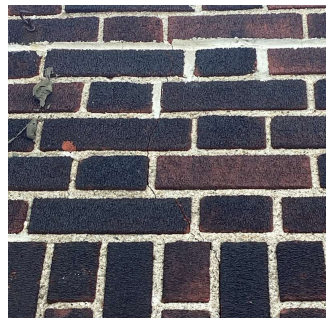
BULKHEAD/PENTHOUSE WALLS/EXTERIOR: CRACKS/SPALLING - MINOR

Question	Response
EXTERIOR	
ROOF	
Specialties	
BULKHEAD/PENTHOUSE	
Potential Action	REPAIR
Urgency of Action	PRIORITY 3
Purpose of Action	LEVEL 2
Deficiency Photo1

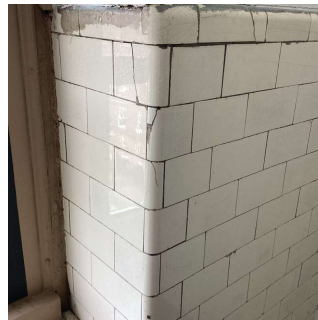
BH
 No violations recorded.

Violations	BH
Deficiency	No violations recorded.
Deficiency	BULKHEAD/PENTHOUSE WALLS/INTERIOR: GLAZED BLOCK CRACKS/SPALLING

40
 S.F.
 REPLACE
 PRIORITY 3
 LEVEL 2

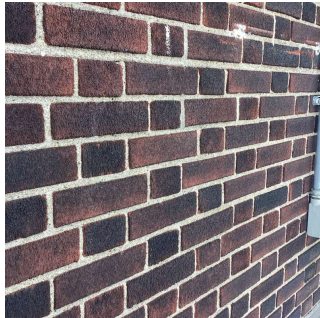
Deficiency **BULKHEAD/PENTHOUSE WALLS/EXTERIOR: DETERIORATED JOINTS**

60
 S.F.
 REPOINT
 PRIORITY 3
 LEVEL 2

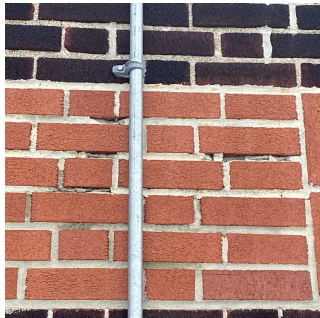
Violations	BH No violations recorded.
Deficiency	BULKHEAD/PENTHOUSE WALLS/EXTERIOR: DETERIORATED JOINTS
Roof Plan reference	Q777

Deficiency Quantity	20
Quantity Uom	S.F.
Potential Action	REPOINT
Urgency of Action	PRIORITY 4
Purpose of Action	LEVEL 2
Deficiency Photo1

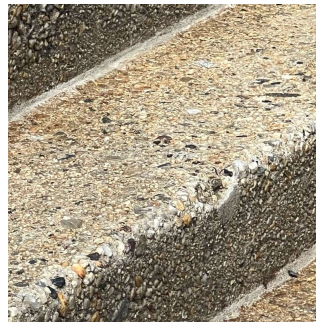
Facade G

CONCRETE: WORN-OUT TREAD/RISER/NOSING

Deficiency Quantity	10
Quantity Uom	S.F.
Potential Action	REPLACE
Urgency of Action	PRIORITY 4
Purpose of Action	LEVEL 2

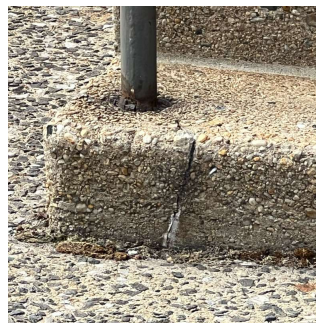
Facade G

CONCRETE: CRACKS/SPALLING - MAJOR

REPLACE

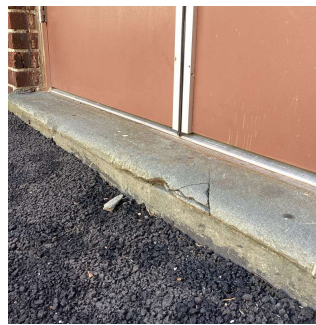
Facade D

STONE: WORN-OUT TREAD/RISER/NOSING

20
S.F.
REPLACE
PRIORITY 4
LEVEL 2

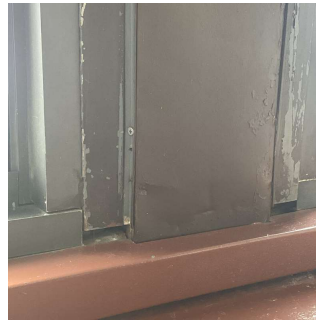
Facade B - Corridor near Room 312
No violations recorded.

ALUMINUM - DOUBLE HUNG: DETERIORATED

150
S.F.
REPLACE WINDOW
PRIORITY 4
LEVEL 2

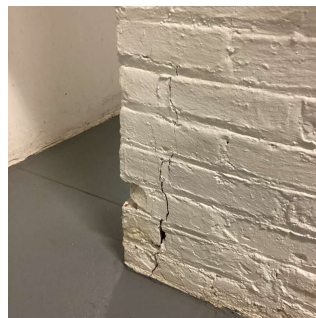
STEEL COLUMNS/BEAMS: DETERIORATED MASONRY
FIREPROOFING

REPLACE

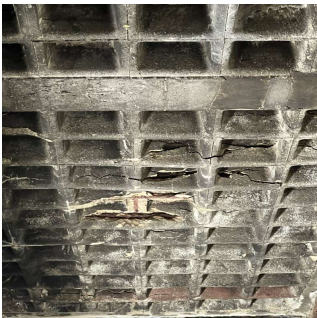
No	Potential Falling Debris	Deteriorated concrete slab structure is a potential falling debris hazard.	INTERIOR STRUCTURAL VAULTS- BUNKERS Slab Structure	Basement - Above Boiler Room Stairwell, Vault opposite Room C02	Dino Hondroulis	Custodian
----	--------------------------	--	--	---	-----------------	-----------

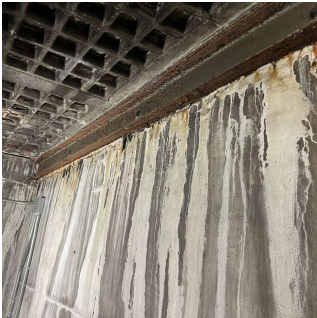
Basement - Above Boiler Room Stairwell
Violations	No violations recorded.
Deficiency	CONCRETE: WATER INFILTRATION IN NON- INSTRUCTIONAL SPACE

Question	Response
INTERIOR	
STRUCTURAL	
VAULTS-BUNKERS	
Slab Structure	
Quantity Uom	S.F.
Potential Action	INSTALL WATERPROOFING
Urgency of Action	PRIORITY 5
Purpose of Action	LEVEL 5
Deficiency Photo1

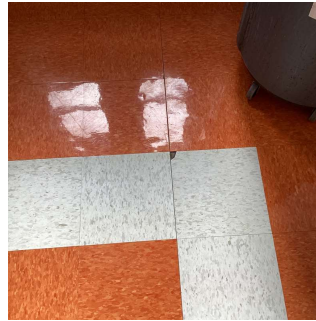
Corridor near Stair B/2

Deficiency	No deficiencies recorded
Floor Finish	
Condition	2 - Between Good and Fair
Deficiency	VINYL TILES: BROKEN/DETERIORATED/MISSING TILES
Deficiency Location/Instance	Corridor near Stair B/2, Corridor near Rooms 105A, 302
Deficiency Quantity	25
Quantity Uom	S.F.
Potential Action	REPLACE
Urgency of Action	PRIORITY 3
Purpose of Action	LEVEL 2

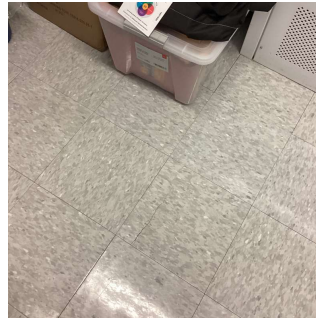
Room 312B

VINYL TILES: DETERIORATED SUBSTRATE

REPLACE

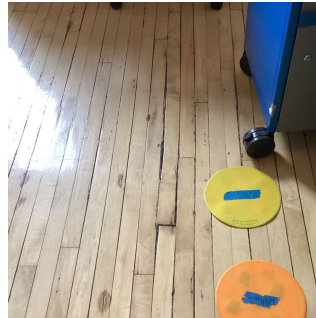
Room 205

WOOD: DAMAGED/DETERIORATED

REPLACE

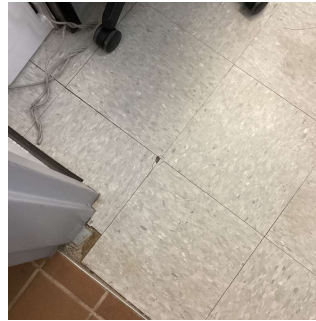
Deficiency	VINYL TILES: BROKEN/DETERIORATED/MISSING TILES
Deficiency Location/Instance	Room B05B
Deficiency Quantity	10
Quantity Uom	S.F.
Potential Action	REPLACE
Urgency of Action	PRIORITY 3
Purpose of Action	LEVEL 2

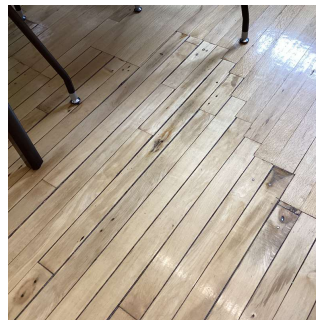
Left Side

WOOD: DAMAGED/DETERIORATED

REPLACE

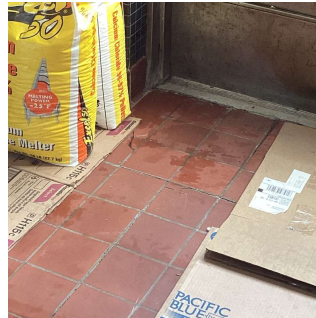
Stair B/1 - Exit 2 Vestibule

QUARRY TILE: BROKEN/MISSING

REPLACE

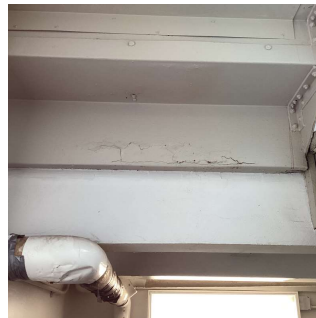
Stair B/Basement

METAL: RUST - MAJOR

REPLACE

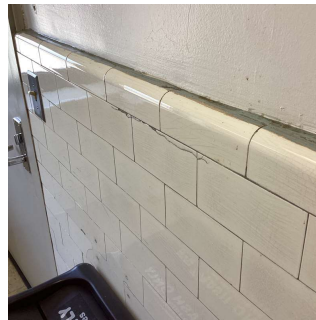
Room M200

CERAMIC TILE: BROKEN/ MISSING

REPLACE

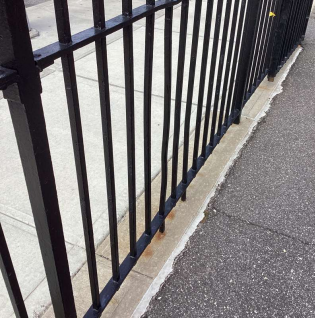
Violations	44th Street No violations recorded.
Deficiency	WROUGHT IRON: DAMAGED/DETERIORATED
Deficiency Location/Instance	44th Street
Deficiency Quantity	200
Quantity Uom	S.F.
Potential Action	REPLACE
Urgency of Action	PRIORITY 3
Purpose of Action	LEVEL 2
Deficiency Photo1

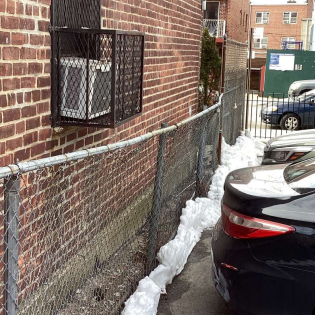
Violations	44th Street No violations recorded.
Deficiency	CHAIN LINK: DAMAGED POST/RAIL
Deficiency Location/Instance	Schoolyard
Deficiency Quantity	60
Quantity Uom	L.F.
Potential Action	REPLACE
Urgency of Action	PRIORITY 3
Purpose of Action	LEVEL 2
Deficiency Photo1
