NYC Department of Education
Building Condition Assessment Survey 2023 - 2024

Architectural Inspection

Asset: **JOHN ADAMS HS ANNEX - QUEENS, 120-27 141ST STREET, New York, 11436**

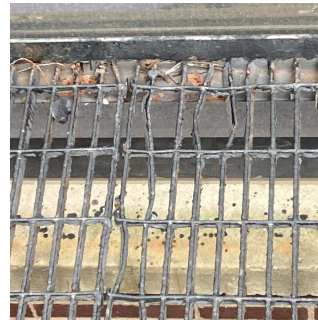
Facade A - AW1

Question	Response
Architectural	
EXTERIOR	Inspected
AREAWAY	Inspected
Instance on AW1-AW5	Inspected
Instance Condition	3 - Fair
Instance Quantity	5
Instance Quantity Uom	EACH
Deficiency	AREAWAY GRATINGS: MAJOR RUSTING / OR BROKEN

REPLACE

PRIORITY 4

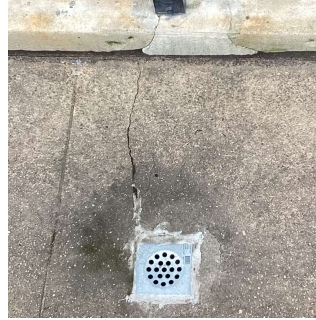
Facade C - AW5

AREAWAY SLAB: CRACKS AND SPALLING

REPAIR

PRIORITY 3

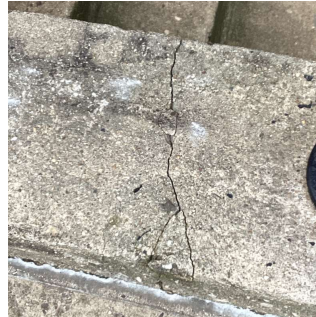
Facade C - AW4

AREAWAY WALLS: CRACKS AND SPALLING

REPAIR

PRIORITY 3

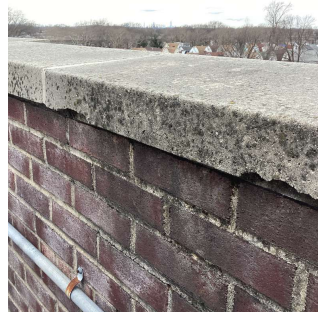
Roof 1

CAST STONE: CRACKED/BROKEN PIECES

REPLACE-IN-KIND

PRIORITY 4

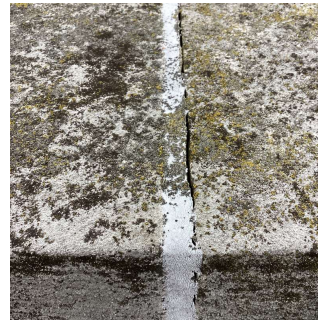
Roof 1

CAST STONE: DETERIORATED TRANSVERSE JOINTS

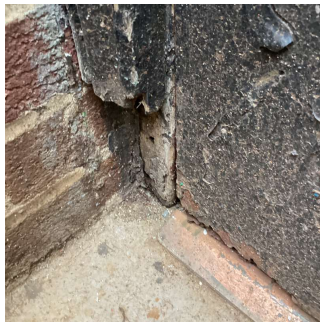
Violations	Facade B No violations recorded.
DOORS	Inspected
DOORS AND FRAMES	Inspected
Condition	5 - Poor
Deficiency	METAL: DETERIORATED DOOR AND FRAME - MAJOR DETERIORATION
Roof Plan reference	<p>Q781</p>

Deficiency Quantity	2
Quantity Uom	EACH
Potential Action	REPLACE
Urgency of Action	PRIORITY 4
Purpose of Action	LEVEL 2
Deficiency Photo1

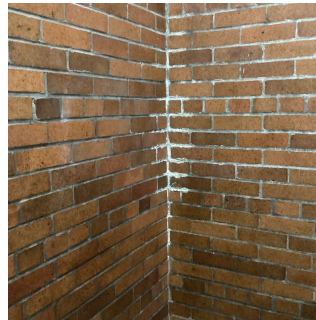
Facade A - North Staircase, also Facade B - North Staircase

BRICK: WATER INFILTRATION IN INSTRUCTIONAL SPACE

REPAIR

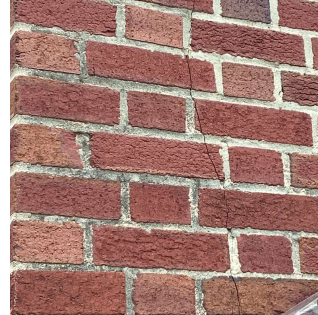
Facade C

BRICK: CRACKS/DISPLACED/SPALLED BRICK AT BUILDING CORNERS

REMOVE AND REBUILD
PRIORITY 4
LEVEL 2

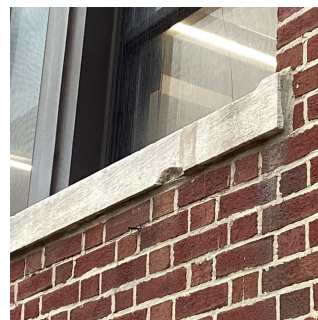
BRICK: DETERIORATED MASONRY SILLS - MINOR

30
L.F.
REPAIR
PRIORITY 3
LEVEL 2

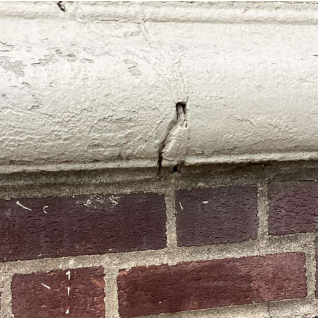
Question	Response
EXTERIOR	
EXTERIOR WALLS	
Violations	Facade C No violations recorded.
Deficiency	STONE: CHIPPED/SPALLED/BROKEN PIECES - MINOR
Roof Plan reference	<p>Q781</p>

Deficiency Quantity	10
Quantity Uom	S.F.
Potential Action	REPAIR
Urgency of Action	PRIORITY 3
Purpose of Action	LEVEL 2
Deficiency Photo1

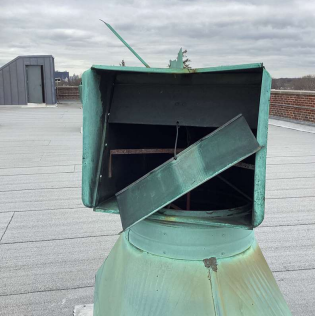
Question	Response
EXTERIOR	
ROOF	
Specialties	
DUNNAGE STEEL	Does not Exist
SKYLIGHT/ROOF VENT	Inspected
Material Type(s)	Other
Condition	3 - Fair
Deficiency	SHAFT VENTS DAMAGED
Roof Plan reference	<p>Q781</p>

Deficiency Quantity	1
Quantity Uom	EACH
Potential Action	MAINTENANCE
Urgency of Action	PRIORITY 5
Purpose of Action	LEVEL 6
Deficiency Photo1

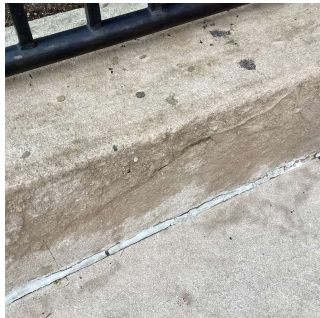
Violations	Roof 1 No violations recorded.
ROOF/GRAVITY TANK	Does not Exist
STAIRS/RAMPS: EXTERIOR	Inspected
BUILDING CHEEK/FLANK WALLS	Inspected
Condition	2 - Between Good and Fair
Deficiency	STONE: CRACKS/SPALLING - MINOR
Roof Plan reference	<p>Q781</p>

Deficiency Quantity	10
Quantity Uom	S.F.
Potential Action	REPAIR
Urgency of Action	PRIORITY 3
Purpose of Action	LEVEL 2
Deficiency Photo1

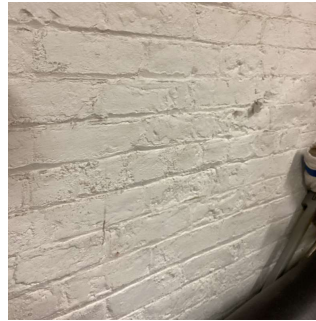
Violations	Basement - South Multi-Purpose Room No violations recorded.
FLOOR STRUCTURE	Inspected
Condition	2 - Between Good and Fair
Deficiency	No deficiencies recorded
FOUNDATION WALLS	Inspected
Material Type(s)	Masonry
Condition	4 - Between Fair and Poor
Deficiency	BRICK: CRACKED/SPALLED
Deficiency Location/Instance	Basement - Boiler Room
Deficiency Quantity	30

Quantity Uom	S.F.
Potential Action	RESTITCH
Urgency of Action	PRIORITY 3
Purpose of Action	LEVEL 5

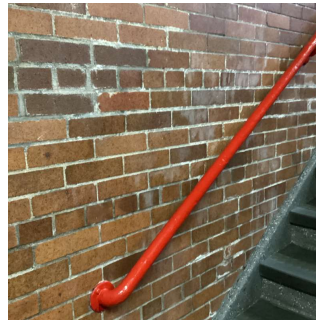
Basement - South Staircase

BRICK: WATER INFILTRATION IN INSTRUCTIONAL SPACE

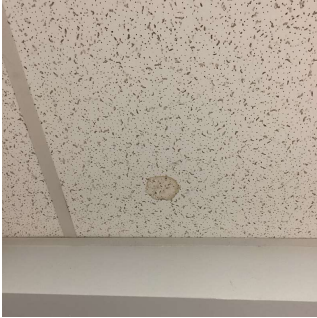
Room 106
Violations	No violations recorded.
Deficiency	ACOUSTIC TILES: DAMAGED/MISSING
Deficiency Location/Instance	Near Multi-Purpose Room - South

Question	Response
INTERIOR	
CLASSROOMS/CORRIDORS/ADMIN SPACES	
Ceiling	
Quantity Uom	S.F.
Potential Action	REPLACE
Urgency of Action	PRIORITY 3
Purpose of Action	LEVEL 2
Deficiency Photo1

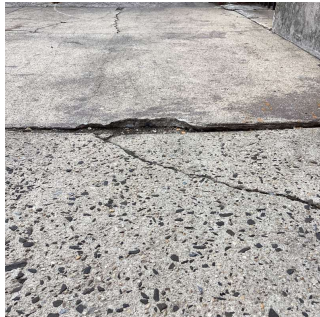
Site Sidewalks & Walkways	Inspected
Asphalt	Does not Exist
Concrete	Inspected
Condition	4 - Between Fair and Poor
Deficiency	DAMAGED/DETERIORATED/MISSING SECTIONS
Deficiency Location/Instance	South Walkway leading out to 141St Street.
Deficiency Quantity	50
Quantity Uom	S.F.
Potential Action	REPLACE
Urgency of Action	PRIORITY 5
Purpose of Action	LEVEL 6

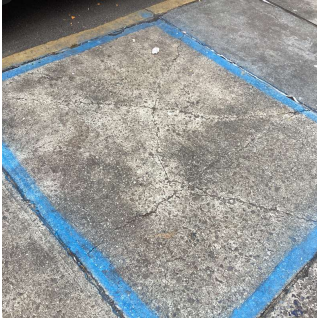
Violations	Near Church No violations recorded.
Pavers	Does not Exist
DOT Sidewalk	Inspected
Asphalt	Does not Exist
Concrete	Inspected
Condition	3 - Fair
Deficiency	DAMAGED/DETERIORATED/MISSING SECTIONS
Deficiency Location/Instance	141st Street
Deficiency Quantity	400
Quantity Uom	S.F.
Potential Action	REPLACE
Urgency of Action	PRIORITY 3
Purpose of Action	LEVEL 2

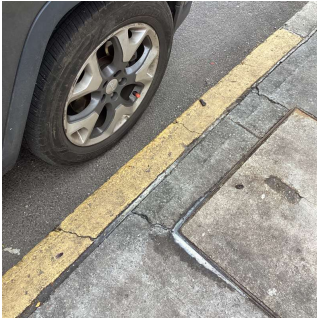
Violations	141st Street No violations recorded.
Deficiency	DAMAGED CURBS
Deficiency Location/Instance	141st Street
Deficiency Quantity	90
Quantity Uom	L.F.
Potential Action	REPLACE
Urgency of Action	PRIORITY 3
Purpose of Action	LEVEL 2
Deficiency Photo1
