NYC Department of Education
Building Condition Assessment Survey 2023 - 2024

Architectural Inspection

Asset: **NORTH QUEENS COMMUNITY HS - Q, 141-25 77TH ROAD, New York, 11367**

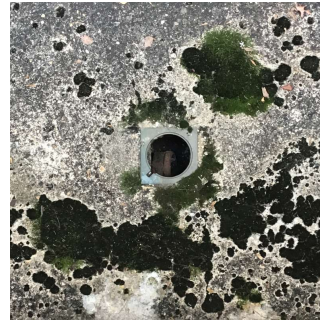
AW5

AREAWAY WALLS: CRACKS AND SPALLING

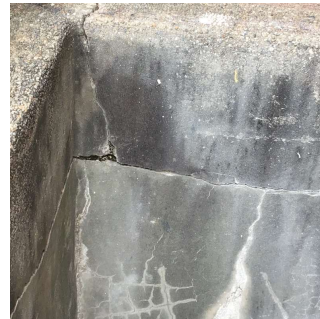
AW4

AREAWAY WALLS: CRACKS AND SPALLING

60
 S.F.
 REPAIR
 PRIORITY 3
 LEVEL 2

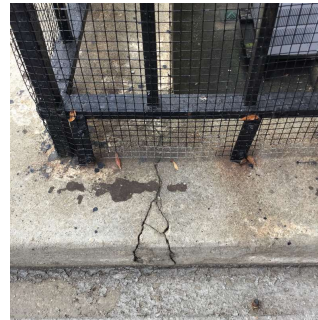
AW7
 No violations recorded.

AREAWAY SLAB: CRACKS AND SPALLING

40
 S.F.
 REPAIR
 PRIORITY 3
 LEVEL 2

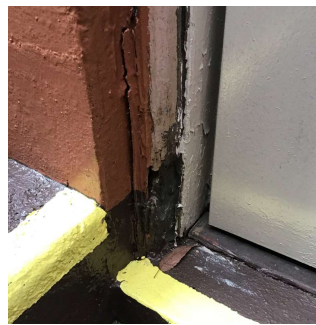
Facade A

METAL: DETERIORATED DOOR AND FRAME - MAJOR DETERIORATION

3
EACH
REPLACE
PRIORITY 4
LEVEL 2

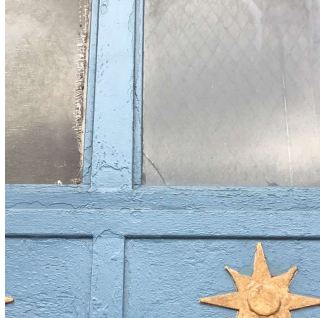
WOOD: BROKEN GLASS

10
S.F.
MAINTENANCE

Facade A - Main Entrance
Violations	No violations recorded.
EXTERIOR WALLS	
Material Type(s)	Inspected Masonry
Replacement Quantity	8,000
Replacement Uom	S.F.
Instance on All Facades	Inspected
Instance Condition	4 - Between Fair and Poor
Instance Quantity	8,000
Instance Quantity Uom	S.F.
Deficiency	STUCCO CEMENT SURFACE: CRACKS, SPALLING
Roof Plan reference	Q792

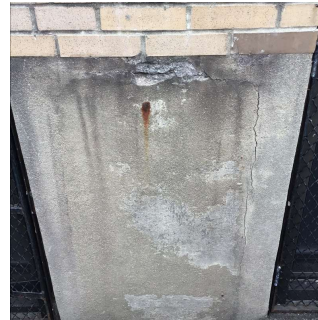
Facade C

BRICK: MAJOR BULGING, STEEL DAMAGE

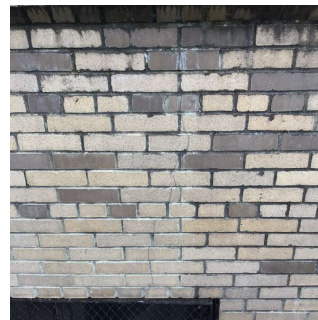
Facade B

BRICK: DETERIORATED JOINTS

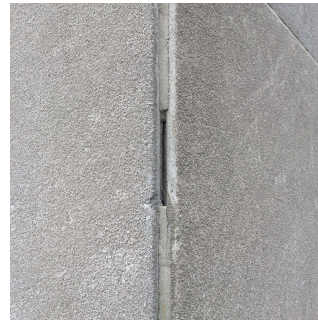
Facade A

STONE: CHIPPED/SPALLED/BROKEN PIECES - MAJOR

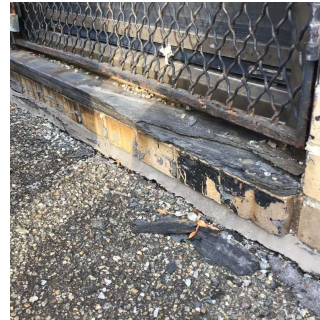
Facade B

BRICK: RELIEVING ANGLES - MAJOR DETERIORATION

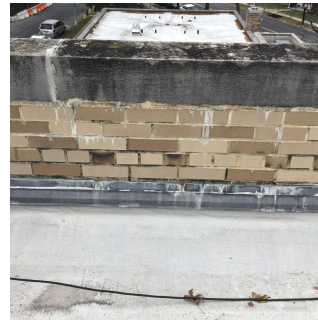
Roof 1 - Facade B

BRICK: MINOR CRACKS, SPALLING

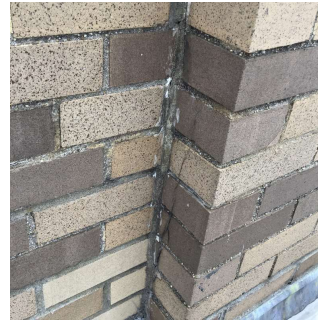
Roof 1

BRICK: MAJOR DETERIORATION/CRACKS

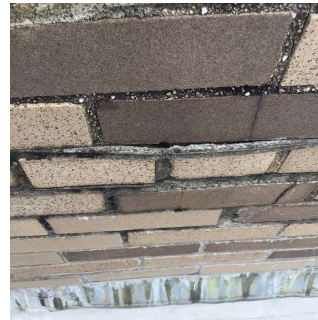
Roof 1
No violations recorded.

BRICK: DETERIORATED JOINTS

10
S.F.
REPOINT
PRIORITY 4
LEVEL 2

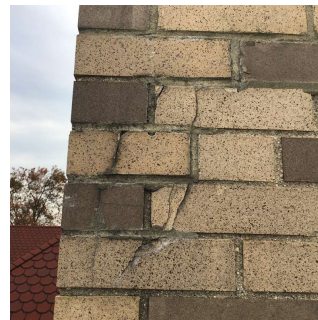
BH2

**BULKHEAD/PENTHOUSE WALLS/EXTERIOR:
CRACKS/SPALLING - MINOR**

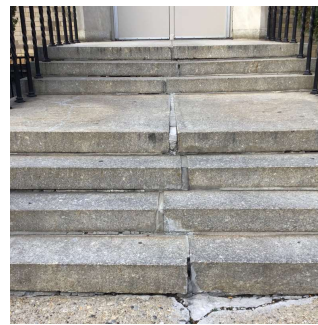
Facade A - Main Entrance
No violations recorded.

STONE: DETERIORATED SUBSTRATE

80
S.F.
REPLACE SUBSTRATE AND RESET
PRIORITY 4
LEVEL 2

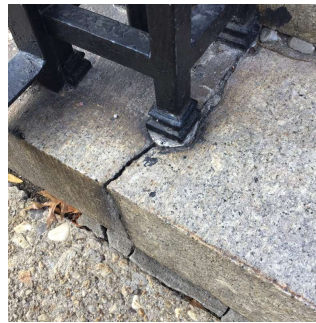
Facade A - Main Entrance

STONE: CRACKS/SPALLING - MAJOR

20
S.F.
REPLACE
PRIORITY 4
LEVEL 2

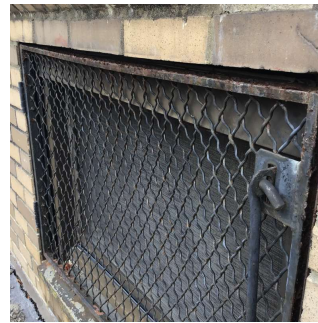
Facade B

RUST - MAJOR

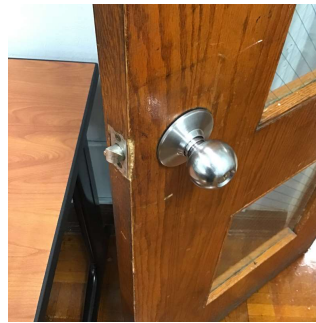
Room 201

AUDITORIUM	
	Does not Exist
CAFETERIA	
	Does not Exist
CLASSROOMS/CORRIDORS/ADMIN SPACES	
	Inspected
Ceiling	
	Inspected
Condition	2 - Between Good and Fair
Deficiency	No deficiencies recorded
Door(s)	
	Inspected
Condition	5 - Poor
Deficiency	WOOD: DETERIORATED DOOR
Deficiency Location/Instance	Rooms 207, 206, 205, 201, 102 and others
Deficiency Quantity	11
Quantity Uom	EACH
Potential Action	MAINTENANCE
Urgency of Action	PRIORITY 3
Purpose of Action	LEVEL 2

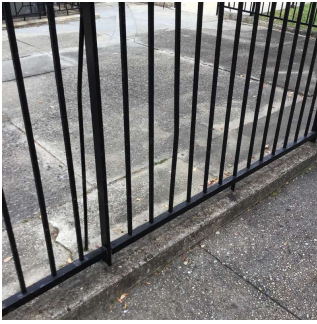
Violations	Room 108 No violations recorded.
LIFE SAFETY	Inspected
F.D. HOLDING AREA	Does not Exist
STEEL STAIRS	Does not Exist
SITE	Inspected
CONTAINERIZATION	Does not Exist
Drainage System for Asphalt	Does not Exist
Drainage System for Concrete	Does not Exist
Drainage System for Soil	Does not Exist
DRINKING FOUNTAINS	Does not Exist
FENCES	Inspected
Condition	3 - Fair
Deficiency	WROUGHT IRON: DAMAGED/DETERIORATED
Deficiency Location/Instance	77th Road
Deficiency Quantity	280
Quantity Uom	S.F.
Potential Action	REPLACE
Urgency of Action	PRIORITY 3
Purpose of Action	LEVEL 2
Deficiency Photo1

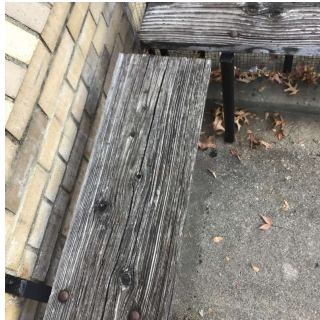
Question	Response
SITE	
SEATING	
Benches	
Metal/Wood/Plastic	Inspected
Condition	5 - Poor
Deficiency	DAMAGED/DETERIORATED
Deficiency Location/Instance	77th Road
Deficiency Quantity	3
Quantity Uom	EACH
Potential Action	REPLACE
Urgency of Action	PRIORITY 3
Purpose of Action	LEVEL 2
Deficiency Photo1
