NYC Department of Education
Building Condition Assessment Survey 2023 - 2024

Architectural Inspection

Asset: PS 150 ANNEX - QUEENS, 41-12 44TH STREET, New York, 11104

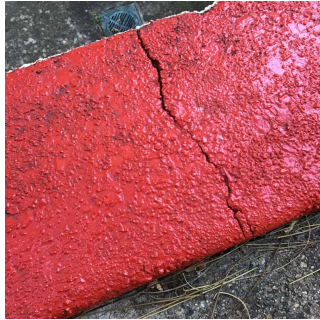
Question	Response
Architectural	
EXTERIOR	Inspected
AREAWAY	Inspected
Instance on AW1 - AW6	Inspected
Instance Condition	3 - Fair
Instance Quantity	6
Instance Quantity Uom	EACH
Deficiency	AREAWAY WALLS: CRACKS AND SPALLING
Roof Plan reference	Q797

Violations	AW5 No violations recorded.
Deficiency	AREAWAY SLAB: CRACKS AND SPALLING
Roof Plan reference	Q797

Question	Response
EXTERIOR	
AREAWAY	
Quantity Uom	S.F.
Potential Action	REPLACE
Urgency of Action	PRIORITY 4
Purpose of Action	LEVEL 2
Deficiency Photo1

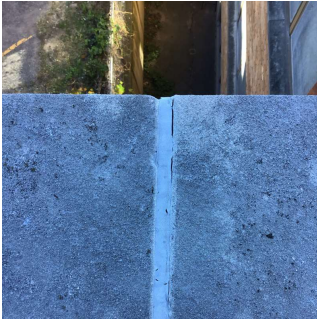
CAST STONE: DETERIORATED TRANSVERSE JOINTS

Violations	Roof 1 No violations recorded.
CORNICE	Does not Exist
DOORS	Inspected
DOORS AND FRAMES	Inspected
Condition	4 - Between Fair and Poor
Deficiency	METAL: DETERIORATED DOOR AND FRAME - MAJOR DETERIORATION
Roof Plan reference	Q797

10
 L.F.
 MAINTENANCE
 PRIORITY 3
 LEVEL 2

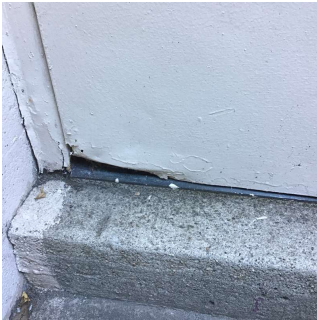
Violations	Facade H No violations recorded.
DOOR HARDWARE	Inspected
Condition	3 - Fair
Deficiency	No deficiencies recorded
LINTELS	Inspected
Condition	3 - Fair

Deficiency Quantity	1
Quantity Uom	EACH
Potential Action	REPLACE
Urgency of Action	PRIORITY 4
Purpose of Action	LEVEL 2
Deficiency Photo1

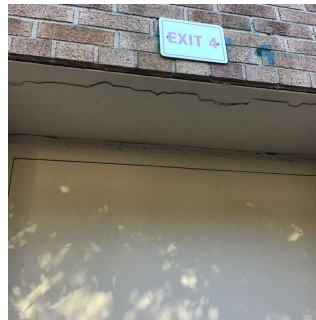
Facade H
 No violations recorded.

STEEL: MAJOR RUSTING

10
 L.F.
 REPLACE
 PRIORITY 4
 LEVEL 2

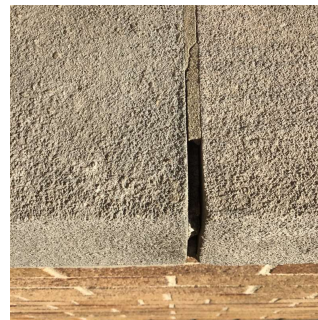
Facade E

Material Type(s)	Inspected
Replacement Quantity	Masonry
Replacement Uom	15,000
	S.F.
Instance on All Facades	Inspected
Instance Condition	3 - Fair
Instance Quantity	15,000
Instance Quantity Uom	S.F.
Deficiency	BRICK: DETERIORATED MASONRY SILLS - MAJOR

REMOVE AND REPLACE

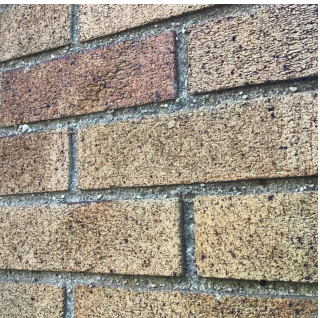
BRICK: DETERIORATED JOINTS

Violations	Facade A No violations recorded.
EXTERIOR SOFFITS	Inspected
Condition	2 - Between Good and Fair
Deficiency	No deficiencies recorded
LOADING DOCK	Does not Exist
LOUVER	Inspected
Condition	2 - Between Good and Fair
Deficiency	No deficiencies recorded
PARAPETS	Inspected
Material Type(s)	Masonry
Replacement Quantity	3,500
Replacement Uom	C.F.
Instance on Roof 1	Inspected
Instance Condition	3 - Fair
Instance Quantity	3,500
Instance Quantity Uom	C.F.
Deficiency	BRICK: DETERIORATED JOINTS

Deficiency Quantity	100
Quantity Uom	S.F.
Potential Action	REPOINT
Urgency of Action	PRIORITY 3
Purpose of Action	LEVEL 2
Deficiency Photo1

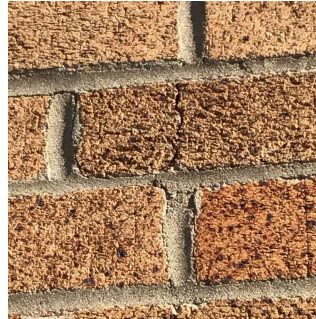
BH1

Deficiency BULKHEAD/PENTHOUSE WALLS/EXTERIOR: CRACKS/SPALLING - MINOR

Deficiency Quantity	15
Quantity Uom	S.F.
Potential Action	REPAIR
Urgency of Action	PRIORITY 3
Purpose of Action	LEVEL 2
Deficiency Photo1

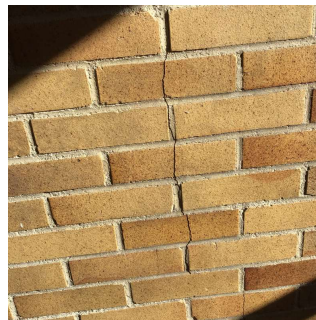
BH2

Deficiency	BULKHEAD/PENTHOUSE WALLS/INTERIOR: BRICK CRACKS/SPALLING
------------	---

Deficiency Quantity	10
Quantity Uom	S.F.
Potential Action	REPLACE
Urgency of Action	PRIORITY 3
Purpose of Action	LEVEL 2
Deficiency Photo1

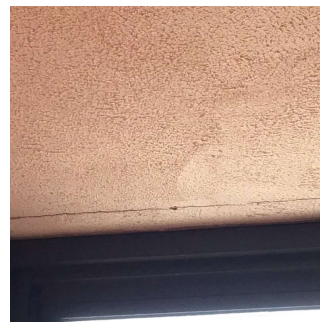
BH2
No violations recorded.

Deficiency	BULKHEAD/PENTHOUSE CEILING: PLASTER DAMAGED/DETERIORATED
------------	---

10
S.F.
REPLACE
PRIORITY 3
LEVEL 2

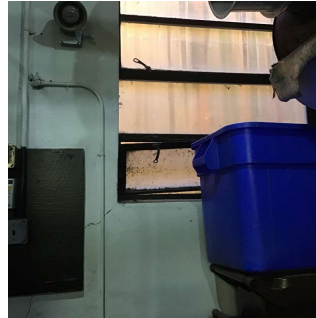
Facade D

Are these windows insulated	No
Installation Year	1956
Source of Installation	Custodial Staff
Deficiency	STEEL: DETERIORATED
Roof Plan reference	Q797

REPLACE WINDOW

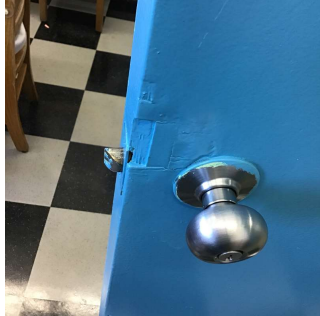
Room 206
Violations	No violations recorded.
Floor Finish	Inspected
Condition	2 - Between Good and Fair
Deficiency	TERRAZZO: CRACKS
Deficiency Location/Instance	Corridor near Rooms 102, 104, 206, Stair A/2
Deficiency Quantity	30
Quantity Uom	S.F.
Potential Action	REPLACE
Urgency of Action	PRIORITY 3
Purpose of Action	LEVEL 2
Deficiency Photo1

Deficiency Quantity	7
Quantity Uom	EACH
Potential Action	MAINTENANCE

Question	Response
INTERIOR	
CLASSROOMS/CORRIDORS/ADMIN SPACES	
Door(s)	
Urgency of Action	PRIORITY 3
Purpose of Action	LEVEL 2
Deficiency Photo1

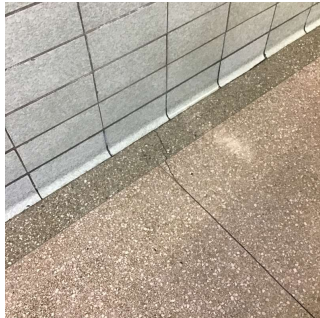
Corridor near Stair A/2
Violations	No violations recorded.
Deficiency	VINYL TILES: BROKEN/DETERIORATED/MISSING TILES
Deficiency Location/Instance	Rooms 200, 203, 204, Corridor near Room 002
Deficiency Quantity	50
Quantity Uom	S.F.
Potential Action	REPLACE
Urgency of Action	PRIORITY 3
Purpose of Action	LEVEL 2

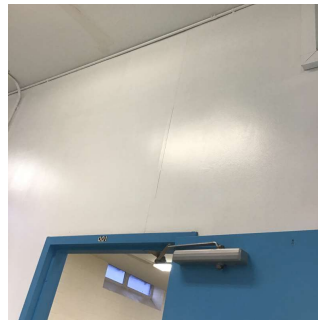
Corridor near Room 001

GYP SUM BOARD: DETERIORATED

REPLACE

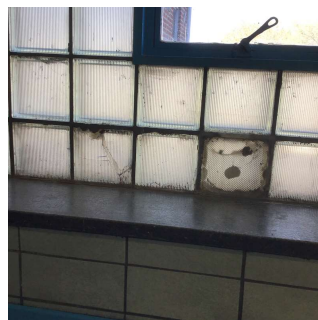
GLASS BLOCK: DAMAGED/MISSING

REPLACE

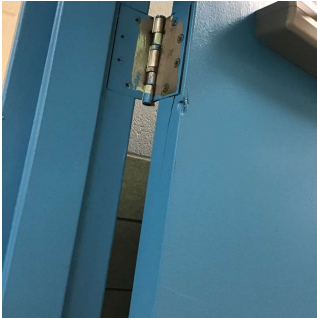
Question	Response
INTERIOR	
MULTI-PURPOSE ROOM	
Door(s)	
Deficiency	WOOD: DETERIORATED DOOR
Deficiency Location/Instance	Entrance
Deficiency Quantity	1
Quantity Uom	EACH
Potential Action	MAINTENANCE
Urgency of Action	PRIORITY 3
Purpose of Action	LEVEL 2
Deficiency Photo1

Violations	Entrance No violations recorded.
Instance on Basement - Room 002 (1,100 SF)	Inspected
Condition	3 - Fair
Deficiency	WOOD: DETERIORATED DOOR
Deficiency Location/Instance	Entrance
Deficiency Quantity	1
Quantity Uom	EACH
Potential Action	MAINTENANCE
Urgency of Action	PRIORITY 3
Purpose of Action	LEVEL 2
Deficiency Photo1

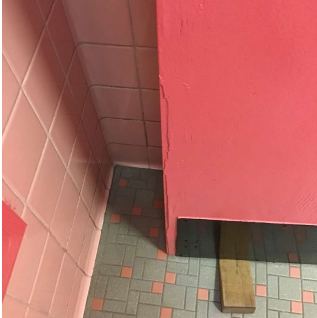
Violations	Girls - 3rd Floor No violations recorded.
Floor Finish	Inspected
Condition	2 - Between Good and Fair
Deficiency	No deficiencies recorded
Stalls	Inspected
Condition	5 - Poor
Deficiency	RUST - MAJOR
Deficiency Location/Instance	Rooms 100, 107, Boys - Basement, 3rd Floor, Girls - Basement, 3rd Floor
Deficiency Quantity	13
Quantity Uom	EACH
Potential Action	REPLACE
Urgency of Action	PRIORITY 3
Purpose of Action	LEVEL 2
Deficiency Photo1

Question	Response
INTERIOR	
TOILET ROOMS - STUDENTS	
Door(s)	
Urgency of Action	PRIORITY 3
Purpose of Action	LEVEL 2
Deficiency Photo1

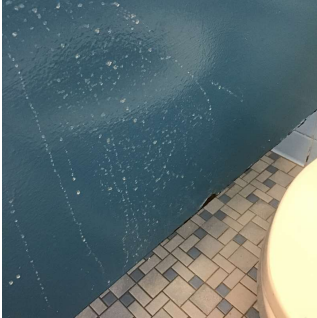
Violations	Boys - 3rd Floor No violations recorded.
Walls	Inspected
Condition	2 - Between Good and Fair
Deficiency	CERAMIC TILE: BROKEN/ MISSING
Deficiency Location/Instance	Rooms 107, Boys - Basement, 3rd Floor, Girls - Basement, 3rd Floor
Deficiency Quantity	80
Quantity Uom	S.F.
Potential Action	REPLACE
Urgency of Action	PRIORITY 3
Purpose of Action	LEVEL 2

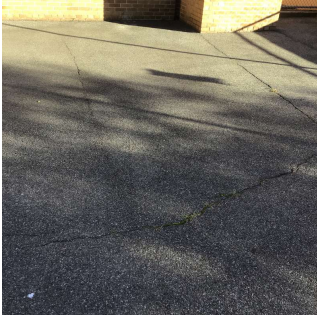
Site Sidewalks & Walkways	Inspected
Asphalt	Inspected
Condition	3 - Fair
Deficiency	CRACKS - MAJOR
Deficiency Location/Instance	Near Exit 3
Deficiency Quantity	100
Quantity Uom	S.F.
Potential Action	REPLACE
Urgency of Action	PRIORITY 3
Purpose of Action	LEVEL 2

Violations	Near Exit 3 No violations recorded.
Concrete	Inspected
Condition	3 - Fair
Deficiency	CRACKS - MAJOR
Deficiency Location/Instance	Near Exits 2, 4
Deficiency Quantity	325
Quantity Uom	S.F.
Potential Action	REPLACE
Urgency of Action	PRIORITY 3
Purpose of Action	LEVEL 2
Deficiency Photo1

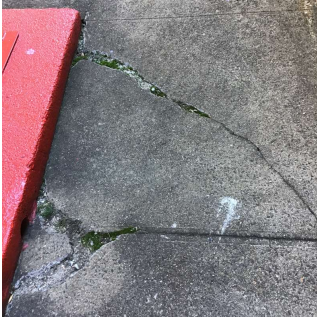
Violations	Near Exit 4 No violations recorded.
Pavers	Does not Exist
DOT Sidewalk	Inspected
Asphalt	Does not Exist
Concrete	Inspected
Condition	3 - Fair
Deficiency	HEAVING
Deficiency Location/Instance	43rd Street
Deficiency Quantity	50
Quantity Uom	S.F.
Potential Action	REPLACE
Urgency of Action	PRIORITY 3
Purpose of Action	LEVEL 2

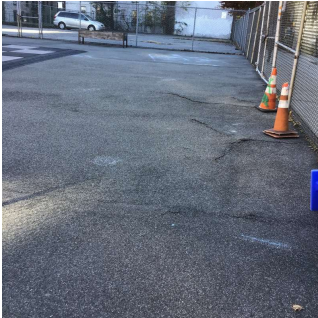
Question	Response
SITE	
PAVING	Inspected
DOT Sidewalk	
Concrete	Inspected
Violations	No violations recorded.
Pavers	Does not Exist
PLAYGROUNDS	Inspected
Instance on 43th Street	Inspected
Benches	
Instance on 43th Street	Does not Exist
Fence	
Instance on 43th Street	Inspected
Condition	2 - Between Good and Fair
Deficiency	No deficiencies recorded
Pavement	
Instance on 43th Street	Inspected
Condition	4 - Between Fair and Poor
Deficiency	ASPHALT: CRACKS - MAJOR
Deficiency Location/Instance	Near 43th Street, Neighbors.
Deficiency Quantity	300
Quantity Uom	S.F.
Potential Action	REPLACE
Urgency of Action	PRIORITY 3
Purpose of Action	LEVEL 2
Deficiency Photo1

Near 43th Street
Violations	No violations recorded.
Play Equipment	
Instance on 43th Street	Inspected
Condition	5 - Poor
Deficiency	BROKEN/DETERIORATED/MISSING
Deficiency Location/Instance	Near Slide
Deficiency Quantity	1
Quantity Uom	EACH
Potential Action	REPLACE
Urgency of Action	PRIORITY 3
