**NYC Department of Education  
Building Condition Assessment Survey 2023 - 2024**

Architectural Inspection

Q798

**Asset: BACCALAUREATE SCL FOR GLOBAL ED-Q, 34-12 36TH AVENUE, New York, 11106**

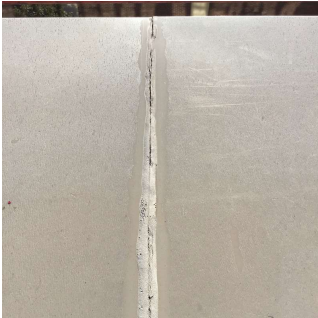
Question	Response
<b>EXTERIOR</b>	
<b>COPING</b>	Inspected
Condition	3 - Fair
Deficiency	TERRA COTTA: DETERIORATED TRANSVERSE JOINTS
Roof Plan reference	<p>Q798</p>

Deficiency Quantity	30
Quantity Uom	L.F.
Potential Action	MAINTENANCE
Urgency of Action	PRIORITY 3
Purpose of Action	LEVEL 2
Deficiency Photo1	No photo recorded
Violations	No violations recorded.
Deficiency	METAL: DETERIORATED TRANSVERSE JOINTS
Roof Plan reference	<p>Q798</p>

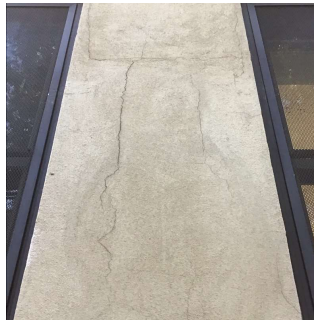
Facade A

STUCCO CEMENT SURFACE: CRACKS, SPALLING

REPLACE

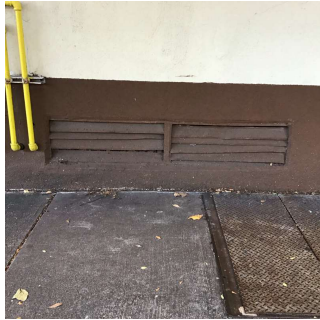
Question	Response
<b>EXTERIOR</b>	
<b>LOUVER</b>	
Deficiency Photo1

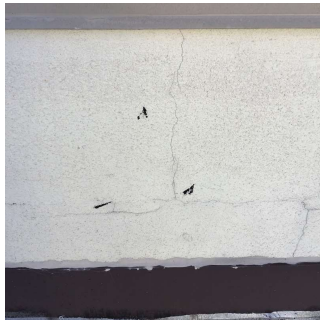
Violations	Facade B No violations recorded.
<b>PARAPETS</b>	Inspected
Material Type(s)	Concrete
Replacement Quantity	2,800
Replacement Uom	C.F.
Instance on All Facades	Inspected
Instance Condition	3 - Fair
Instance Quantity	2,800
Instance Quantity Uom	C.F.
Deficiency	CONCRETE: MINOR CRACKS, SPALLING
Roof Plan reference	<p>Q798</p>

Deficiency Quantity	100
Quantity Uom	S.F.
Potential Action	REPAIR
Urgency of Action	PRIORITY 3
Purpose of Action	LEVEL 2
Deficiency Photo1

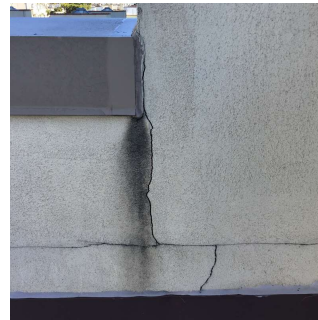
Roof 1 - Facade A

Violations	Roof 1- Facade A No violations recorded.
Deficiency	CONCRETE: MAJOR DETERIORATION/CRACKS

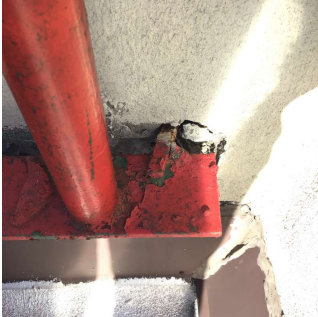
RAILINGS/PANELS: DETERIORATED, MAJOR RUSTING

Question	Response
<b>EXTERIOR</b>	
<b>ROOF</b>	
<b>Roofing</b>	
<b>ROOF BARRIER/FENCE</b>	
Deficiency Quantity	10
Quantity Uom	S.F.
Potential Action	REPLACE
Urgency of Action	PRIORITY 4
Purpose of Action	LEVEL 2
Deficiency Photo1

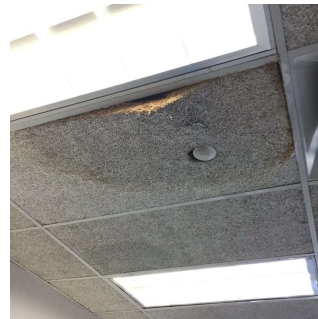
Roof 1
Instance Quantity	10,000
Instance Quantity Uom	S.F.
Does the roof have major mechanical equipment sitting on Dunnage Steel less than 18" above the Roofing?	No
Does this roof instance have a Sustainable Roof System?	Yes
Sustainable Roof Type	White Roof
Sustainable Roof Location (Roof Number)	Roof 1
Do solar panels exist on these roofs?	No
Is/Are the roof(s) suitable for Solar Panel installation?	No
Installation Year	2002
Source of Installation	Custodial Staff
Deficiency	MODIFIED BITUMEN: ROOFING: MAJOR ACTIVE ROOF LEAKS IN INSTRUCTIONAL SPACE

Roof 1 - Room 400 (Roof 1 - Rooms 402, 403, 404, 410 similar)  
No violations recorded.

REPLACE ROOFING WITHOUT MAJOR EQUIPMENT REMOVAL

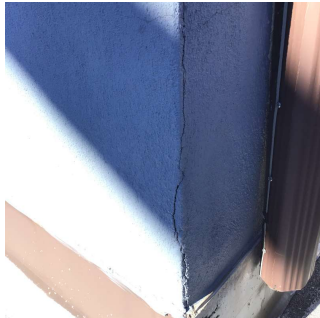
Violations	Roof 1 No violations recorded.
<b>ROOFING DRAINS</b>	Inspected
Condition	2 - Between Good and Fair
Deficiency	No deficiencies recorded
<b>Specialties</b>	Inspected
<b>BULKHEAD/PENTHOUSE</b>	Inspected
Condition	4 - Between Fair and Poor
Deficiency	BULKHEAD/PENTHOUSE WALLS/EXTERIOR: CRACKS/SPALLING - MAJOR
Roof Plan reference	Q798

Deficiency Quantity	20
Quantity Uom	S.F.
Potential Action	REPLACE
Urgency of Action	PRIORITY 4
Purpose of Action	LEVEL 2
Deficiency Photo1

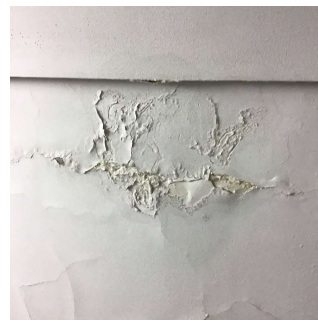
BH2  
No violations recorded.

Violations	BH1 No violations recorded.
Deficiency	BULKHEAD/PENTHOUSE WALLS/EXTERIOR: WATER INFILTRATION

200  
S.F.  
REPAIR  
PRIORITY 5  
LEVEL 2

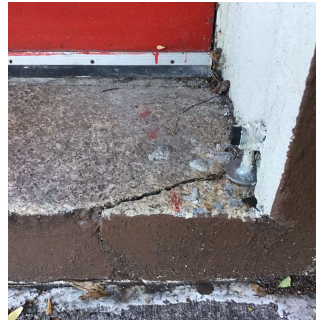
Facade B

Question	Response
<b>EXTERIOR</b>	
<b>ROOF</b>	
<b>Specialties</b>	
<b>BULKHEAD/PENTHOUSE</b>	
Deficiency Photo1	 
	BH2
Violations	No violations recorded.
<b>CUPOLA/ SPIRES/ TOWERS</b>	Does not Exist
<b>DORMER</b>	Does not Exist
<b>DUNNAGE STEEL</b>	Inspected
Condition	2 - Between Good and Fair
Deficiency	No deficiencies recorded
<b>SKYLIGHT/ROOF VENT</b>	Does not Exist
<b>ROOF/GRAVITY TANK</b>	Does not Exist
<b>STAIRS/RAMPS: EXTERIOR</b>	Inspected
<b>BUILDING CHEEK/FLANK WALLS</b>	Does not Exist
<b>RAILINGS</b>	Does not Exist
<b>STAIRS/RAMPS</b>	Inspected
Condition	3 - Fair
Deficiency	STONE: CRACKS/SPALLING - MAJOR
Roof Plan reference	<p><b>Q798</b></p>  
Deficiency Quantity	10
Quantity Uom	S.F.
Potential Action	REPLACE
Urgency of Action	PRIORITY 4
Purpose of Action	LEVEL 2

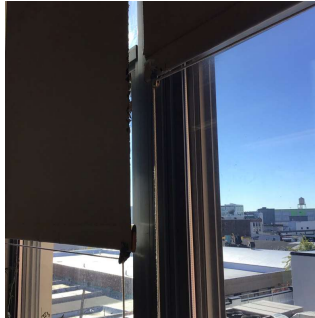
ALUMINUM - DOUBLE HUNG: DETERIORATED

150  
S.F.  
REPLACE WINDOW  
PRIORITY 4  
LEVEL 2

Facades A - Room 202 (Facade A - Rooms 300, 409 similar)  
No violations recorded.

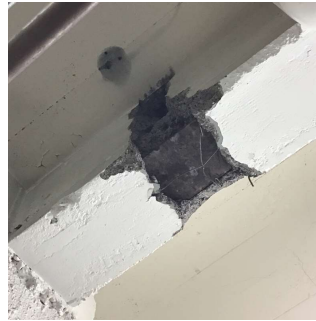
Question	Response
<b>EXTERIOR</b>	
<b>WINDOWS</b>	
<b>WINDOWS</b>	
Potential Action	REPLACE TRIM, SILLS OR WEATHERSTRIPPING
Urgency of Action	PRIORITY 5
Purpose of Action	LEVEL 2
Deficiency Photo1	 
Violations	Facade A - Room 400 (Facade A - Rooms 202, 203, 300, 302, 303, 400, 403, Boys and Girls Locker Rooms, Facade B - Rooms 304, 403, Facade C - Rooms 310, 410) No violations recorded.
<b>INTERIOR</b>	Inspected
<b>POOLS</b>	Does not Exist
<b>STRUCTURAL</b>	Inspected
<b>COLUMNS/BEAMS/BEARING WALLS</b>	Inspected
Condition	3 - Fair
Deficiency	STEEL COLUMNS/BEAMS: DETERIORATED CONCRETE FIREPROOFING
Deficiency Location/Instance	Roof 1 - BH2, Room 407, Basement - Room 006
Deficiency Quantity	40
Quantity Uom	S.F.
Potential Action	REPLACE
Urgency of Action	PRIORITY 3
Purpose of Action	LEVEL 5
Deficiency Photo1	 
Violations	Roof 1 - BH1 No violations recorded.
Deficiency	STEEL COLUMNS/BEAMS: DETERIORATED CONCRETE FIREPROOFING

Deficiency Location/Instance	Basement - Boiler Room
Deficiency Quantity	20
Quantity Uom	S.F.
Potential Action	REPLACE
Urgency of Action	PRIORITY 4
Purpose of Action	LEVEL 5

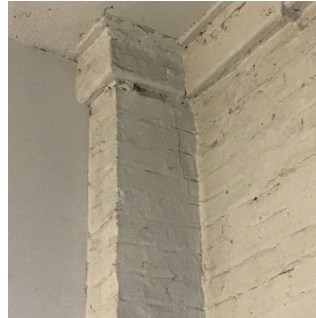
Stair A/3

**STEEL COLUMNS/BEAMS: DETERIORATED MASONRY FIREPROOFING**

REPLACE

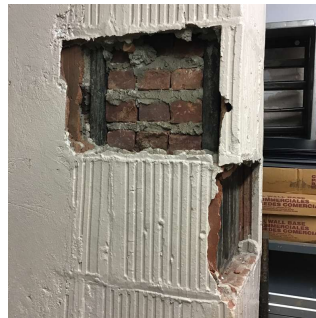
Basement - Boiler Room

**STEEL COLUMNS/BEAMS: DETERIORATED MASONRY FIREPROOFING**

REPLACE

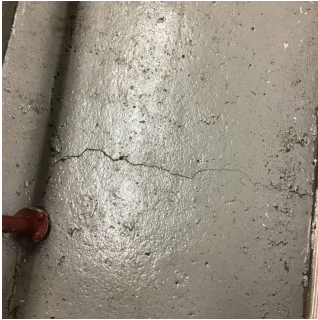
Question	Response
<b>INTERIOR</b>	
<b>STRUCTURAL</b>	
<b>COLUMNS/BEAMS/BEARING WALLS</b>	Inspected
Violations	No violations recorded.
<b>FLOOR STRUCTURE</b>	Inspected
Condition	3 - Fair
Deficiency	CONCRETE SLAB ON GRADE: THRU CRACKS
Deficiency Location/Instance	Room 407, Basement - Rooms 002, 006, Boiler Room
Deficiency Quantity	60
Quantity Uom	S.F.
Potential Action	REPAIR
Urgency of Action	PRIORITY 3
Purpose of Action	LEVEL 5
Deficiency Photo1

Violations	Basement - Room 006 No violations recorded.
Deficiency	CONCRETE SLAB ON GRADE: THRU CRACKS
Deficiency Location/Instance	Basement - Room 006, Boiler Room, Electrical Panel Room
Deficiency Quantity	80
Quantity Uom	S.F.
Potential Action	REPLACE
Urgency of Action	PRIORITY 4
Purpose of Action	LEVEL 5
Deficiency Photo1

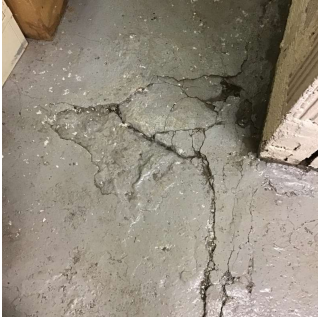
Violations	Basement - Room 006 No violations recorded.
Deficiency	CONCRETE: CRACKS/SPALLED/REINFORCEMENT EXPOSED
Deficiency Location/Instance	Basement - Mechanical Room 002

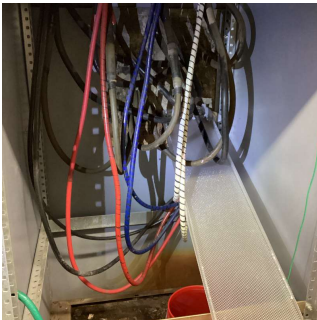
Question	Response
<b>INTERIOR</b>	
<b>STRUCTURAL</b>	
<b>FLOOR STRUCTURE</b>	Inspected
Deficiency Photo1	 
	Basement - Mechanical Room 002
Violations	No violations recorded.
<b>FOUNDATION WALLS</b>	
Material Type(s)	Inspected Concrete
Condition	4 - Between Fair and Poor
Deficiency	CONCRETE: WATER INFILTRATION IN ELECTRICAL PANEL ROOM
Deficiency Location/Instance	Basement - Electrical Panel Room
Deficiency Quantity	100
Quantity Uom	S.F.
Potential Action	INSTALL WATERPROOFING
Urgency of Action	PRIORITY 5
Purpose of Action	LEVEL 6
Deficiency Photo1

Electrical Panel Room
Violations	No violations recorded.
Deficiency	CONCRETE: CRACKED/SPALLED/REINFORCEMENT EXPOSED
Deficiency Location/Instance	Basement - Boiler Room
Deficiency Quantity	10
Quantity Uom	S.F.
Potential Action	REPAIR
Urgency of Action	PRIORITY 4
Purpose of Action	LEVEL 5

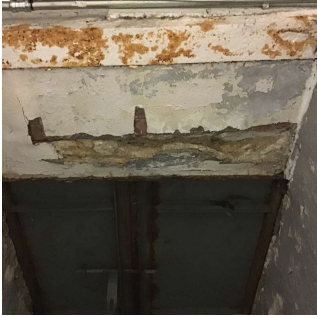
No	Potential Falling Debris	Deteriorated concrete slab at Ash Hoist Vault is a potential falling debris hazard.	INTERIOR   STRUCTURAL   VAULTS-BUNKERS   Slab Structure	Ash Hoist Vault	Joseph Blanco	Fireman

Question	Response
<b>INTERIOR</b>	
<b>STRUCTURAL</b>	
<b>VAULTS-BUNKERS</b>	
<b>Slab Structure</b>	
Deficiency Photo1

Violations	Vault No violations recorded.
<b>Vault/Ash Hoist Doors and Framing</b>	Inspected
Condition	5 - Poor
Deficiency	DETERIORATED/DAMAGED VAULT/ASH HOIST DOORS AND FRAMING
Deficiency Location/Instance	Basement - Vault
Deficiency Quantity	2
Quantity Uom	EACH
Potential Action	REPLACE
Urgency of Action	PRIORITY 4
Purpose of Action	LEVEL 2
Deficiency Photo1

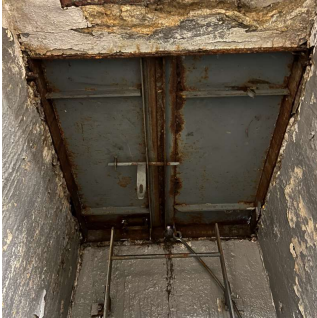
Violations	Vault No violations recorded.
Deficiency	WATER INFILTRATION
Deficiency Location/Instance	Basement - Vault
Deficiency Quantity	10
Quantity Uom	S.F.
Potential Action	REPAIR
Urgency of Action	PRIORITY 5
Purpose of Action	LEVEL 2

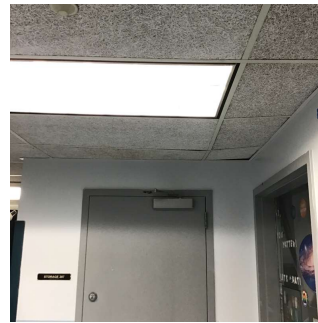
No	Potential Falling Debris	Severely damaged ceiling tile frame with loose tectum tile is a potential safety hazard.	INTERIOR   CLASSROOMS /CORRIDORS/ ADMIN SPACES   Ceiling	Corridor near Room 208	Joseph Blanco	Fireman

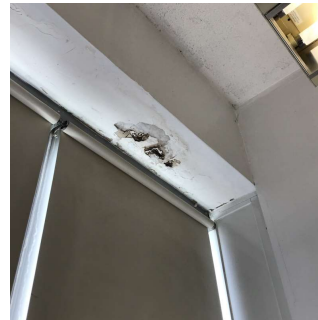
Room 403

**GYPSUM BOARD: DAMAGED/DETERIORATED - ACTIVE LEAK**

REPLACE

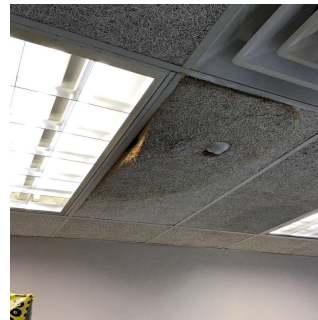
Room 400

**TECTUM: DAMAGED/MISSING - ACTIVE LEAK**

REPLACE

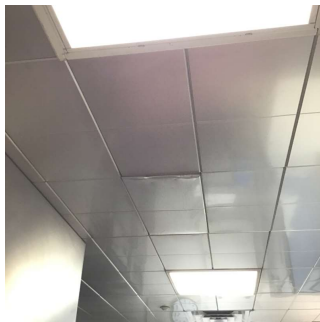
Question	Response
<b>INTERIOR</b>	
<b>KITCHEN</b>	
<b>Ceiling</b>	
Instance on 1st Floor	Inspected
Condition	2 - Between Good and Fair
Deficiency	TECTUM: DAMAGED/MISSING
Deficiency Location/Instance	Office/Storage Room
Deficiency Quantity	10
Quantity Uom	S.F.
Potential Action	REPLACE
Urgency of Action	PRIORITY 3
Purpose of Action	LEVEL 2
Deficiency Photo1	 
Violations	Office/Storage Room No violations recorded.
Deficiency	METAL PAN: DAMAGED/MISSING
Deficiency Location/Instance	Prep area
Deficiency Quantity	10
Quantity Uom	S.F.
Potential Action	REPLACE
Urgency of Action	PRIORITY 3
Purpose of Action	LEVEL 2
Deficiency Photo1

Violations	Prep area No violations recorded.
<b>Door(s)</b>	
Instance on 1st Floor	Inspected
Condition	2 - Between Good and Fair
Deficiency	No deficiencies recorded
<b>Floor Finish</b>	
Instance on 1st Floor	Inspected
Condition	2 - Between Good and Fair
Deficiency	VINYL TILES: DETERIORATED SUBSTRATE

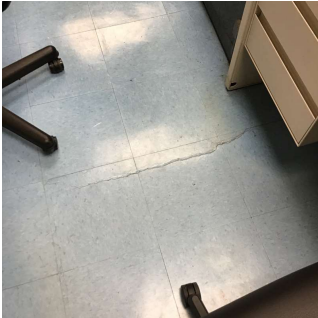
Deficiency Location/Instance	Office/Storage Room

Question	Response
<b>INTERIOR</b>	
<b>KITCHEN</b>	
<b>Floor Finish</b>	
Deficiency Quantity	30
Quantity Uom	S.F.
Potential Action	REPLACE
Urgency of Action	PRIORITY 3
Purpose of Action	LEVEL 2
Deficiency Photo1

Violations	Office/Storage Room No violations recorded.
<b>Walls</b>	
Instance on 1st Floor	Inspected
Condition	2 - Between Good and Fair
Deficiency	No deficiencies recorded
<b>LIBRARY</b>	
Instance on Room 213	Inspected
<b>Built-in Furnishing</b>	
Instance on Room 213	Inspected
Condition	2 - Between Good and Fair
Deficiency	No deficiencies recorded
<b>Ceiling</b>	
Instance on Room 213	Inspected
Condition	2 - Between Good and Fair
Deficiency	No deficiencies recorded
<b>Door(s)</b>	
Instance on Room 213	Inspected
Condition	2 - Between Good and Fair
Deficiency	No deficiencies recorded
<b>Floor Finish</b>	
Instance on Room 213	Inspected
Condition	2 - Between Good and Fair
Deficiency	VINYL TILES: BROKEN/DETERIORATED/MISSING TILES

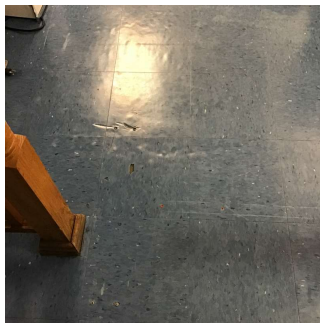
Deficiency Location/Instance	Main Entrance, Center
Deficiency Quantity	20
Quantity Uom	S.F.
Potential Action	REPLACE
Urgency of Action	PRIORITY 3
Purpose of Action	LEVEL 2

Question	Response
<b>INTERIOR</b>	
<b>LIBRARY</b>	
<b>Floor Finish</b>	
Deficiency Photo1

Main Entrance
Violations	No violations recorded.
<b>Walls</b>	
Instance on Room 213	Inspected
Condition	2 - Between Good and Fair
Deficiency	GYPSON BOARD: DETERIORATED
Deficiency Location/Instance	Right Side
Deficiency Quantity	10
Quantity Uom	S.F.
Potential Action	REPLACE
Urgency of Action	PRIORITY 3
Purpose of Action	LEVEL 2
Deficiency Photo1

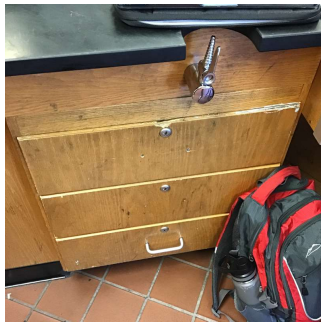
<b>Fixed Equipment</b>	
Instance on Rooms 310, 307	Inspected
Condition	4 - Between Fair and Poor
Deficiency	CABINETRY: MISSING/DAMAGED
Deficiency Location/Instance	Rooms 310, 307
Deficiency Quantity	20
Quantity Uom	L.F.
Potential Action	REPLACE
Urgency of Action	PRIORITY 3
Purpose of Action	LEVEL 2
Deficiency Photo1

Room 310	
Violations	No violations recorded.
<b>SCIENCE PREP ROOM</b>	Inspected
Instance on Room 308	Inspected

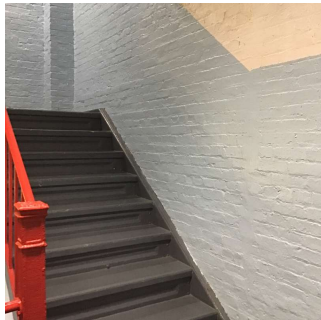
Question	Response
<b>INTERIOR</b>	
<b>SCIENCE PREP ROOM</b>	
Alternative use	No
<b>Fixed Equipment</b>	
Instance on Room 308	Inspected
Condition	2 - Between Good and Fair
Deficiency	No deficiencies recorded
<b>SHOWER ROOM</b>	
	Does not Exist
<b>STAIRS/RAMPS: INTERIOR</b>	
Do Letter Stair Signs Exist?	Inspected
	Yes
<b>Ceiling</b>	
	Inspected
Condition	2 - Between Good and Fair
Deficiency	No deficiencies recorded
<b>Door(s)</b>	
	Inspected
Condition	2 - Between Good and Fair
Deficiency	No deficiencies recorded
<b>Partition</b>	
	Does not Exist
<b>Railings</b>	
	Inspected
Condition	5 - Poor
Deficiency	METAL: MISSING
Deficiency Location/Instance	Stairs A/1-4, B/1-4
Deficiency Quantity	80
Quantity Uom	L.F.
Potential Action	REPLACE
Urgency of Action	PRIORITY 5
Purpose of Action	LEVEL 6
Deficiency Photo1

Stair A/1
Violations	No violations recorded.
<b>Stairs and Landings</b>	
	Inspected
Condition	3 - Fair
Deficiency	METAL: RUST - MAJOR

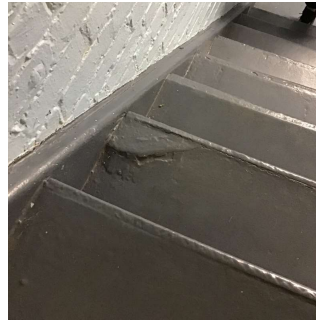
Yes	Tripping Hazard	Severely damaged concrete step is a potential tripping hazard.	INTERIOR   STAIRS/RAMP S: INTERIOR   Stairs and Landings	Stair A/3	Joseph Blanco	Fireman

REPLACE

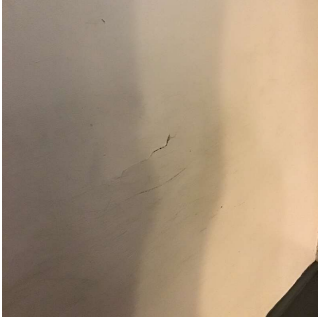
Question	Response
<b>INTERIOR</b>	
<b>STAIRS/RAMPS: INTERIOR</b>	
<b>Walls</b>	Inspected
Condition	2 - Between Good and Fair
Deficiency	PLASTER: CRACKS/SPALLING
Deficiency Location/Instance	Stairs A,4, B/4, 3, 2, 1
Deficiency Quantity	50
Quantity Uom	S.F.
Potential Action	REPLACE
Urgency of Action	PRIORITY 3
Purpose of Action	LEVEL 2
Deficiency Photo1

Violations	Stair B/2 No violations recorded.
Deficiency	PLASTER: CRACKS/SPALLING - ACTIVE LEAK
Deficiency Location/Instance	Stairs B/2, 1
Deficiency Quantity	100
Quantity Uom	S.F.
Potential Action	REPLACE
Urgency of Action	PRIORITY 5
Purpose of Action	LEVEL 2
Deficiency Photo1	 
Violations	Stair B/2 No violations recorded.
Deficiency	BRICK: CRACKS/SPALLING
Deficiency Location/Instance	Stairs A/4, 3, 2, 1, B/1
Deficiency Quantity	50
Quantity Uom	S.F.
Potential Action	REPLACE
Urgency of Action	PRIORITY 3
Purpose of Action	LEVEL 2

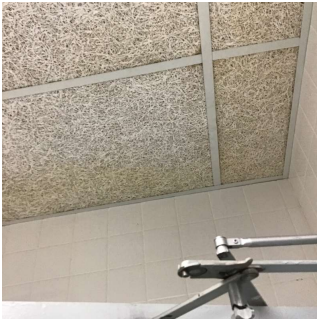
Question	Response
<b>INTERIOR</b>	
<b>STAIRS/RAMPS: INTERIOR</b>	
<b>Walls</b>	
Deficiency Photo1	 
Violations	Stair A/3 No violations recorded.
<b>TOILET ROOMS - STAFF</b>	Inspected
<b>Ceiling</b>	Inspected
Condition	3 - Fair
Deficiency	TECTUM: DAMAGED/MISSING
Deficiency Location/Instance	Room 123
Deficiency Quantity	10
Quantity Uom	S.F.
Potential Action	REPLACE
Urgency of Action	PRIORITY 3
Purpose of Action	LEVEL 2
Deficiency Photo1

Violations	Room 123 No violations recorded.
<b>Door(s)</b>	Inspected
Condition	2 - Between Good and Fair
Deficiency	No deficiencies recorded
<b>Floor Finish</b>	Inspected
Condition	2 - Between Good and Fair
Deficiency	No deficiencies recorded
<b>Stalls</b>	Does not Exist
<b>Walls</b>	Inspected
Condition	2 - Between Good and Fair
Deficiency	No deficiencies recorded
<b>TOILET ROOMS - STUDENTS</b>	Inspected
<b>Ceiling</b>	Inspected
Condition	2 - Between Good and Fair
Deficiency	TECTUM: DAMAGED/MISSING

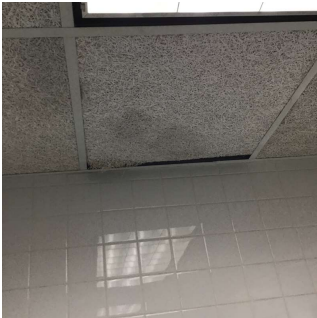
Question	Response
<b>INTERIOR</b>	
<b>TOILET ROOMS - STUDENTS</b>	
<b>Ceiling</b>	
Deficiency Quantity	40
Quantity Uom	S.F.
Potential Action	REPLACE
Urgency of Action	PRIORITY 3
Purpose of Action	LEVEL 2
Deficiency Photo1

Room 415
Violations	No violations recorded.
<b>Door(s)</b>	Inspected
Condition	5 - Poor
Deficiency	METAL: DETERIORATED DOOR
Deficiency Location/Instance	Room 218
Deficiency Quantity	1
Quantity Uom	EACH
Potential Action	MAINTENANCE
Urgency of Action	PRIORITY 3
Purpose of Action	LEVEL 2
Deficiency Photo1

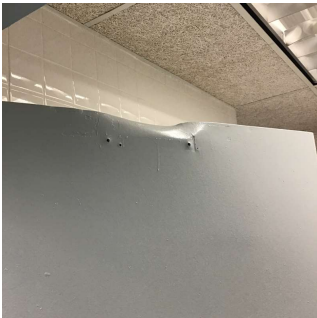
Room 218
Violations	No violations recorded.
<b>Floor Finish</b>	Inspected
Condition	2 - Between Good and Fair
Deficiency	No deficiencies recorded
<b>Stalls</b>	Inspected
Condition	2 - Between Good and Fair
Deficiency	No deficiencies recorded
<b>Walls</b>	Inspected
Condition	2 - Between Good and Fair
Deficiency	CERAMIC TILE: BROKEN/ MISSING
Deficiency Location/Instance	Room 218
Deficiency Quantity	10

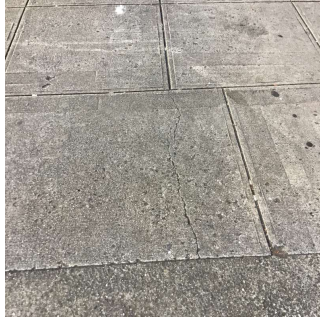
Question	Response
<b>SITE</b>	
<b>PAVING</b>	
<b>DOT Sidewalk</b>	
<b>Concrete</b>	
Purpose of Action	LEVEL 2
Deficiency Photo1

36th Avenue
Violations	No violations recorded.
<b>Deficiency</b>	<b>DAMAGED CURBS</b>
Deficiency Location/Instance	36th Avenue, 35th Street
Deficiency Quantity	70
Quantity Uom	L.F.
Potential Action	REPLACE
Urgency of Action	PRIORITY 3
Purpose of Action	LEVEL 2
Deficiency Photo1

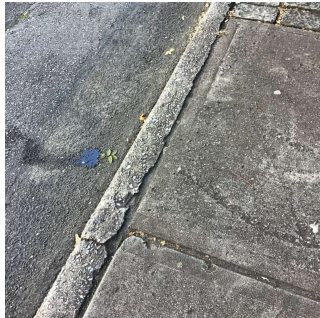
36th Avenue
Violations	No violations recorded.
<b>Pavers</b>	Does not Exist
<b>PLAYGROUNDS</b>	Does not Exist
<b>PLAYING SURFACE</b>	Does not Exist
<b>RETAINING WALLS</b>	Does not Exist
<b>SEATING</b>	Does not Exist
<b>SITE WALLS (NOT RETAINING WALLS)</b>	Does not Exist
<b>STAIRS/RAMPS: EXTERIOR</b>	Does not Exist
<b>ARTWORK</b>	Does not Exist
